| AIRCRAFT ACCIDENT SHORT REPORT |

CA18/3/2/1203 ZU-JEO, Occurrence title : During the landing the undercarriage failed to extend
Date and time : 18 April 2018, 11:09Z
Aircraft registration : ZU-JEO
Aircraft manufacturer and model : TL Ultralight, TL-2000 STING
Last Point of departure : Kuruman Airfield (FAKU), Northern Cape Province
Next point of intended landing : ZU-JEO
Location of accident site with reference to easily defined geographical points (GPS readings if possible) : Rand Aerodrome (FAGM), Gauteng Province (Elevation: 5200ft)
 (GPS:26°21'07.2" E027°58'08.4" Gauteng Province)
Meteorological Information : Surface wind: Calm. Wind direction: 270° Visibility: CAVOK
Type of operation : Private (Part 94)
Persons on board : 1 + 0
Injuries : Nil
Damage to aircraft : Substantial

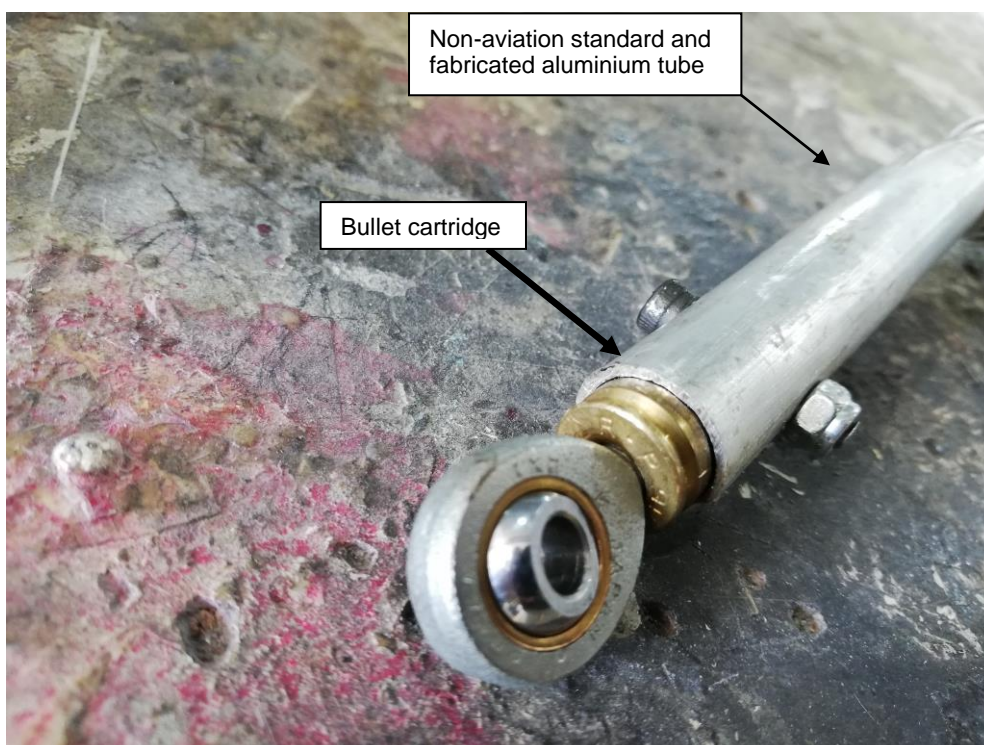
- The manufacturer recommended the use of Part number 120006669.
- The modification was done using non-aviation grade aluminium hollow tube, as well as a bullet cartridge, which housed a clevis bolt end as seen in figure 1.

- The modification made couldn't sustain the force required to move the nose gear, which led to the fabricated tube bending and not extending the nose gear. This failure caused the actuators to draw more current and cause a low voltage in the system.

Figure 1: Shows fabricated tube and bullet cartridge.

- 7.1 The undercarriage failed to extend due to the bending of the nose gear actuator tube. The bending resulted from a non-aviation standard modification which was fitted to the aircraft.

6.1 Owners should refrain from using non-standard or un-approved parts as they will lead to failure and injury.

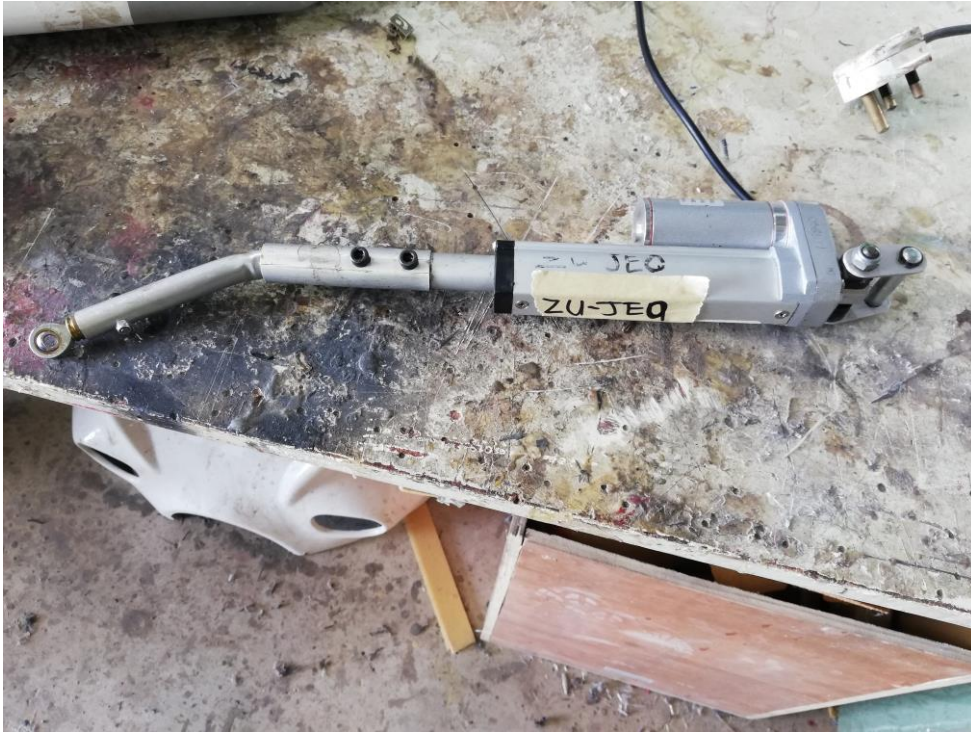
Figure 2: Shows nose actuator.

- 2.4 The aircraft had a valid Authority to fly which was issued on 27 March 2018 with expiry date of 16 March 2019.
- 2.5 The aircraft nose gear actuator was fitted with a non-aviation standard aluminium tube and a bullet casing which housed a clevis bolt.

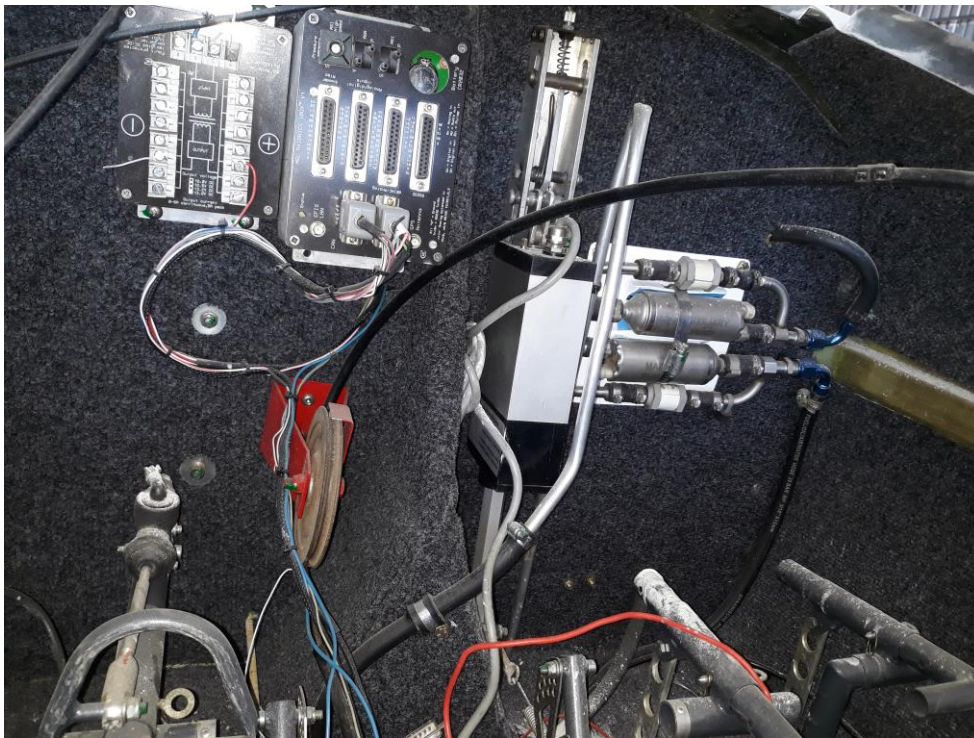
Figure 3: Picture showing original part in a similar aircraft type

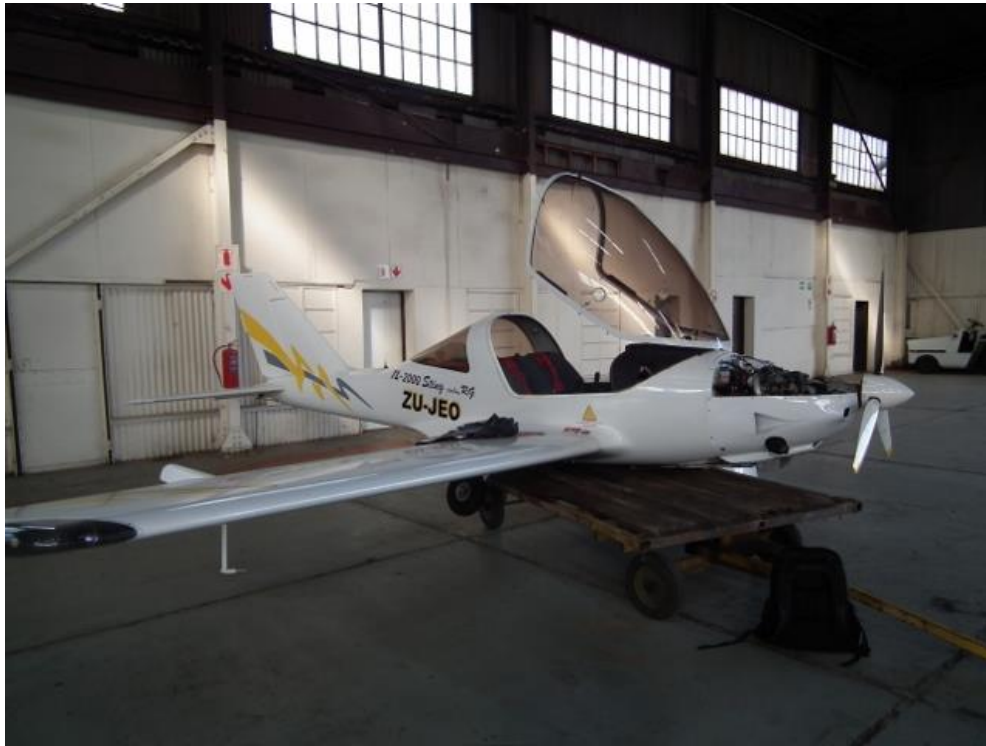
- 1.2 The pilot then elected to divert to Rand Aerodrome (FAGM) where emergency services were available. Upon arrival the pilot stated that he declared an emergency and was given permission to land on runway 29. The pilot further stated that he switched off the engine during the flare to minimise damage. During landing the undercarriage collapsed and the aircraft landed on its belly. The aircraft was substantially damaged and the pilot sustained no injuries.

Figure 3: Aircraft after being recovered from the accident
