AIRCRAFT INCIDENT SHORT REPORT

CA18/3/2/1204: ZS-ALO, Loss of separation between aircraft 1 and 2 on final approach for runway 29

Date and time : 17 April 2018 at 0955Z
Occurrence type : Serious Incident
Aircraft registration : ZS-ALO
Aircraft manufacturer and model : Embraer ERJ-135LR
Last point of departure : Cape Town International Aerodrome (FACT)
Next point of intended landing : Wonderboom Aerodrome (FAWB)
Location of incident site with reference to easily defined geographical points (GPS readings if possible) : On approach for runway 29 at FAWB
(GPS position; 25°39'19.11" South 028°13'16.81" East)
Meteorological information : Surface wind: 230°/ 6kts, Temperature: 23°C, Clouds: SCT at 8000 feet, Visibility: 10km
Type of operation : Air Transport Operations (Part 121)
Persons on board : 3 + 29
Injuries : None
Damage to aircraft : None

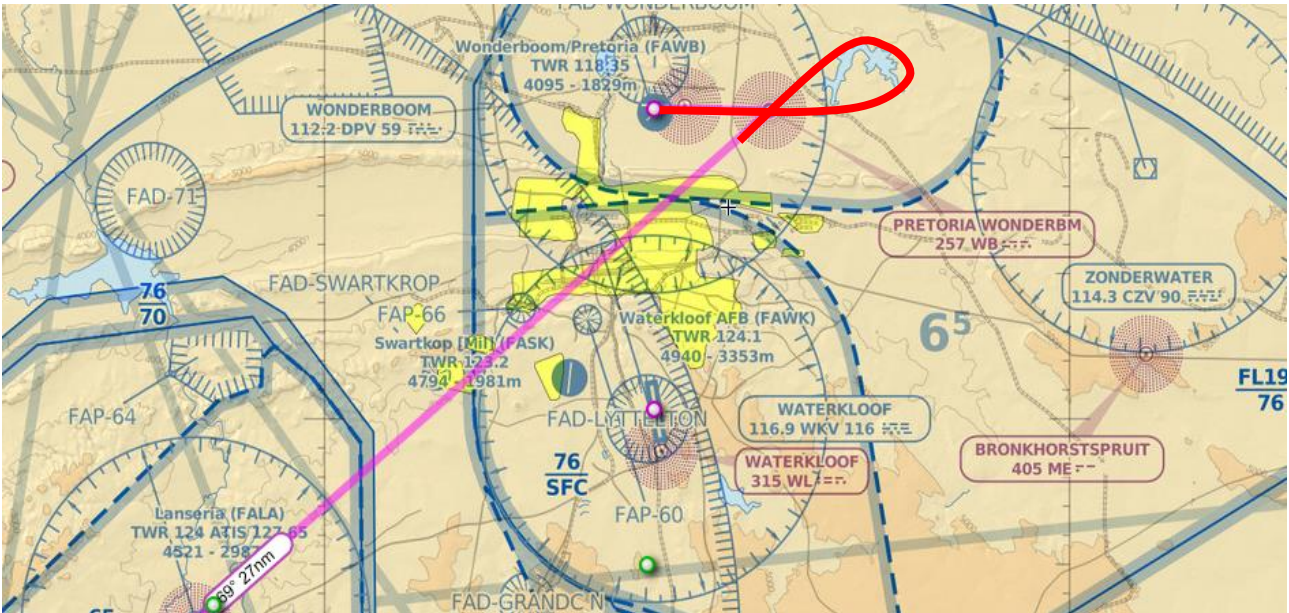
Figure 1: The flight plan routing from LIV to WB (Skyvector)

- 2.3 It was not possible for the crew to join on a right downwind from their current position and the pilot opted to fly over the WB beacon and position for a wide teardrop, which put the aircraft on a late downwind / base leg for runway 29. They assumed that this would have allowed enough spacing between them and the preceding student pilot in a Cessna 172 (ZS-OHN). Once they turned base they requested ATC to descend. They were advised to continue with the approach and they were number 2 for landing.

The red portion shows the tear-drop pattern to join on final approach that SA8678 carried out
