<b>AIRCRAFT INCIDENT REPORT AND EXECUTIVE SUMMARY</b>
---

Reference:	CA18/3/2/1206	
<b>Aircraft Registration</b>	ZS-VDP	<b>Date of Incident</b>	4 May 2018		<b>Time of Incident</b>	0728Z
<b>Type of Aircraft</b>	Boeing 737-300		<b>Type of Operation</b>	Part 121 (Air Transport Operations)		
<b>Pilot-in-command Licence Type</b>	ATPL	<b>Age</b>	54	<b>License Valid</b>	Yes	
<b>Pilot-in-command Flying Experience</b>	Total Flying Hours	8217		<b>Hours on Type</b>	3026	
<b>Last point of departure</b>	Port Elizabeth International Airport (FAPE), Eastern Cape					
<b>Next point of intended landing</b>	O.R. Tambo International Airport (FAOR), Gauteng					
<b>Location of the incident site with reference to easily defined geographical points (GPS readings if possible)</b>						
75 NM outbound from VOR PEV en-route to FAOR						
<b>Meteorological Information</b>	Wind: 060 <sup>0</sup> /10 <sup>0</sup> kt, Temperature: 19°C, Dew point: 08°C, Visibility: 9999m					
<b>Number of people on board</b>	8+116	<b>No. of people injured</b>	0	<b>No. of people killed</b>	0

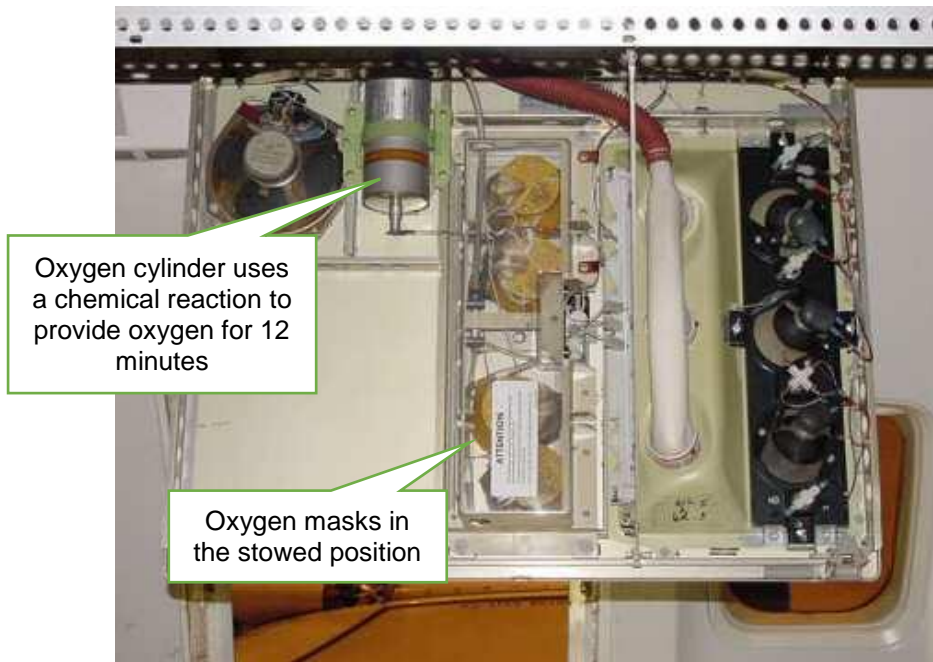
**Figure 6:** Passenger oxygen mask. Similar masks are fitted above the cabin crew stations and in the lavatories

1.15.2 The passengers had access to drop-down oxygen masks from the overhead passenger service units (PSUs). The PSUs above rows 4DEF and 24DEF had not opened and deployed the masks. An elderly female passenger sitting in seat 4E was given a mask from row 5DEF. The forward lavatory mask also did not deploy, but the lavatory was not occupied at the time of the incident.

1.15.3 The cabin crew had access to drop-down masks for immediate use. Portable oxygen bottles were also available. The drop-down masks at the forward cabin crew station dropped down, but when pulled to activate the oxygen flow, no flow was noted.

- Row 4DEF and row 24DEF did not drop out. The corrective action carried out included an inspection of the PSU and a drop test. All operations are now normal.
- Forward lavatory mask did not drop out. During inspection, it was found that the panel had been poorly masked during painting. This caused excessive paint to harden and prevent the masks from deploying. The excess paint was removed and the panel tested. All operations were normal

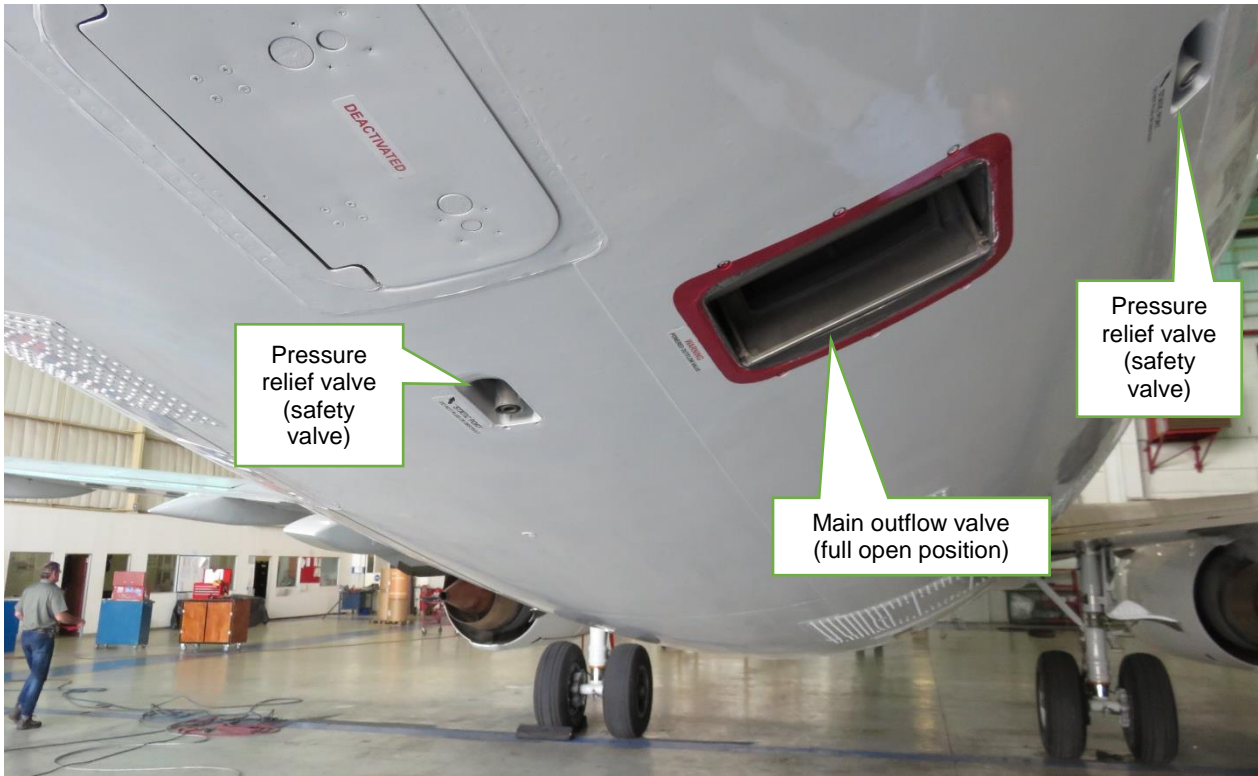
**Figure 7:** Main outflow valve and two pressure relief valves

2.4 Based on the crew report for the inbound leg from FAOR to FAPE, while the aircraft was in the cruise at FL360, the cabin pressure differential was observed to be in the region of 9,4 psi. The crew descended to FL340 and then on to FL320 to lower the cabin differential pressure. The descent help lower the pressure to below the amber band. Due to this excessive high pressure, it is evident that the two pressure relief valves did not operate as

- 3.1.10 After the incident had occurred, both pressure relief valves were removed for inspection. A bench test was carried out on each unit to check for serviceability. Paint over spray was found in both valves static ports. This was cleaned up prior to the commencement of the test therefore the actual effect of the over spray could not be determined. Both valves “crack” pressure was noted to be too high and was adjusted to the correct “crack” pressure. (refer to Appendix F for work pack extract)

The secondary cause of the pressurisation failure, which caused the high cabin pressure differential, was due to the failure of both pressure relief valves. Neither of these valves opened at 8,3 psi to ensure that the cabin differential did not exceed the amber band.

- Cabin pressure controller replaced. After carrying out a test, all operations were found to be normal.
- Both pressure relief valves were removed and sent for testing.

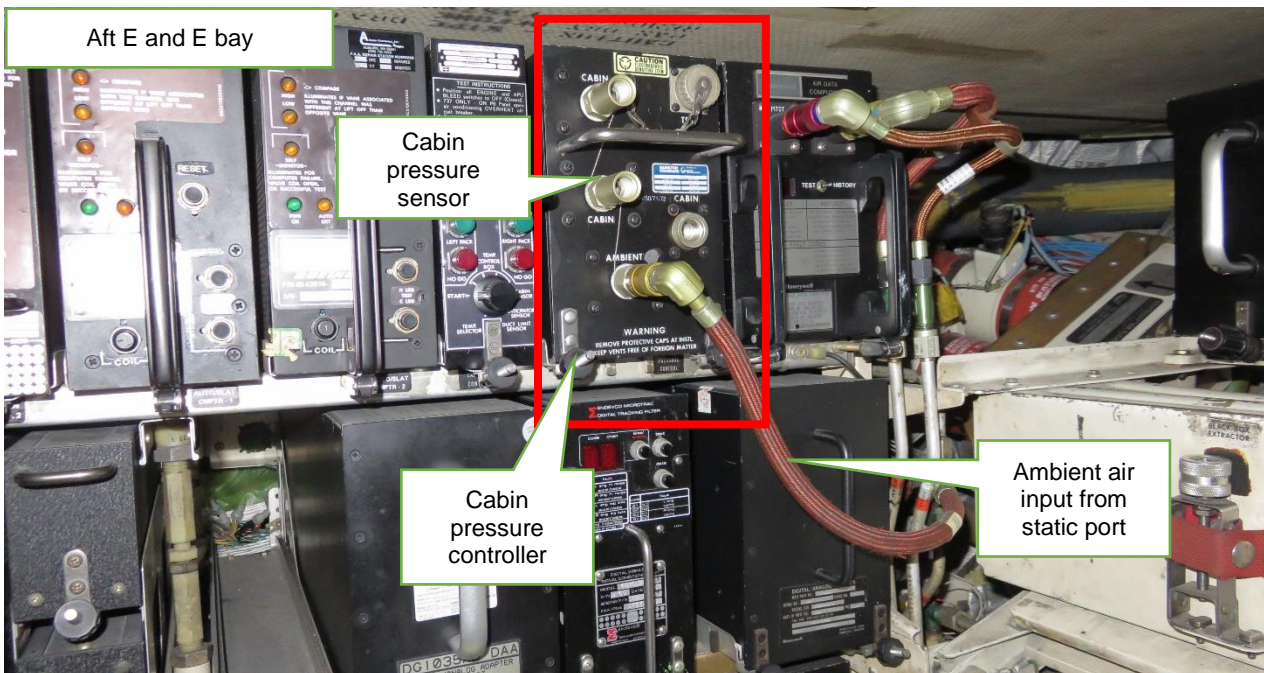
**Figure 8:** Cabin pressure controller in the Aft E and E bay

- 2.7 The investigation revealed that the Cabin Pressure Controller (CPC) had failed to modulate the outflow valve to maintain the correct pressure schedule and the failure of the safety valves to open and relief pressure at 8.3Psi differential.

The primary cause of the loss of pressurisation control was due to a loss of the CPC’s ability to correctly modulate the outflow valve position.

1.16.2 After replacing the CPC, the outflow valve was tested. All operations were than normal.
