AIRCRAFT INCIDENT SHORT REPORT

CA18/3/2/1207: ZU-WCG, Nose landing gear collapse on touchdown runway 08 at Port Elizabeth Airport

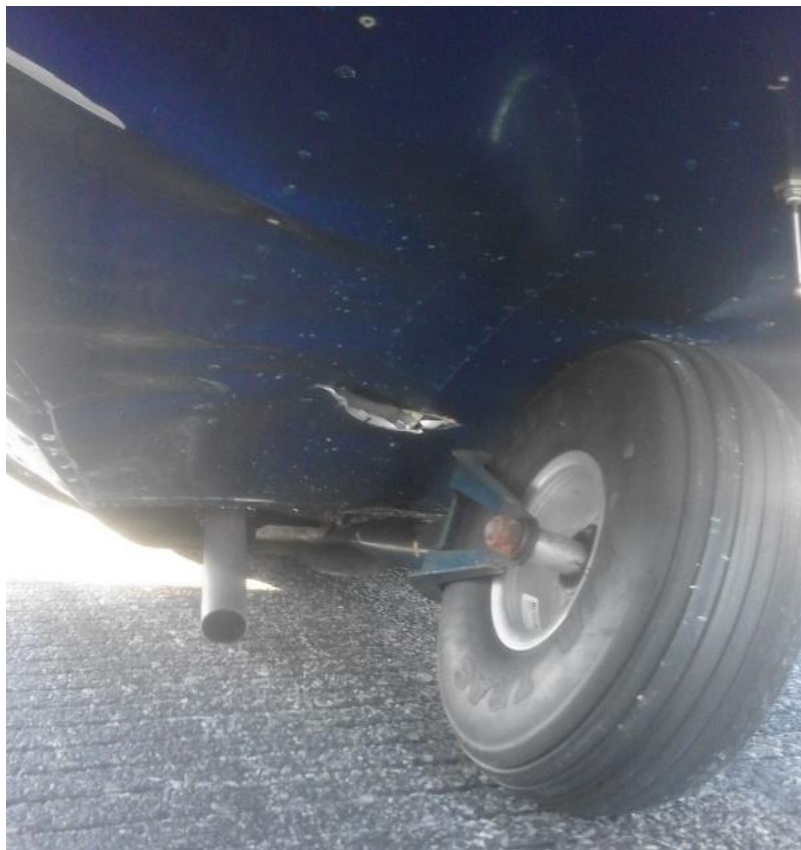
- 3.2.1 The aircraft had flown 34 hours since the last inspection. The aircraft was in possession of a valid certificate of Release to Service and Authority to Fly.
- 3.2.2 The nose gear collapsed backward. (See Appendix C and D). The paint on the strut showed signs of peeling. This process had happened over time as corrosion had become evident on the strut.
- 3.2.3 The wind direction was a head wind of 14 knots. No wind gusts were reported on the day. Therefore, the weather may not have played a factor in the incident.
- 3.2.4 The Sling 2 aircraft type has had in excess of 12 nose gear collapses in the past 5 years (See appendix E for photos of previous incidents)

Figure 1: A view of the collapsed nose gear (source: C Coetzee)

Due to weakening of the nose gear strut over time, a possible excessive force applied to the gear on touch down caused the nose gear strut to bend backward and collapse.

Safety message: It is recommended that operators of the Sling 2 aircraft carry out more frequent inspections on the nose landing gear strut for signs of distortion or damage. This is more pertinent to operators especially in the training environment who carry out a large amount of cycles between maintenance inspections.

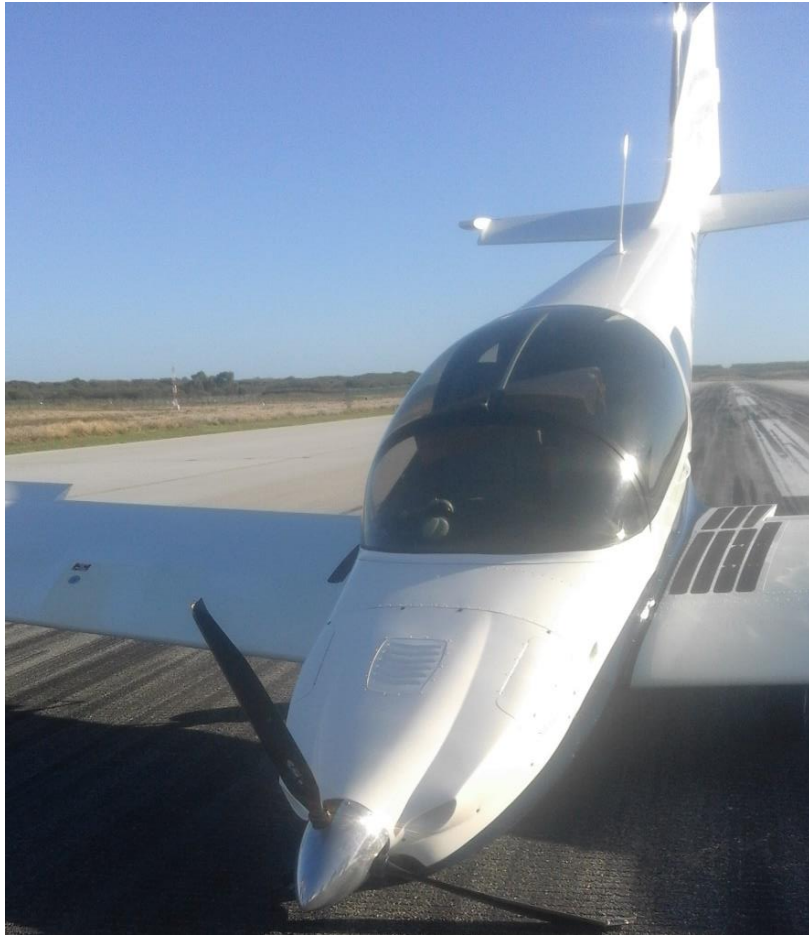
Figure 2: The aircraft as it came to rest on the runway (source: C Coetzee)

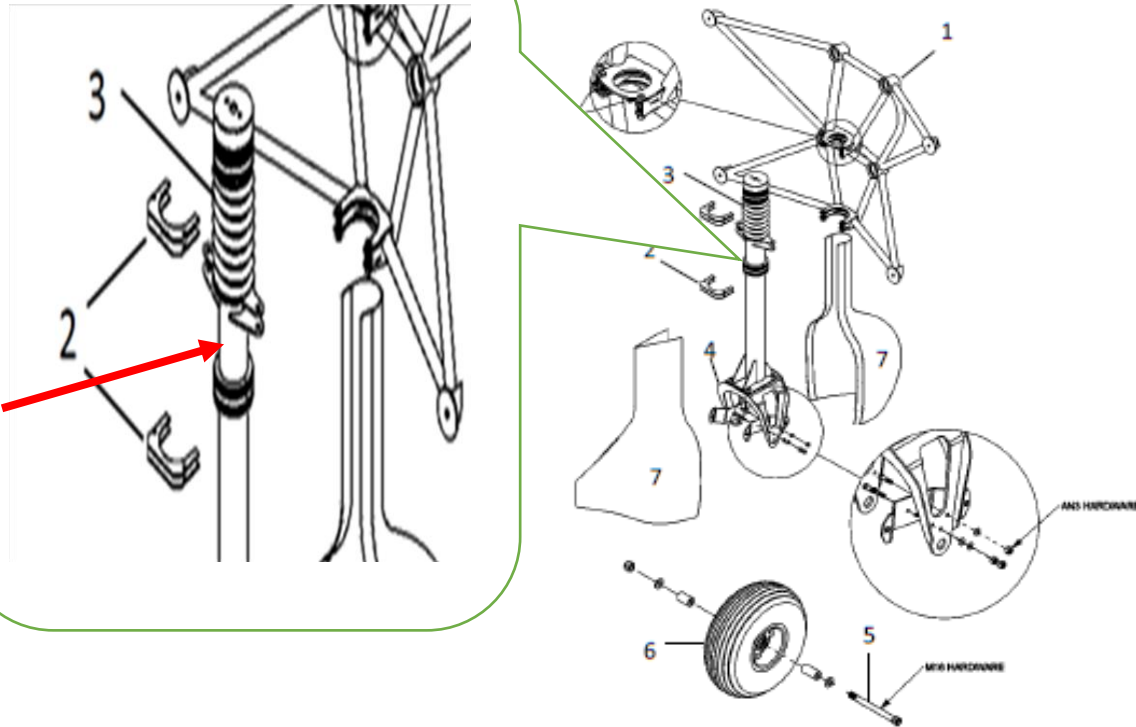
Figure 38: Nose gear.

(The red arrow depicts the approximate position of the nose gear damage) (Source: Sling 2 Maintenance Manual)

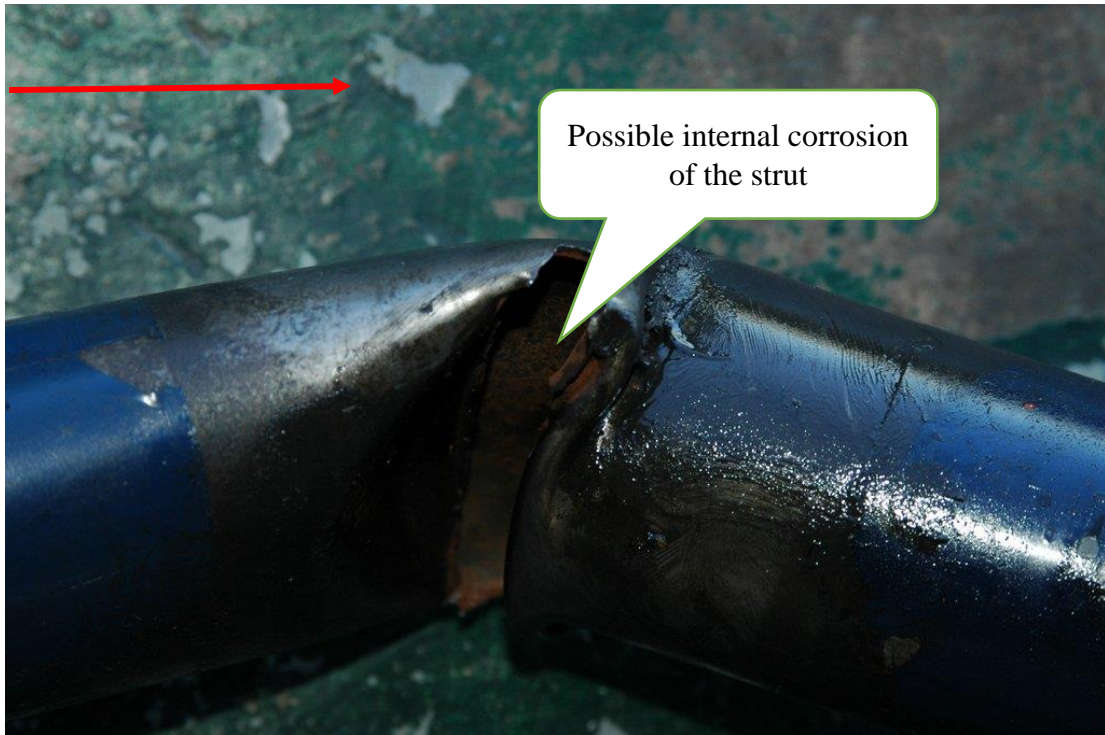
View B (before the strut was straightened) (Source: T Meyer)

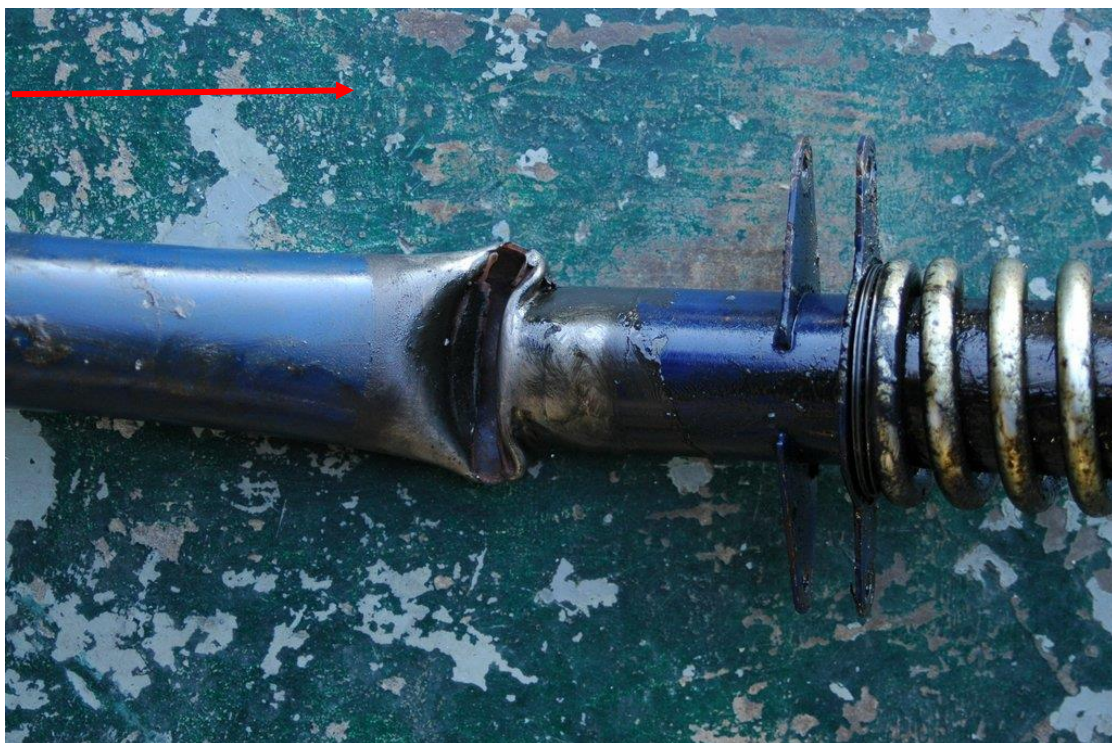
View C (After the strut was straightened) (Source: T Meyer)
