**AIRCRAFT INCIDENT REPORT AND EXECUTIVE SUMMARY**

Reference:	CA18/3/2/1209	
<b>Aircraft Registration</b>	ZS-NBG	<b>Date of Incident</b>	11 May 2018		<b>Time of Incident</b>	0616Z
<b>Type of Aircraft</b>	Bombardier CL-600-2C10		<b>Type of Operation</b>	Commercial (Part 121)		
<b>Pilot-in-command Licence Type</b>	ATPL	<b>Age</b>	60	<b>Licence Valid</b>	Yes	
<b>Pilot-in-command Flying Experience</b>	Total Flying Hours	18 417		Hours on Type	8 885	
<b>Last point of Departure</b>	East London Airport (FAEL), Eastern Cape Province					
<b>Next Point of Intended Landing</b>	O.R. Tambo Airport (FAOR), Gauteng Province					
<b>Location of the incident site with reference to easily defined geographical points (GPS readings if possible)</b>						
FAEL at GPS coordinates determined to be S33°02'13.16" E027°49'23.36" at an elevation of about 435ft						
<b>Meteorological Information</b>	Wind direction: 270V300; wind speed: 4 kt; air temperature: 14°C; visibility: CAVOK; dew point: 8°C

<b>SRP Date</b>	19 July 2019		<b>Publication Date</b>	30 July 2019

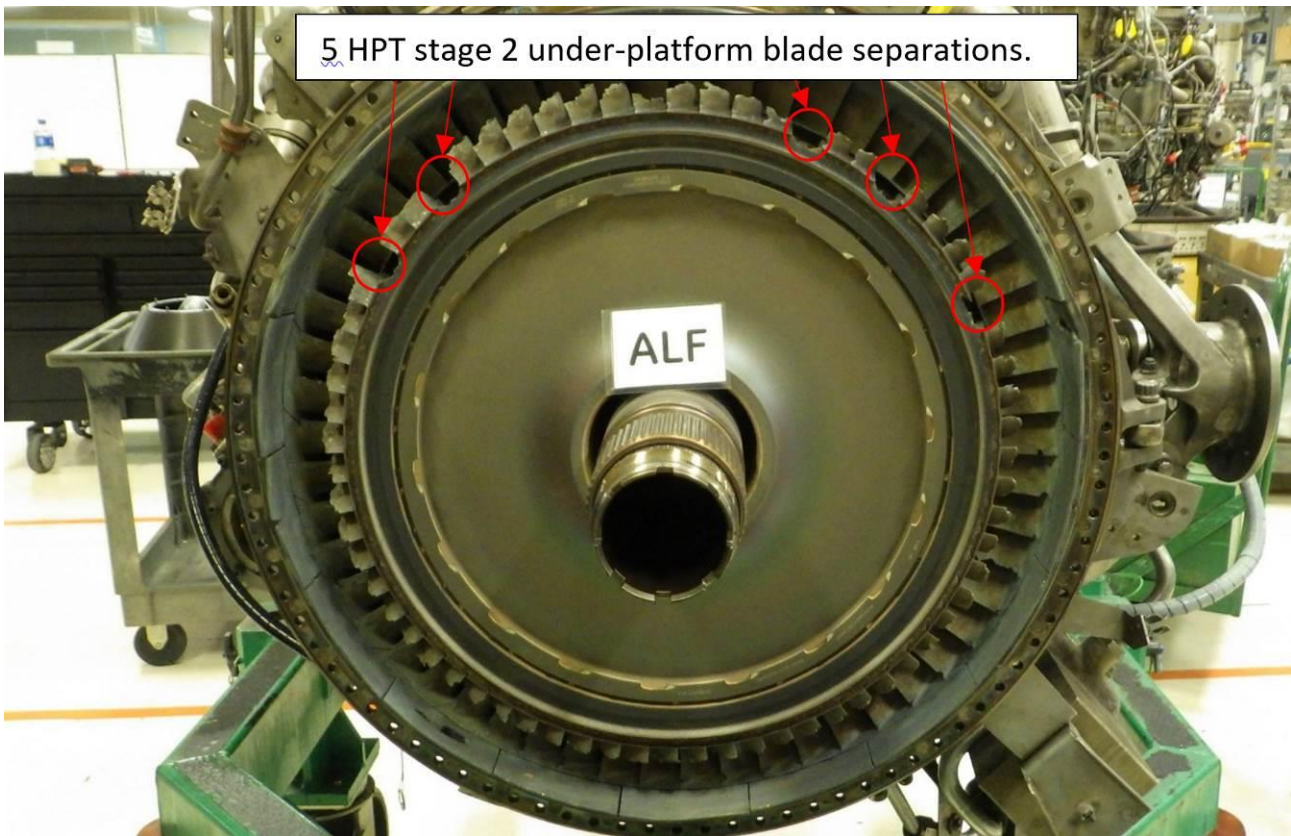
According to the NTSB field notes, it was observed that the engine had no breaches of case containment or evidence of fire, but that all the HPT stage-two blades were fractured. Five of the blades were separated below the platform and the remaining 63 blade fractures measured  $\frac{1}{4}$  to  $\frac{1}{2}$  inch (6.4mm to 12.7mm) above the platform. The report further described severe collateral damage to the LPT module, with a large quantity of liberated aerofoil fragments found loose along the entire flow path. According to the field notes, the combustion module was partially disassembled, and inspection observations indicated that the inspected parts were in typical condition of a combustor with the time in service.

**Figure 1:** Five HPT stage-two blade separations

- 3.2.14 The FDR download and analysis indicated that all parameters were normal and that the number 1 engine had failed.
- 3.2.15 The engine teardown revealed that the HPT stage-two assembly had experienced five blades under-platform separations. Examination of the fractured surfaces by the manufacturer revealed a fatigue region originating at the convex shank surface. The fatigue features were consistent with corrosion-assisted fatigue having significant discolouration with a smooth, indistinct topography.

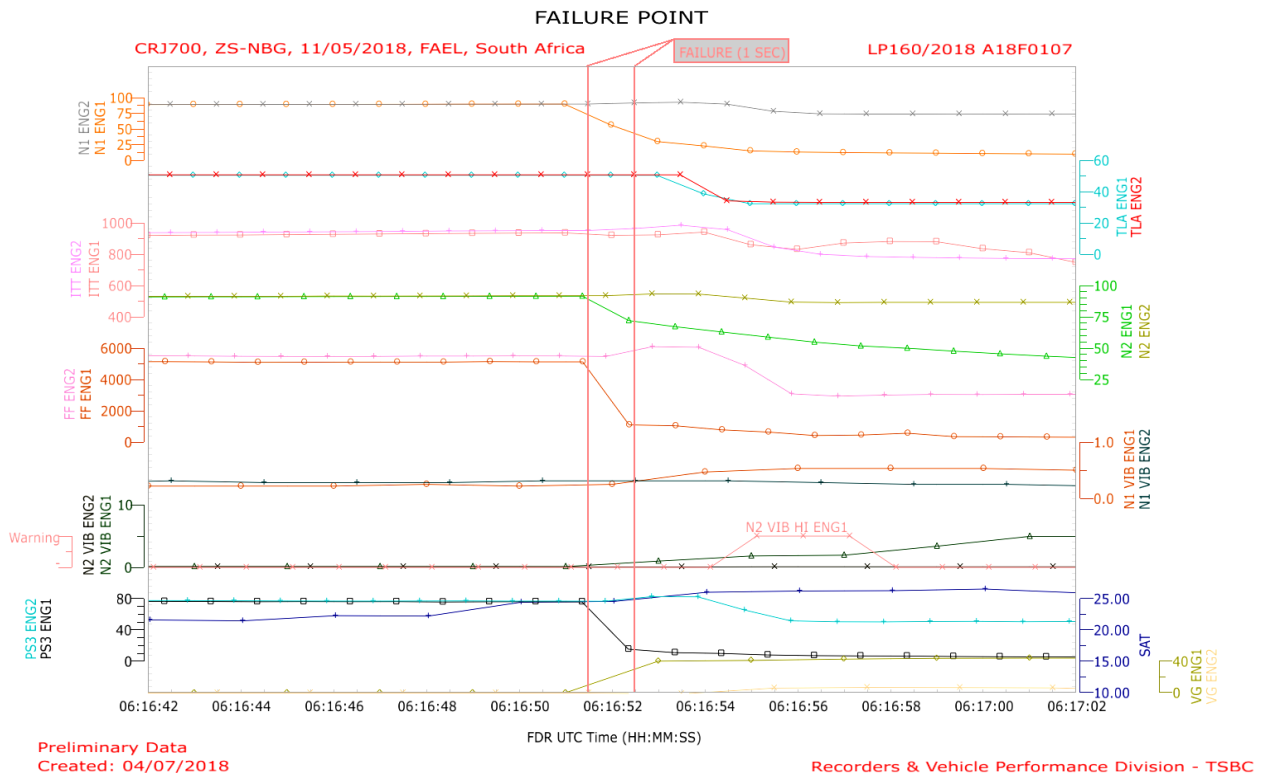
**Figure 2:** FDR download highlighting the number 1 engine failure point

1.11.2 The FDR download and analysis revealed that all parameters were normal and that engine number 1 encountered a sudden catastrophic failure. In Figure 2, it is evident that when engine number 1 failed at 06:16:52, the N1 decreased, N2 decreased, fuel flow decreased, and the vibration increased. The FDR download also showed a warning of N2 high vibration for engine number 1 after the engine failure between 06:16:54 and 06:16:58.

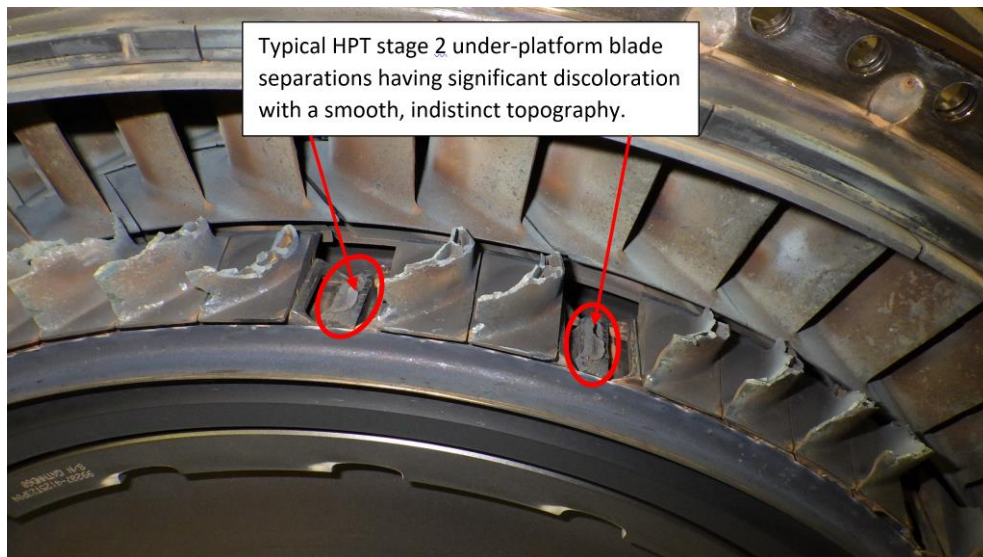
Metallurgical evaluation of previous stage two turbine blade revealed a fatigue region originating at the convex shank surface. The fatigue features were consistent with corrosion-assisted fatigue having significant discolouration with smooth, indistinct topography. GE introduced an improved stage two blade with P/N 4125T65G01 in 2010, adding an under-platform corrosion coating along with geometry changes to reduce shank stresses to meet the requirements of the coated LCF life. GE SB 72-0228 was originally issued in April 2010, introducing the modification at customer convenience. The SB was revised in February 2013 to change the compliance to recommended at next shop visit due to the number of blade failure events recorded. SB 72-0228 was not embodied on the CF34-8C5B1 engine with S/N 965272 which failed.

**Figure 3:** Typical HPT stage-two under-platform blade separations having significant discolouration with a smooth, indistinct topography

- 3.3.1 The number 1 engine failure because of the HPT turbine stage-two assembly blade separations. Examination of the fractured blades revealed a fatigue region originating at the convex shank surface which was caused by corrosion.

A corrective action is in place. GE introduced an improved stage-two turbine blade with P/N 4125T65G01 in 2010, adding under-platform corrosion coating along with geometry changes to reduce the shank stresses to meet the coated LCF life. The improved blade is introduced through a GE field plan whereby operators must accomplish the GE SBs 72-0228 R1 for CF34-8C series engines or 72-0119 R1 for CF34-8E series engines. The SBs are rated CAT 3 at GE, which means fulfilment of the SB is recommended at the next shop visit. The last shop visit of the engine was on 7 May 2010 just after the initial release of the SB in April 2010 which was to be embodied at customer convenience. At the time of the engine failure, the GE database showed that 71.2% CF34-8C series engines and 92.2% CF34-8E series engines have complied with the recommended modification.

- 4.2.1 Safety intervention: The manufacturer had issued the SB 72-0228: The installation of the improved stage-two turbine blade with P/N 4125T65G01 in accordance with GE service bulletin SB 72-0228 should be mandatory at the next shop visit for unmodified engines due to the number of significant IFSD events recorded thus far. From 2010 to present, there have been 29 confirmed significant events on CF34-8C and CF34-8E series engines at between 7 554 and 20 962 cycles at the time of failure. At the time of the incident, the engine had accumulated a total of 20 962 cycles.
