**AIRCRAFT SERIOUS INCIDENT SHORT REPORT**

**CA18/3/2/1210:** ZS-NMI, in-flight engine shutdown during the climb phase

**Date and time** : 16 May 2018, 0535Z  
**Occurrence type** : Serious incident  
**Aircraft registration** : ZS-NMI  
**Aircraft manufacturer and model** : Bombardier/Canadair Regional Jet CL-600-2B19

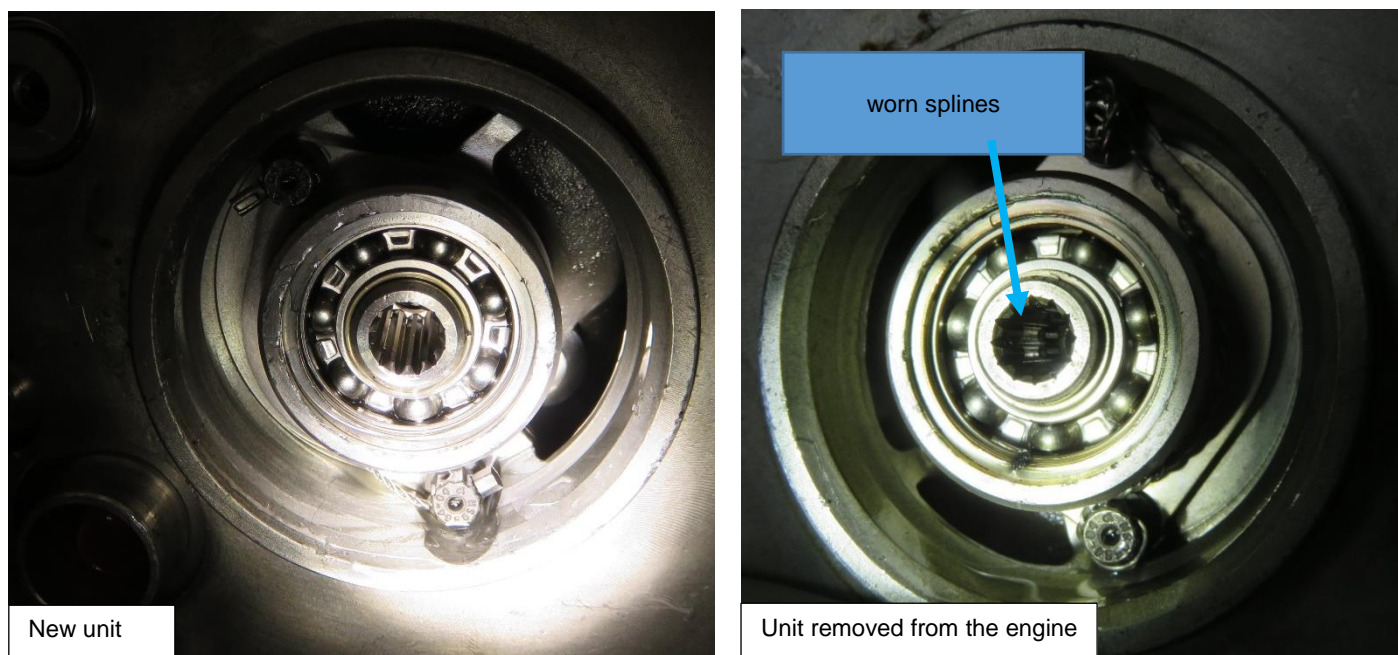
- 2.3 The Accident and Incident Investigation Division (AIID) was notified of the incident and an investigating team was dispatched to the aircraft maintenance organization (AMO) at FAOR, where the aircraft had been towed into a maintenance hangar. The engine did not display any visible damage. The engine fault-finding checklist was followed. It was recommended that the drive shaft between the fuel pump and the fuel management unit (FMU) be inspected for continuity. The FMU was removed where it was attached to the fuel pump, and the drive shaft was found to display signs of excessive wear on the side of the FMU. The gear train on the FMU also displayed evidence of wear that had caused the drive gear to slip in operation. This disrupted the fuel supply to the engine, resulting in an engine shutdown.

**Figure 2:** FMU splines of a new unit (left) compared with the unit removed from the engine (right)

- 4.1 Failure of the FMU drive gear and shaft splines leading to engine flame out

- 7.1 Safety Message: The operator needs to review their maintenance control to ensure that safety alerts (SB/AD) are incorporated to prevent incidents such as this one from reoccurring.

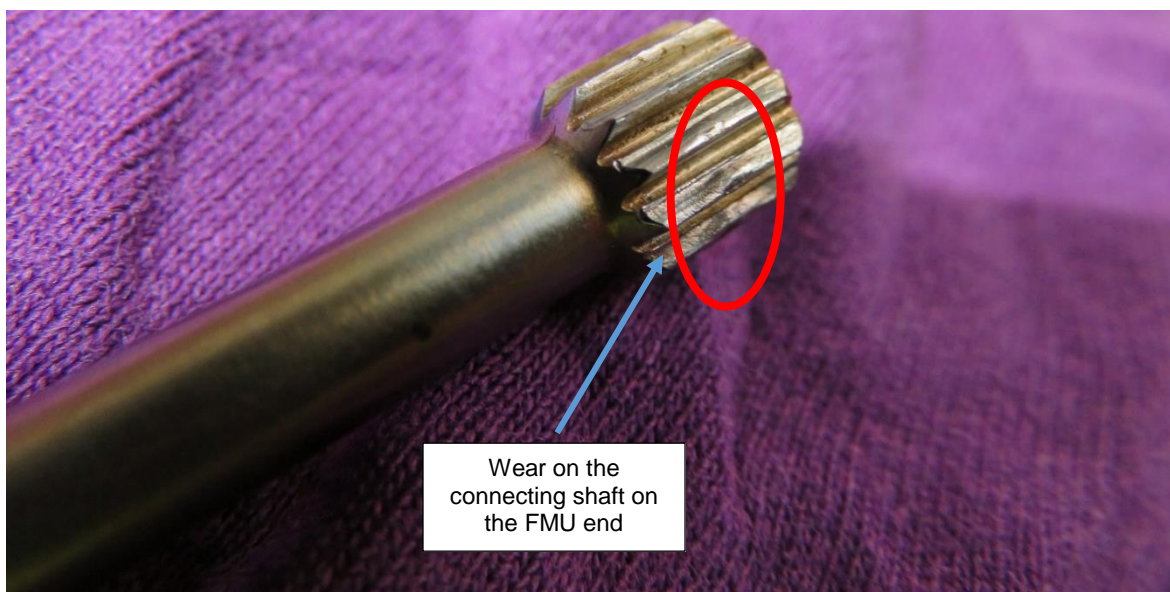
**Figure 3:** The interconnecting drive shaft that links the fuel pump to the FMU. The FMU side of the shaft is shown.

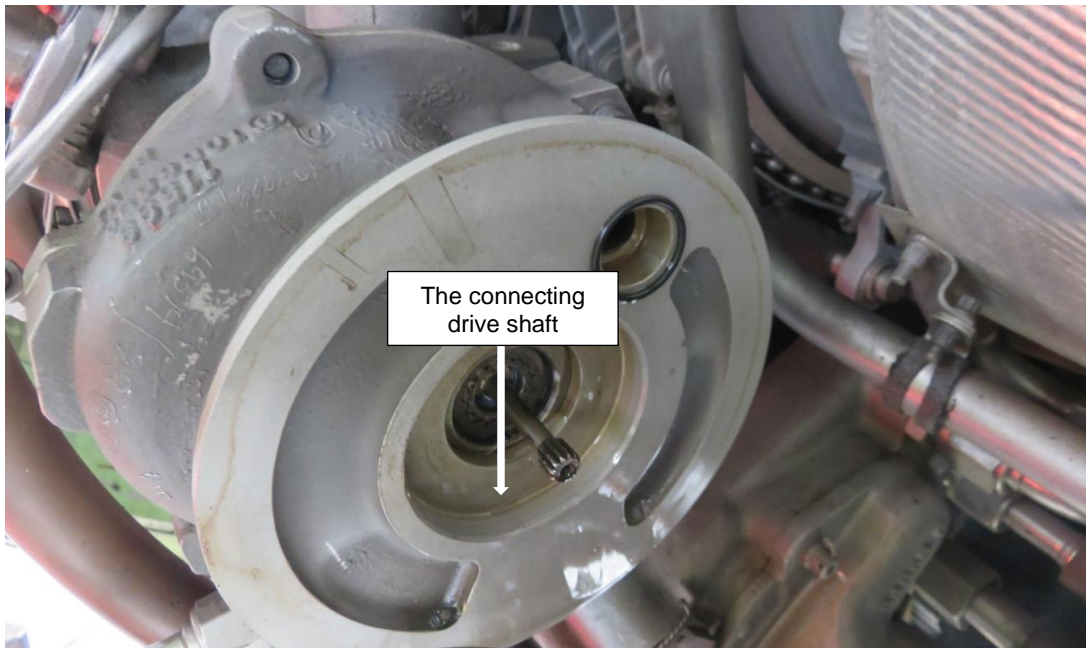
**Figure 5:** The connecting drive shaft still inserted in the main fuel pump drive train
