AIRCRAFT ACCIDENT SHORT REPORT

CA18/3/2/1211 ZS-KPC, emergency landing on a field following engine power loss due undetermined reasons.

Aircraft registration : ZS-KPC

Aircraft manufacturer and model : Air Tractor, AT-301

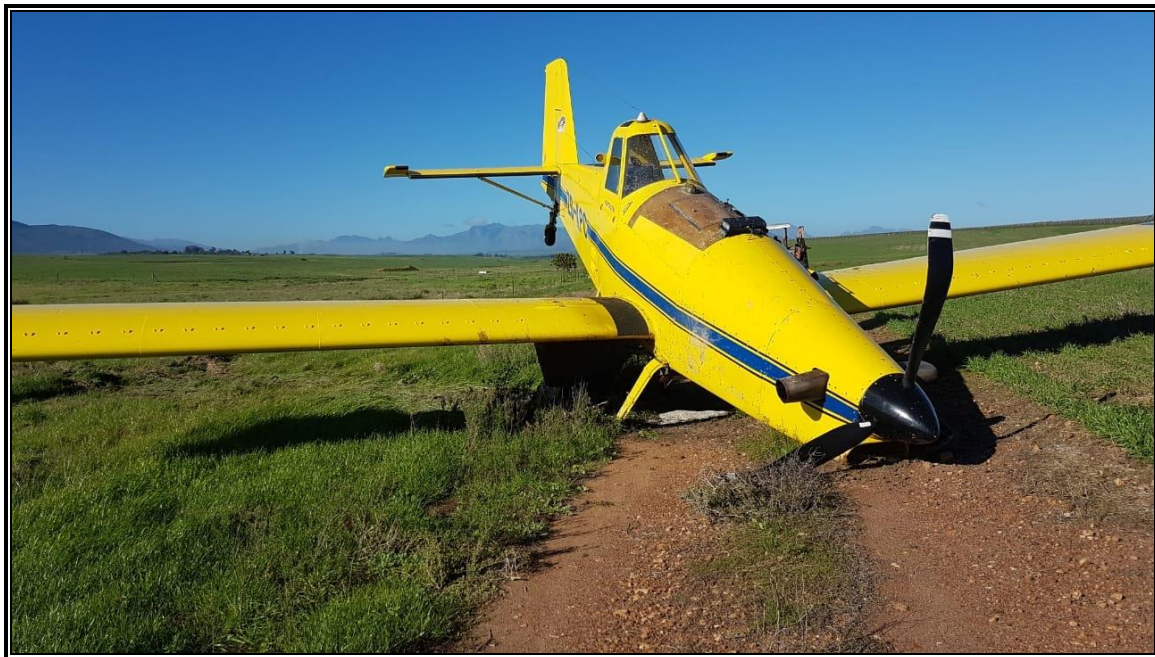
- 2.3 On touch-down, the main landing gears dug into the soft ground and caused the nose to tip over. The propeller then impacted the ground. The aircraft came to rest in a nose-down attitude. Damage to the aircraft included the main landing gear, the propeller, support structure and a portion of the nose cowling. The pilot stated that there was 220Lt of fuel remaining on board after the accident. The pilot sustained no injuries during the forced landing sequence.

Figure 2: The aircraft as it came to rest (photo: AC le Roux).

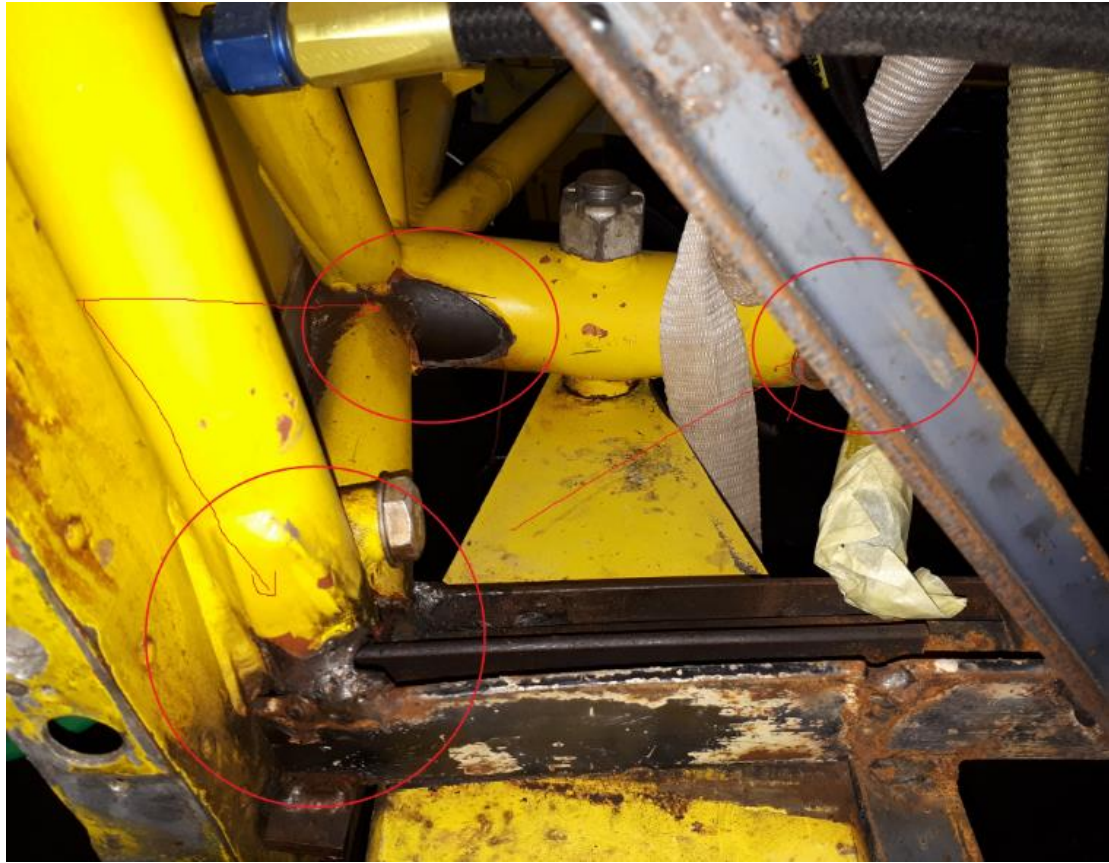
- 1.3 Upon touch-down, the aircraft nosed over and the propeller impacted the ground. Damage to the aircraft was limited to the undercarriage, the nose cowling and the propeller. The pilot sustained no injuries during the landing sequence.

Figure 3: Damage to aircraft structure.

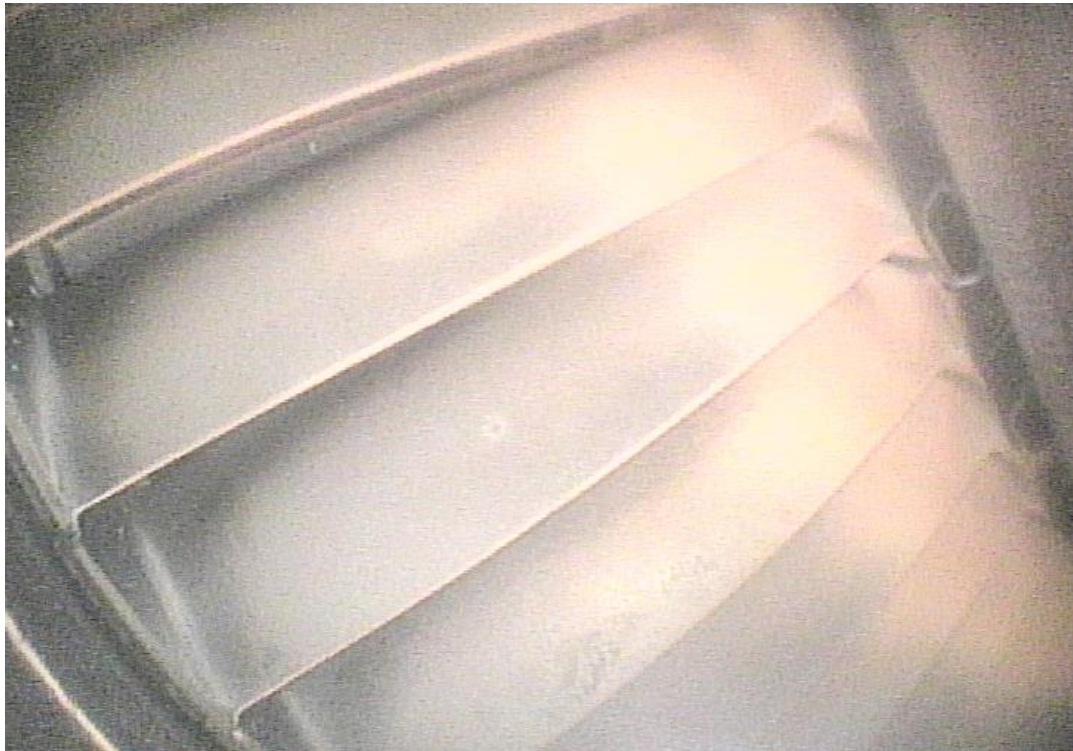
- 3.14 A borescope inspection was carried out on the engine after the incident. No internal faults were identified by the AMO.
- 3.15 Various troubleshooting procedures were carried out on the fuel and engine bleed systems after the accident by the AMO. No fault could be isolated.

Figure 3: Turbine blades.
