AIRCRAFT INCIDENT SHORT REPORT

CA18/3/2/1214, Nose gear failed to extend during approach and the aircraft landed with nose gear retracted.

Date and time : 23 July 2018 at 1257Z
Aircraft registration : ZS-MBU
Aircraft manufacturer and model : Cessna Aircraft Company; Model T210M
Last point of departure : Wonderboom Aerodrome (FAWB)
Next point of intended landing : Wonderboom Aerodrome (FAWB)
Location of incident site with reference to easily defined geographical points (GPS readings if possible) : Wonderboom Aerodrome (FAWB), Gauteng (GPS:25°39'13.79" E028°13'51.53")
Meteorological information : Surface wind: Calm, CAVOK
Type of operation : Training (Part 141)
Persons on-board : 2
Injuries : Nil
Damage to aircraft : Substantial

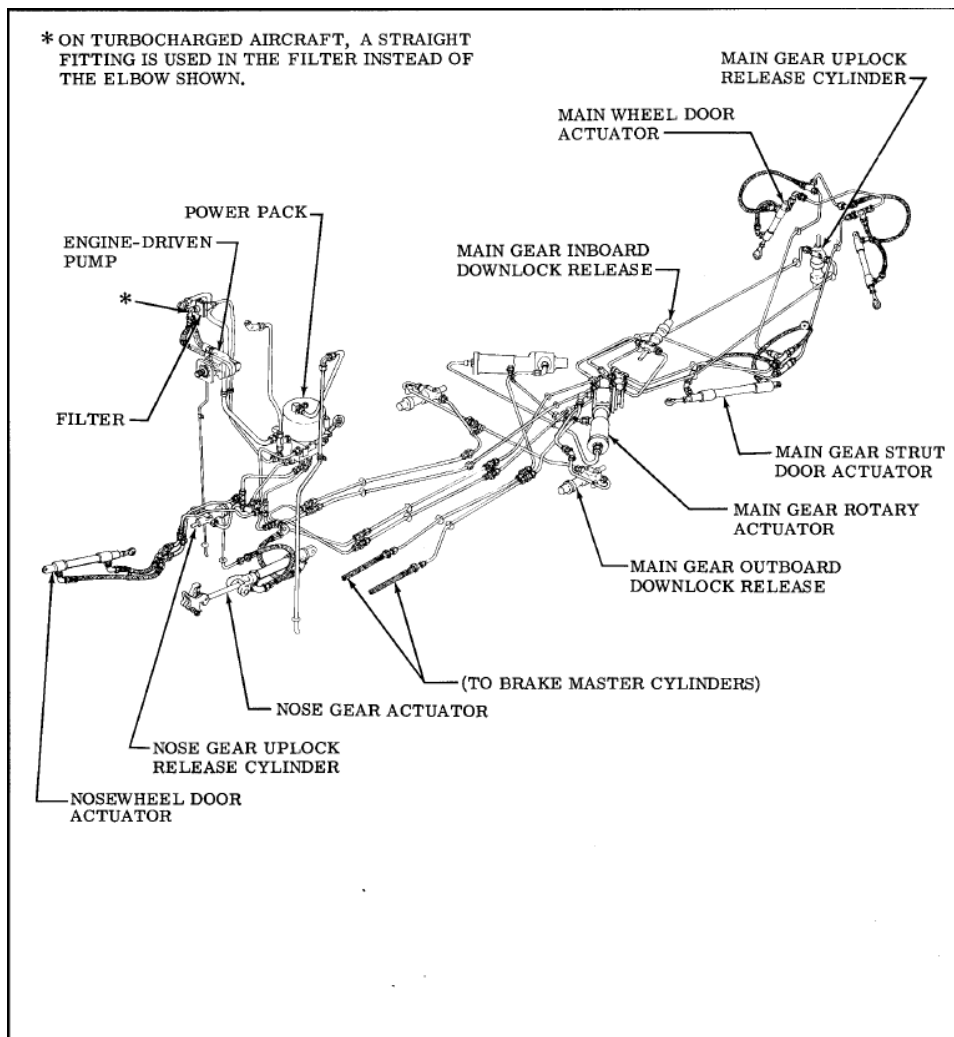
Figure 1: Hydraulic system components

2.1.10 The nose gear system failed to extend when the landing gears were selected down and only the main gears did extend. The check valve opens the doors when the pressure in the system reaches 400 pounds per square inch (psi) and if that pressure is not reached, the system will not operate which resulted in the nose gear failing to extend.

- 2.1.11 When the emergency hand pump was used, it had no effect as the hydraulic fluid flows through the same nose gear door check valve and increases the pressure to 400psi. If the pressure fails to get to 400 psi, then the rest of the system will not operate. As a result the nose gear will not extend.
- 2.1.12 The investigation revealed that it is likely that there was a blockage in the nose gear door check valve which prevented the flow of the hydraulic fluid into the nose gear door actuator system as a result there was not enough pressure (400psi) required to open the door check valve which will automatically open the priority valve to extend the nose gear. The emergency system operation couldn't extend the nose gear as it depends on the opening of the check valve which failed to open.

- 3.11 The investigation revealed that it is likely that there was a blockage and/or leakage in the nose gear door check valve system which prevented the flow of the hydraulic fluid into the nose gear door actuator system as a result the required 400 psi pressure could not be reached resulting in the nose gear failing to extend.
