AIRCRAFT INCIDENT SHORT REPORT

CA18/3/2/1217: ZS-WZP, Runway excursion after an aborted take-off

Aircraft registration : ZS-WZP

Aircraft manufacturer and model : Atlas Angel X328

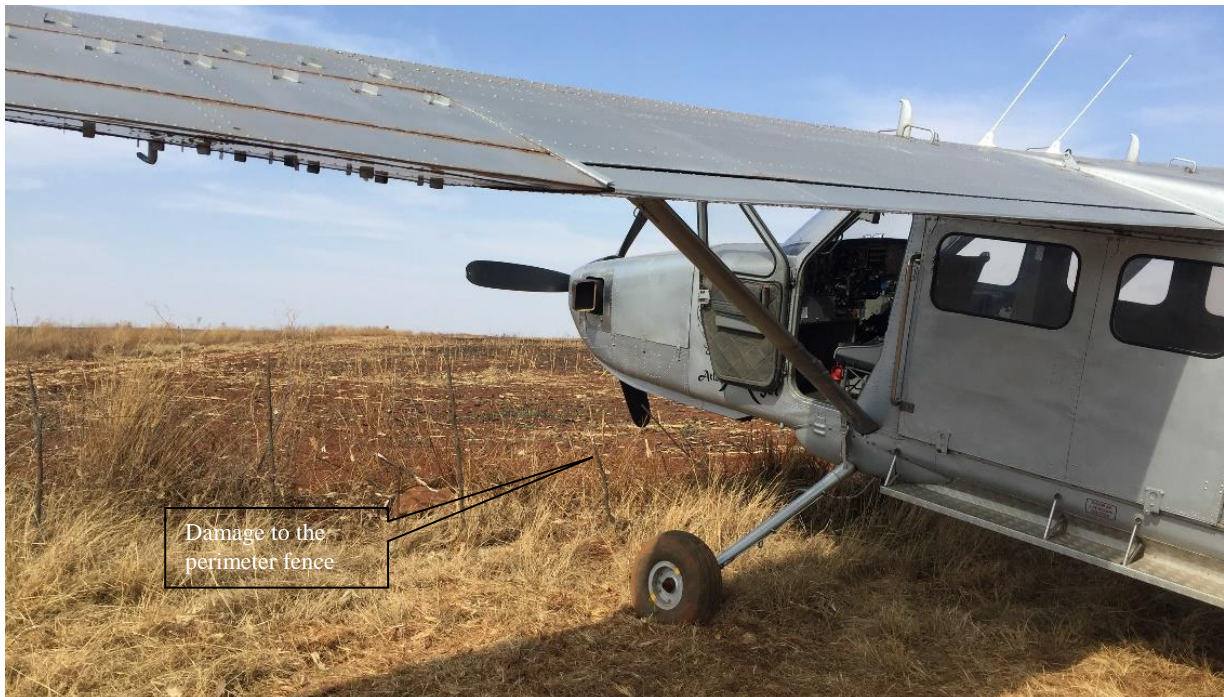
Figure 1: The aircraft at the incident site

- 1.6 The investigation revealed that the aircraft experienced loss of engine power during take-off and as a result, the pilot decided to abort take-off. There was insufficient runway length available and the aircraft overshot the runway and collided with a perimeter fence.

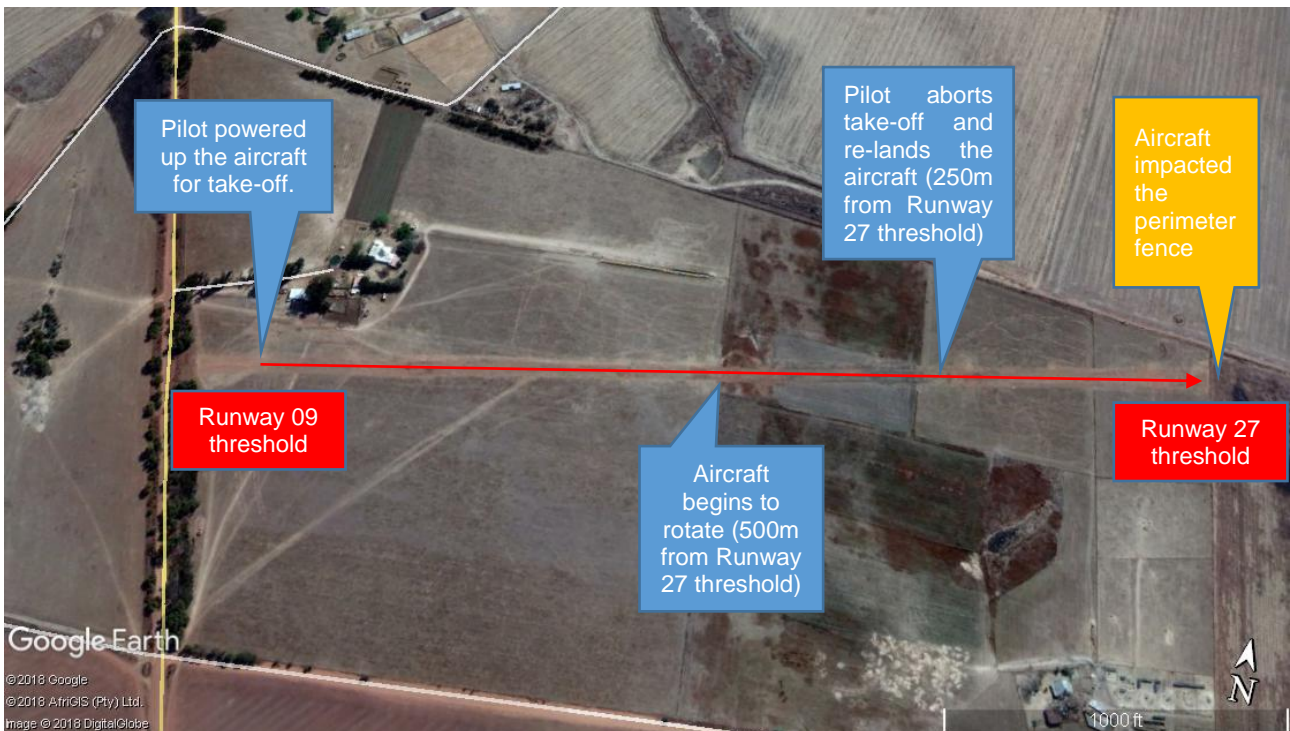
3.7 The runway that was used for the operation is located on a private farm. The field elevation is 5 015 ft. above mean sea level. Runway 09 is approximately 1000m in length and is made up of sand and grass. The pilot rotated the aircraft at approximately 500m down the runway and landed the aircraft at approximately 250m from the opposite threshold runway 27. There is no separation between the runway threshold and the perimeter fence. The airfield is not registered.

Figure 4: Approximated sequence of events leading to the runway excursion (Google Earth)

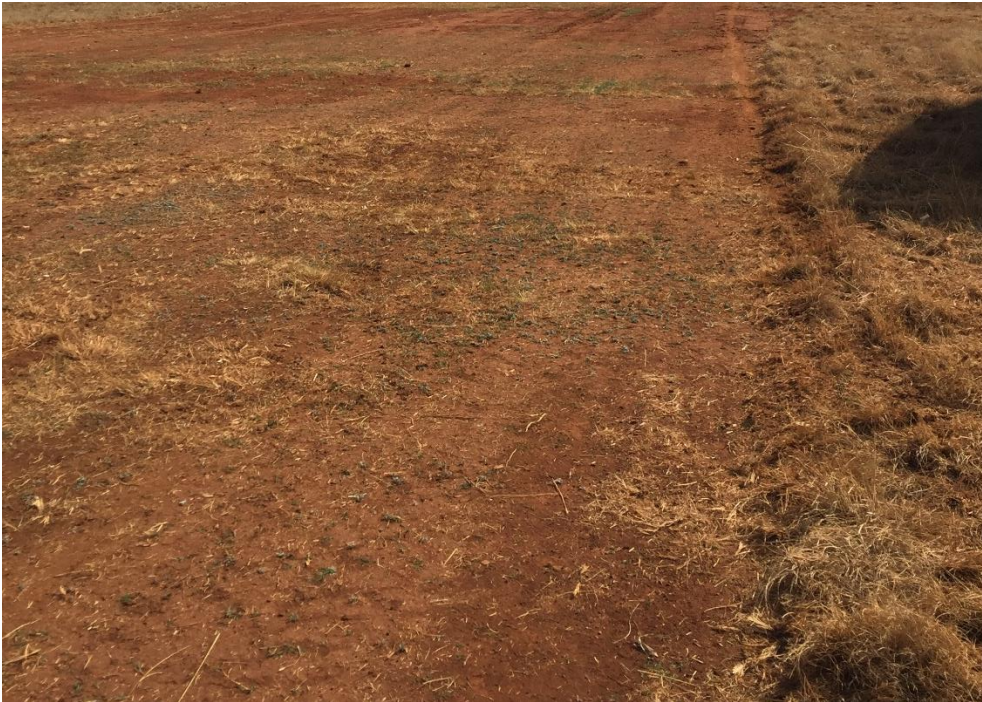
Figure 5: The runway surface texture (photo provided by the pilot)

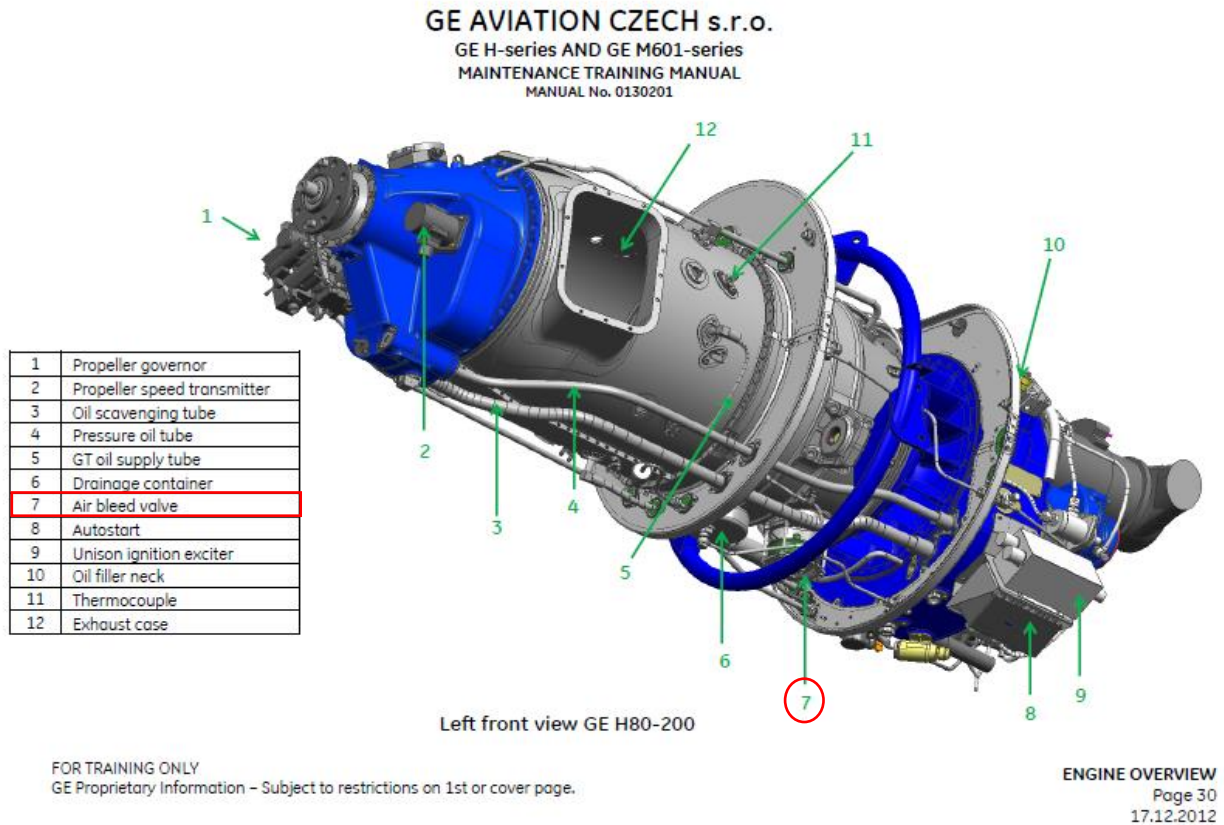
- 3.10 After the incident, the engine was inspected and the bleed valve on the compressor case was found to have remained in the open position. This caused the air in the compressor to be dumped back into the compressor inlet, leading to a loss of power.

3.1.14 Below is the photo of the engine with the bleed valve identified as item 7.

Figure 7: Location of the air bleed valve (General Electric H series and M601-Series Maintenance Training Manual revision 17.12.2012 (Manual Number 0130201) page 30.)

5.1 A contaminated bleed valve due to a lack of a compressor wash following operations in contaminated areas caused the engine power loss.

9.1 All operators operating in the contaminated areas such as the following, sea, dust, ash, flue gases and sand carry out a compressor wash in line with manufacturer’s recommendations. Doing compressor wash may remove any dirt picked up during operation, increase efficiency and longevity of the engine.

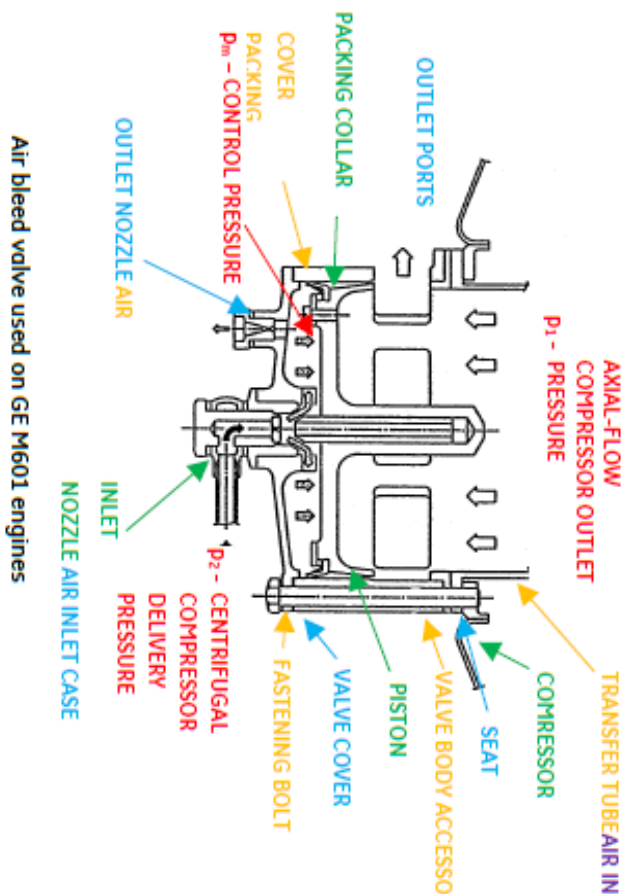
COMPRESSOR SECTION
Page 50
17.12.2012

Bleed valve schematic (General Electric H series and M601-Series Maintenance Training Manual (Manual Number 0130201) page 50 revision 17.12.2012)

In my personal opinion, the bleed valve did not close properly due to the dusty conditions and thus caused the compressor stall. I suggest than in future, all aircraft operating in dusty conditions need to be compressor and bleed valve washed with every 25 hour service.
