AIRCRAFT INCIDENT SHORT REPORT

CA18/3/2/1218: Inflight engine failure resulting in an autorotation landing which was unsuccessful as the helicopter landed hard. Damage limited to the skids and no injuries were reported.

Aircraft manufacturer and model : Bell Helicopter Textron 206B Jetranger-III

SUBJECT: EXAMINATION OF A MODEL 206B3 PC SAFETY VALVE FROM WARNE AVIATION IN SOUTH AFRICA

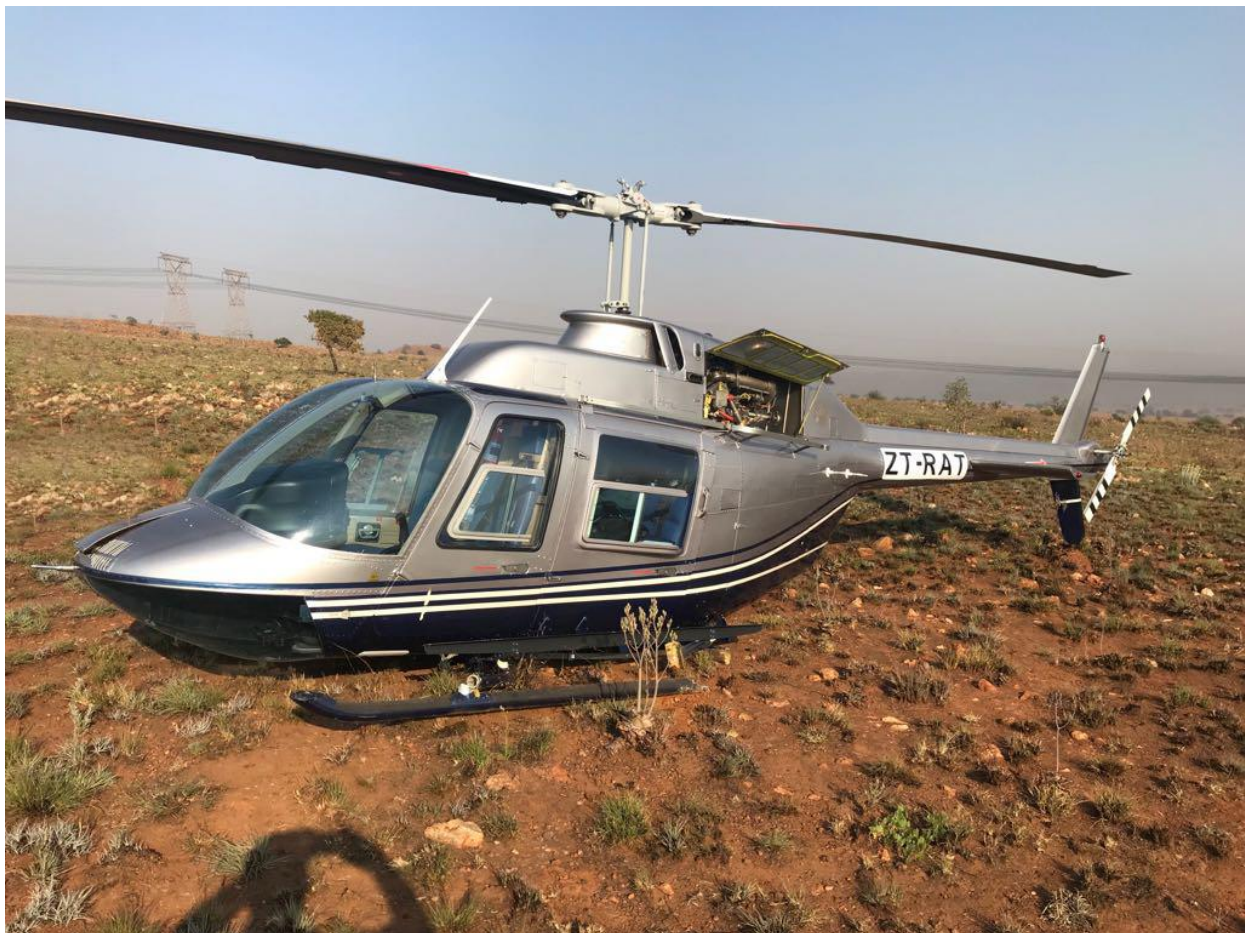
- 1.3. An on-site investigation revealed that the helicopter landed hard and sustained damages on the landing gear skids, which broke on impact with the ground. The pilot and passenger sustained no injuries.

Figure 3: The helicopter as it came to rest — left-hand side

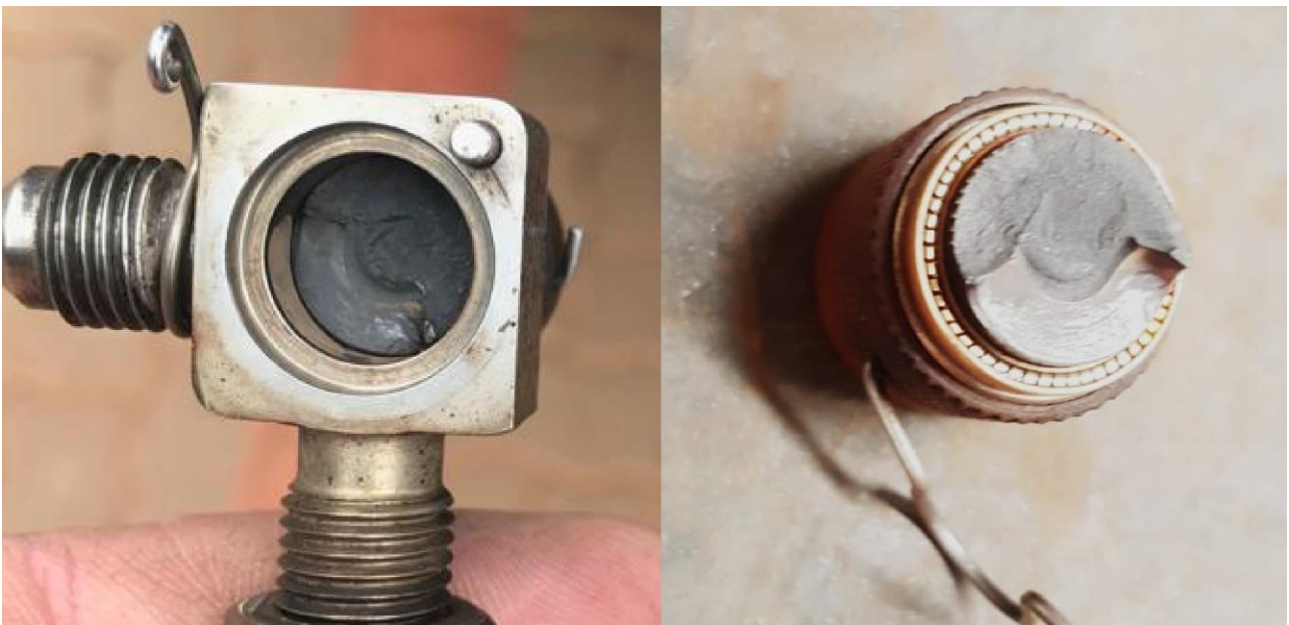
2.1.6. The engine (Allison 250-C20J) flameout was caused by the Pc Safety Valve failure (valve stem broke off).

Figure 5 & 6: The Pc Safety Valve was found broken and the half stem could not be found. (Source: Approved Maintenance Organisation)

- 2.1.8. The Pc Safety Valve was fitted on the compressor scroll line. The back of the valve was broken into two separate pieces and the second half was not recovered. This would cause the governor to lose all Pc sensing pressure to itself and the FCU, reducing engine power to idle. A flameout can occur due to the FCU reducing the fuel flow (FCU will sense the Pc air pressure has dropped and will reduce the fuel accordingly). The Figure 8 shows the location along the fuel schematic.

- 2.1.12 The manufacturer issued an airworthiness instruction (AI) number AA-06107 which required that the Pc Safety Valve be returned to the manufacturer for overhaul after 3500 hours of operation and for those which were not tracked to be limited to 500 hours/year. This (AI) also required operators to inspect the Pc Safety Valve at every 100 hours. There was no evidence of conformance to this AI by the owner/operator of this helicopter.

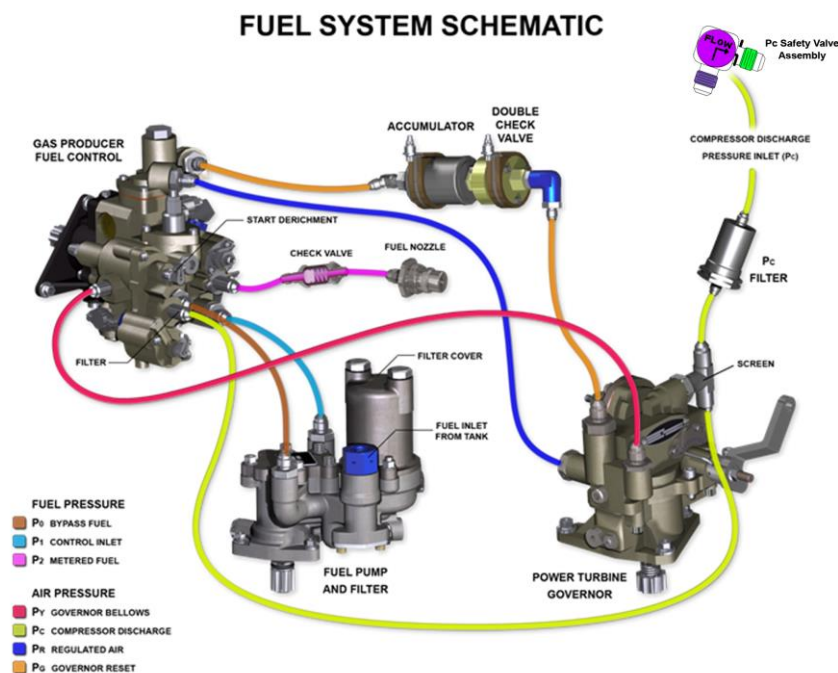
Figure 7: The Pc Safety Valve location (blue) in the fuel control system schematic.
(Source: Approved Maintenance Organisation)

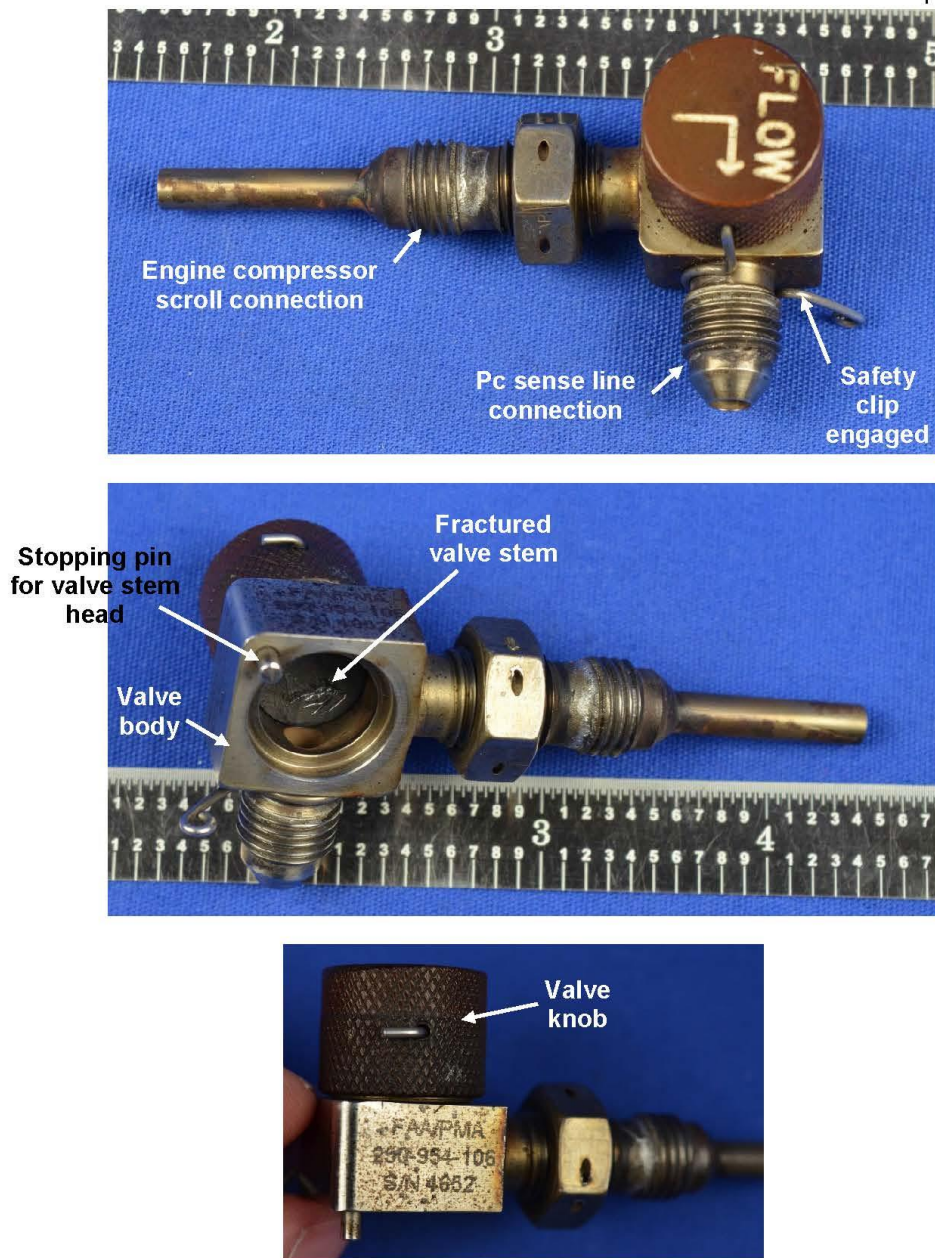
The Model 206B3 Pc safety valve was received fractured as shown in Figure 1. The valve stem fractured in the air passage at the base of the valve knob. The valve stem, that possess the air passage and head, was not received. The knob was engaged with the valve body using a safety clip and was in the "open" position. In the "open" position, the valve stem air passage allows air flow from the engine scroll to the engine fuel control system pneumatic sense line. The air temperature is approximately 500-540°F with an air pressure of approximately 100 psi. The valve stem was reportedly machined from a piece of Vespel material, which is comprised of a resin base and a graphite filler.

Figure 1: Views of the Pc safety valve received with a fractured valve stem (head not received).

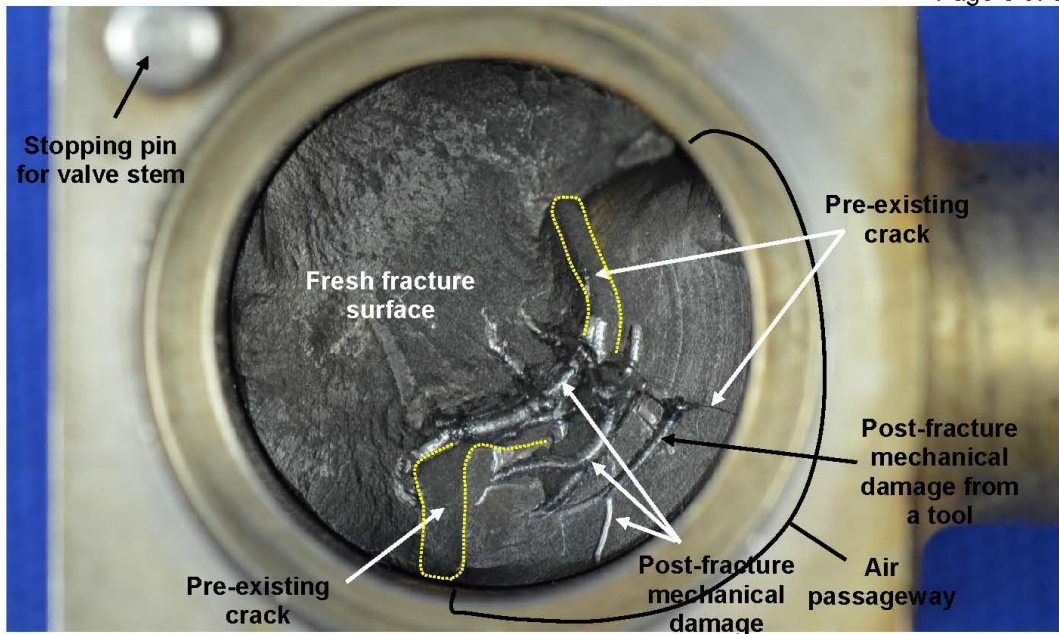
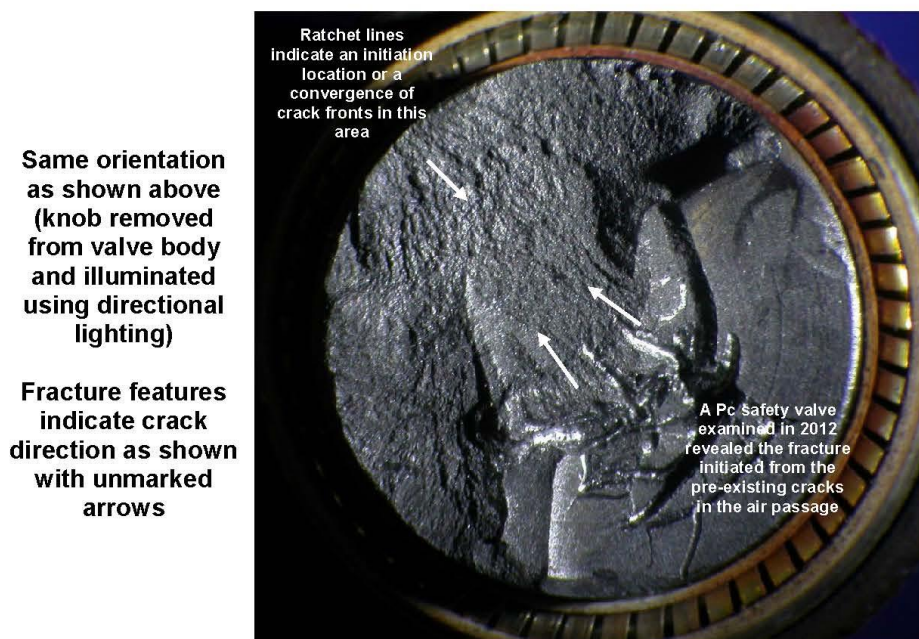
The valve stem head fractured as a result of overload. The fracture initiation area could not definitively be determined. Pre-existing cracks, most likely attributed to cyclic thermal exposure, were noted in the air passageway. There were no tool markings noted on the valve body or knob to indicate improper handling. There was no documentation of maintenance performed on the safety valve, which required a 100-hour inspection to confirm proper functionality.

The valve stem fracture surface is shown in Figure 2. The valve stem fractured as a result of overload. There were no arrest marks noted. The fracture features revealed two conflicting initiation locations. One initiation location was from the air passage at pre-existing cracks that measured 0.1 inch (3 mm) deep. The pre-existing cracks were most likely attributed to cyclic thermal exposure. A Pc safety valve examined in 2012 with a fractured valve stem initiated at this location at pre-existing cracks. The other possible fracture initiation location for the recent valve stem fracture was from the outer diameter surface, opposite from the air passage. These fracture features indicate it was the initiation location or that they were the result of multiple converging crack fronts. The fracture could not have initiated from both locations since the fracture progression was continuous and there was no intersecting line that would have been created. The outer diameter surface was smooth with no mechanical damage.

Figure 2: Views of the fracture valve stem in the “open” position. The fracture features revealed two conflicting initiation locations. Post-fracture mechanical damage was observed.

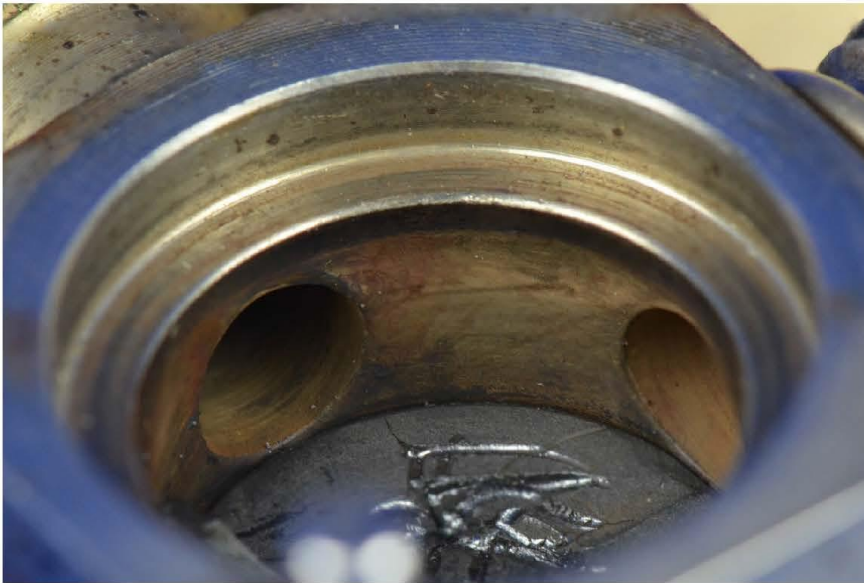
Figure 3 shows the valve body air passage. The valve body did not reveal any tool markings, which may indicate improper handling of the valve.

Figure 3: View of the valve body air passageway openings.
