AIRCRAFT ACCIDENT SHORT REPORT

CA18/3/2/1219: Unsuccessful forced landing after engine failure.

Aircraft registration : ZU-EGU

Aircraft manufacturer and model : Micro Aviation Bantam B22J

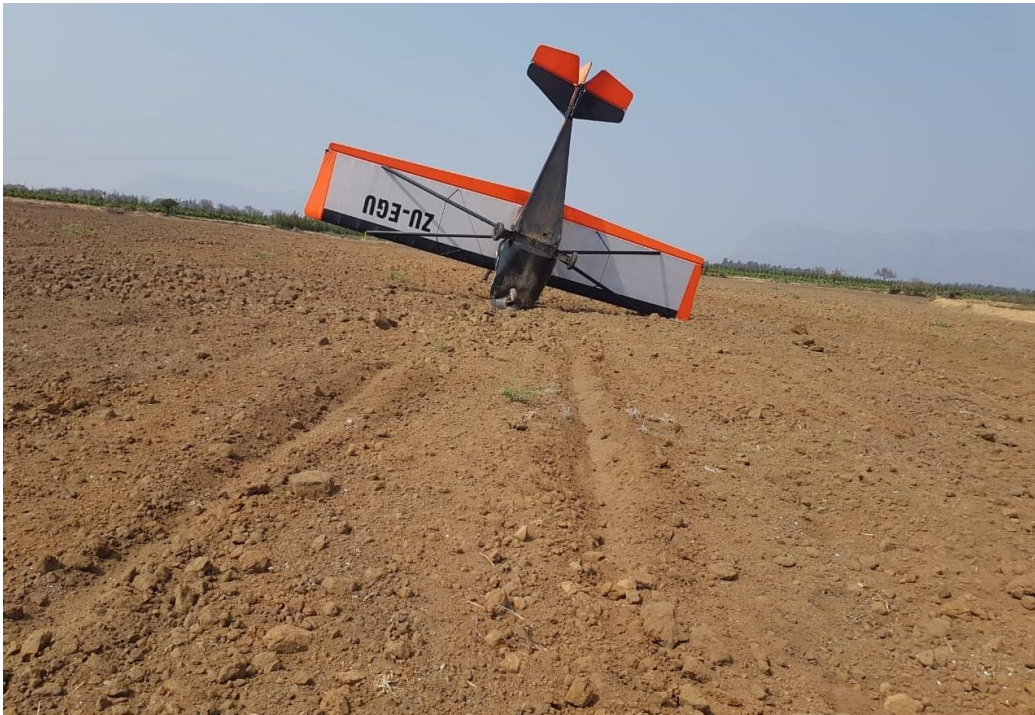
- 2.1.1. On 24 September 2018 at 0500Z, the pilot and a student took-off from Hoedspruit Civil Aerodrome for a training flight around the area. The aircraft had 25 liters of fuel on-board and routed in a south-westerly direction. The flight operated normally and climbed to 2000 feet (ft) above mean sea level (AMSL), cruising at 50 knots (kts).
- 2.1.2. According to the pilot, all the parameters during flight were within limits. He stated that 10 minutes into the flight he heard a loud bang from the engine bay. Thereafter, the engine started to run rough and eventually stopped.
- 2.1.3. The pilot identified an open field and executed a forced landing which was unsuccessful. The aircraft came to a stop with its tail section high and nose perpendicular to the ground.
- 2.1.4. The aircraft was substantially damaged. The pilot and the student sustained no injuries.

Figure 2: The aircraft at the accident site

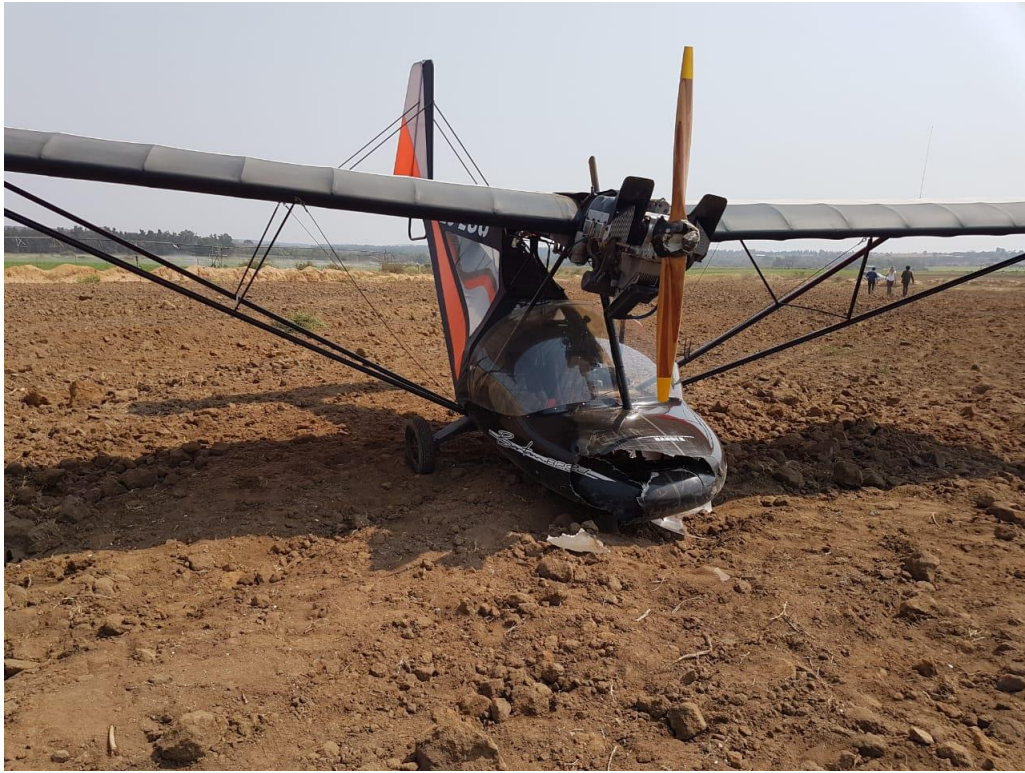
Figure 3: The aircraft during its recovery

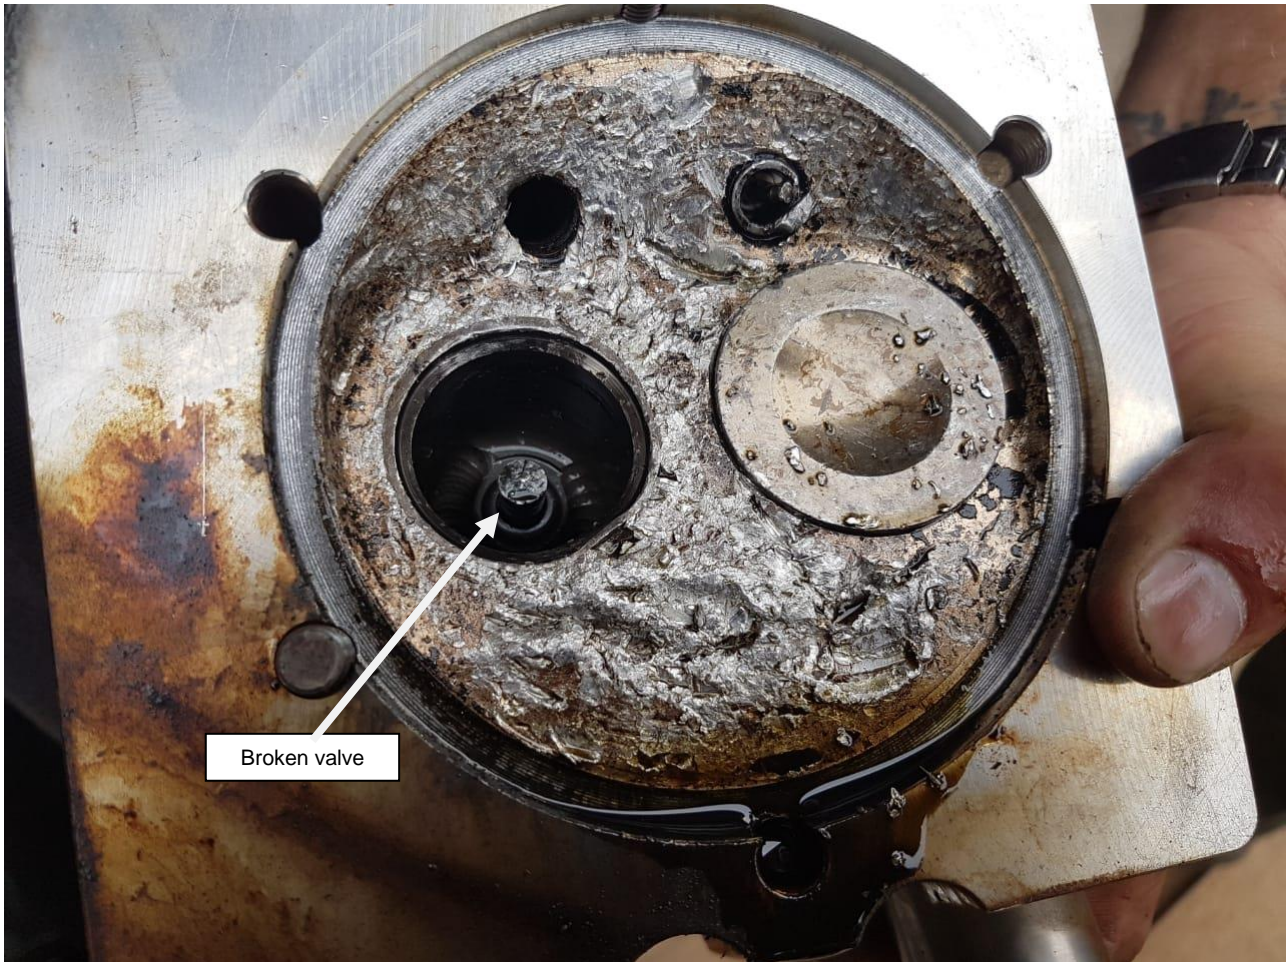
- 2.1.6.1. The engine (Jabiru 2200 with Serial number 22A2484) was disassembled by an approved Aircraft Maintenance Organisation (AMO). The number 4 cylinder exhaust valve was identified as the reason for engine failure. It was discovered that number 4 cylinder exhaust valve was broken and that was the cause of the rough-running engine as this cylinder was not producing enough compression to keep the engine at constant power. The engine had been in operation for 555.6 hours since new.

Figure 5: The number 4 cylinder exhaust valve head with the broken exhaust valve.
(Source: AMO)

The broken valve was not made available to investigators as it was misplaced. Thus, no tests were done to determine the cause of the number 4 cylinder exhaust valve failure.

- 3.7 The number 4 cylinder exhaust valve failed and caused the engine to stop. The cause of the valve failure could not be determined as the valve was misplaced/lost following the dismantling of the engine.

- 4.1 Engine failure resulting on an unsuccessful forced landing in a ploughed field. The cause of engine failure was attributed to failure of number 4 cylinder exhaust valve and the cause of the valve failure could not be determined.

- 6.1 The Regulator, SACAA, should consider the adoption of the Australian CASA document published in November which impose strict limitations on Jabiru aircraft operation.
