AIRCRAFT SERIOUS INCIDENT SHORT REPORT

CA18/3/2/1224: ZS-PHX, cabin decompression while cruising at FL200

PAGE 1 OF 9		
COMPILED FOR: Federal Airlines (Pty) Ltd	FAILURE ANALYSIS REPORT: CABIN WINDOW, BEECHCRAFT 1900D, ZS-PHX	DOCUMENT NUMBER FA-006-11-18		
		<table border="1" style="width: 100%; border-collapse: collapse;"> <tr> <td style="width: 70%;">DATE 2018-11-19</td> <td style="width: 30%;">ISSUE 1</td> </tr> </table>	DATE 2018-11-19	ISSUE 1
DATE 2018-11-19	ISSUE 1			
<p>ITEM: RIGHT-HAND FORWARD EMERGENCY EXIT CABIN WINDOW, PART No 129-430041-1, BEECHCRAFT 1900D, SERIAL No UE-145, No ZS-PHX</p> <p>1. BACKGROUND INFORMATION</p> <p>1.1. The remainder of a failed cabin window (Photo's 2 and 3; Part no 129-430041-1) originating from the forward right-hand (pilot's view) emergency exit position from a Beechcraft 1900D, No ZS-PHX (Photo1), was submitted to determine the most probable root- and contributory causes towards failure during operation.</p> <p>1.2. The relevant cabin window failed during flight at approximately 20000' MSL (FL020) while the aircraft was under pressurization (Photo 2).</p> <p>1.3. The cabin window base material conforms to Polymethyl Methacrylate (PMMA) of

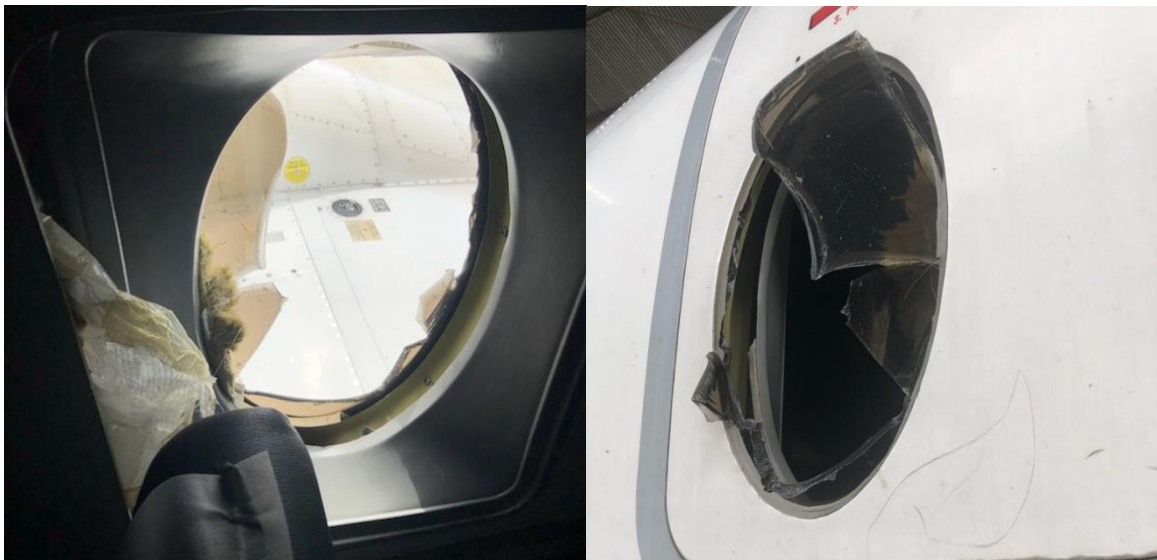
- 2.3 Once the aircraft stabilised at FL120, the first officer inspected the cabin and found that the cause of the decompression was due to the failure of the third cabin window on the right-hand side of the fuselage. The standard terminal arrival for the aircraft was cancelled and the aircraft was routed directly to FAOR. The remainder of the flight was uneventful. The aircraft landed on runway 03R, 57 minutes after departing FALD.

- 2.4 None of the occupants on-board sustained any injuries. Damage to the aircraft was limited to the cabin window, cabin side wall panel and one insulation blanket.

Figure 2: Internal (left) and external (right) view of the failed window

4.1 The aircraft experienced the decompression due to failure of the third cabin window on the right-hand side of the fuselage during flight.

- 7.1 It is recommended to the Director of Civil Aviation to issue maintenance notice to all operators of the B1900D aircraft type to carry out inspection on all cabin windows regardless of the remaining hrs and cycles for the next inspection, this follows the failure of the third cabin window on the right-hand side of the fuselage during flight and subsequent cabin window inspection carried by the operator where by eight (8) cabin windows were replaced due to manufacturer's limits.
- 7.2 **Safety Action taken by the operator**
 - 7.2.1 The operator has carried out a special inspection on all the cabin windows on both B1900D aircraft in its fleet. On completion of this inspection, eight cabin windows were replaced due to being close to the manufacturer's specified limits.

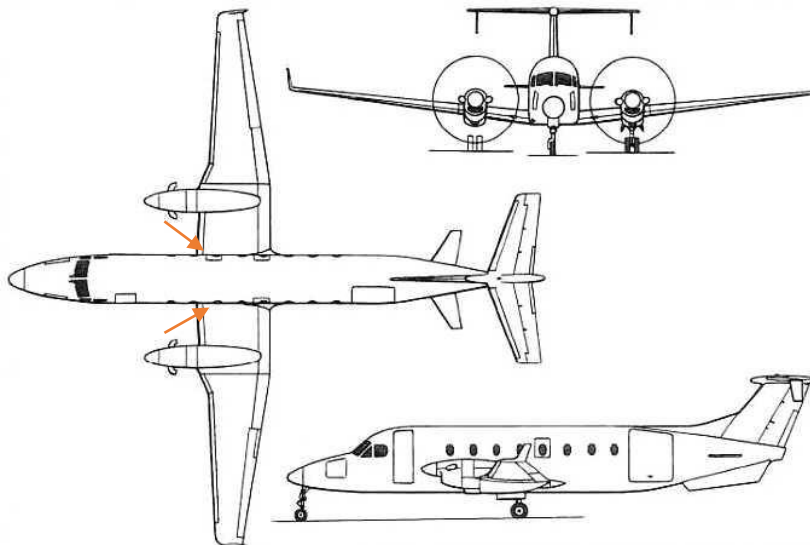
- 3.14 The B1900D is a twin turboprop aircraft, powered by two Pratt & Whitney PT6A-67D power plants. Each power plant has two exhausts on either side. When the propeller is in the feathered position, the exhaust gases are blown directly onto the cabin windows and fuselage. The B1900D Aircraft Flight Manual section on power plant limitations, engine exhaust heating of cabin windows and airframe states: “do not operate the engines with the propellers feathered except during external power starts and propeller feather checks, except that the propellers may be operated in feather at temperatures not to exceed +5°C for a maximum of 3 minutes for the purpose of airframe de-icing.”

Figure 6: View of the power plant exhaust ducts and the direction of exhaust gas flow with the propellers feathered (Skybrary)

Tests have demonstrated that window distortion is caused by "hot" engine exhaust gasses impinging upon the cabin side windows. To date, our research has found that the possibilities of window distortion can be minimized or avoided by simply modifying ground operating procedures listed below.

- 9.1 It is imperative that operators abide by the B1900 communiqué no. 30 during ground operations to avoid excessively heating the cabin windows.

1. Refrain from "backing" of the aircraft.
2. Avoid static ground operation of the aircraft with the propellers in the feather position.
3. Limit operation with the propellers in ground fine to a minimum.
4. Awareness of quartering tail winds and jet blast - these external forces could redirect hot engine exhaust gasses onto the windows. Such exposure should be minimized whenever possible.

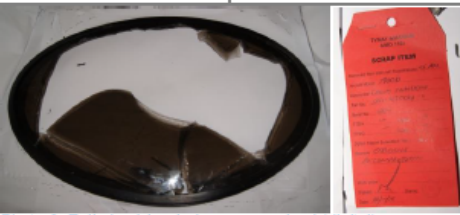
<p>Photo 3: Failed cabin window, as received (digital)</p> <p>1.4. This report is divided into the following sections:</p> <table border="0"> <tr><td>(a) INTRODUCTION & BACKGROUND</td><td>Par. 1</td></tr> <tr><td>(b) APPLICABLE DOCUMENTS</td><td>Par. 2</td></tr> <tr><td>(c) DEFINITIONS</td><td>Par. 3</td></tr> <tr><td>(d) INVESTIGATOR/S</td><td>Par. 4</td></tr> <tr><td>(e) APPARATUS AND METHODOLOGY</td><td>Par. 5</td></tr> <tr><td>(f) INVESTIGATION RESULTS</td><td>Par. 6</td></tr> <tr><td>(g) DISCUSSION & CONCLUSIONS</td><td>Par. 7</td></tr> <tr><td>(h) RECOMMENDATIONS</td><td>Par. 8</td></tr> <tr><td>(i) DECLARATION</td><td>Par. 9</td></tr> </table> <p>2. APPLICABLE DOCUMENTS</p> <table border="0"> <tr><td>(a)</td><td>Photographic evidence, supplied.</td></tr> <tr><td>(b)</td><td>Raytheon Aircraft AFM extract.</td></tr> <tr><td>(c)</td><td>Beechcraft General Maintenance Practices Chapter 56.</td></tr> <tr><td>(d)</td><td>ASM International Document no 06987G.</td></tr> </table> <p>3. DEFINITIONS</p> <table border="0"> <tr><td>(a)</td><td>OEM</td><td>Original Equipment Manufacturer</td></tr> <tr><td>(b)</td><td>AMO</td><td>Aircraft Maintenance Organization</td></tr> <tr><td>(c)</td><td>assy.</td><td>Assembly</td></tr> <tr><td>(d)</td><td>ASM</td><td>American Society for Metals</td></tr> <tr><td>(e)</td><td>PMMA</td><td>Polymethyl Methacrylate</td></tr> </table> <p>4. PERSONNEL</p> <table border="0"> <tr><td>(a)</td><td>The investigative member and compiler of this report is Mr C.J.C. Snyman, ID number 6406105057080. Mr Snyman is a qualified Physical Metallurgist (Professional Engineering Technologist: Metallurgy; ECSA Registration No 201670194), Radiation Protection Officer (RPO, NNR, No 281) and Aircraft Accident Investigator (SCSI).</td></tr> </table> <p>5. APPARATUS AND METHODOLOGY</p> <table border="0"> <tr><td>(a)</td><td>The methodology included visual inspection of the supplied parts and aircraft.</td></tr> </table>			(a) INTRODUCTION & BACKGROUND	Par. 1	(b) APPLICABLE DOCUMENTS	Par. 2	(c) DEFINITIONS	Par. 3	(d) INVESTIGATOR/S	Par. 4	(e) APPARATUS AND METHODOLOGY	Par. 5	(f) INVESTIGATION RESULTS	Par. 6	(g) DISCUSSION & CONCLUSIONS	Par. 7	(h) RECOMMENDATIONS	Par. 8	(i) DECLARATION	Par. 9	(a)	Photographic evidence, supplied.	(b)	Raytheon Aircraft AFM extract.	(c)	Beechcraft General Maintenance Practices Chapter 56.	(d)	ASM International Document no 06987G.	(a)	OEM	Original Equipment Manufacturer	(b)	AMO	Aircraft Maintenance Organization	(c)	assy.	Assembly	(d)	ASM	American Society for Metals	(e)	PMMA	Polymethyl Methacrylate	(a)	The investigative member and compiler of this report is Mr C.J.C. Snyman, ID number 6406105057080. Mr Snyman is a qualified Physical Metallurgist (Professional Engineering Technologist: Metallurgy; ECSA Registration No 201670194), Radiation Protection Officer (RPO, NNR, No 281) and Aircraft Accident Investigator (SCSI).	(a)	The methodology included visual inspection of the supplied parts and aircraft.

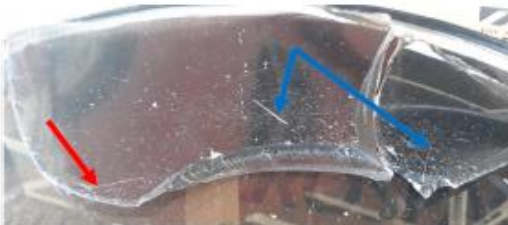
Photo 4: Remainder of cabin window showing multi-direction score marks (digital)

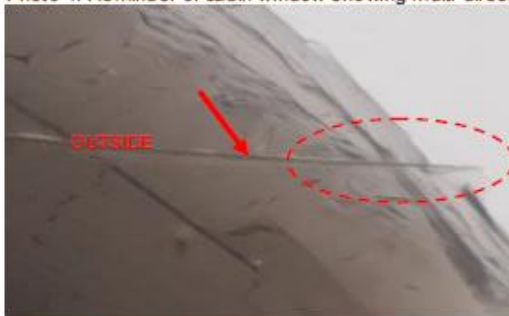
Photo 5: Pre-failure score mark (digital)

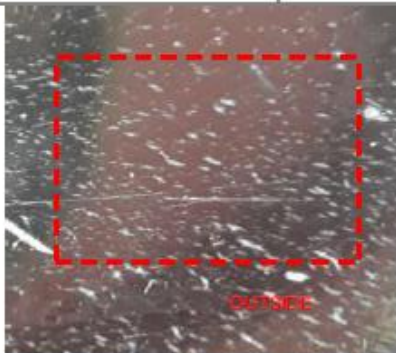
Photo 6: Indications of crazing, scoring and impact marks, outside surface (digital)

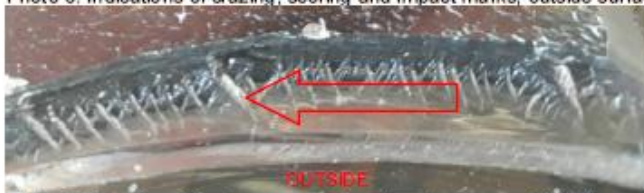
Photo 7: Direction of fracture propagation, long transverse (digital)

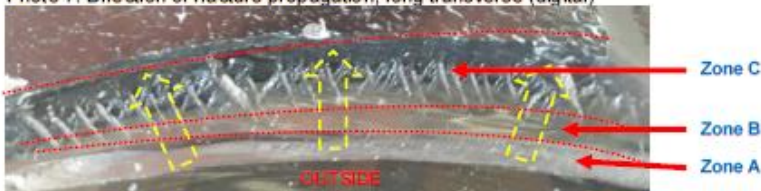
Photo 8: Direction of fracture propagation, short transverse (digital)

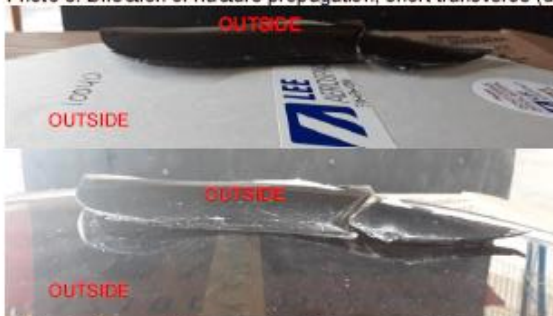
Photo 8: Comparative contouring between new (top) and used (bottom) cabin windows (digital)
