<b>AIRCRAFT INCIDENT REPORT AND EXECUTIVE SUMMARY</b>
---

Reference:	CA18/3/2/1226	
<b>Aircraft Registration</b>	ZU-FRN	<b>Date of Incident</b>	10 November 2018		<b>Time of Incident</b>	1015Z
<b>Type of Aircraft</b>	Yak 52		<b>Type of Operation</b>	Private Part 94		
<b>Pilot-in-command Licence Type</b>	Commercial Pilot		<b>Age</b>	55	<b>Licence Valid</b>	Yes
<b>Pilot-in-command Flying Experience</b>	Total Flying Hours		2254.3	<b>Hours on Type</b>	199.7	
<b>Last point of Departure</b>	Rand Aerodrome (FAGM)-Gauteng Province					
<b>Next Point of Intended Landing</b>	Rand Aerodrome (FAGM)-Gauteng Province					
<b>Location of the incident site with reference to easily defined geographical points (GPS readings if possible)</b>						
In an open field on a private farm near Heineken factory in Vereeniging, next to R56 Road						
<b>Meteorological Information</b>	Wind direction: 045°; Wind Speed: 10kt; Wind temperature: 18°C; Visibility: CAVOK					
<b>Number of People On-board</b>	2+0	<b>No. of People Injured</b>	0	<b>No. of People Killed</b>	0

**Reference Number** : CA18/3/2/1226  
**Name of Owner/Operator** : NVT Aircraft CC  
**Manufacturer** : Yakovlev  
**Model** : YAK 52  
**Nation

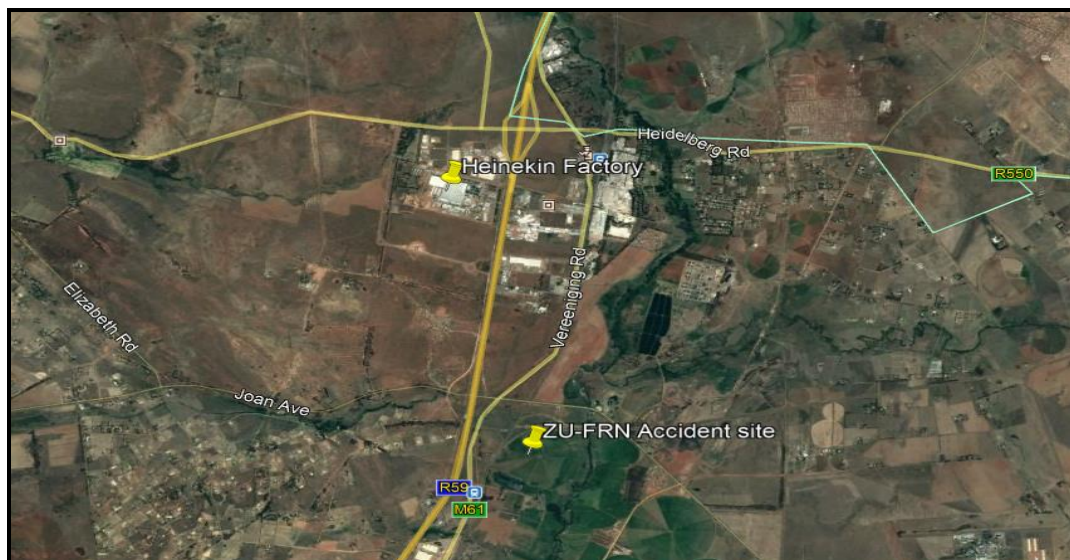
Figure 1: Aerial view of the accident site

1.1.3 The incident occurred near the R59 Road in Vereeniging, Gauteng province. The incident occurred at the following Global Positioning System (GPS) co-ordinates: S 26° 27' 35.63", E 028° 4' 41.57" and at a field elevation of 4862 feet (ft).

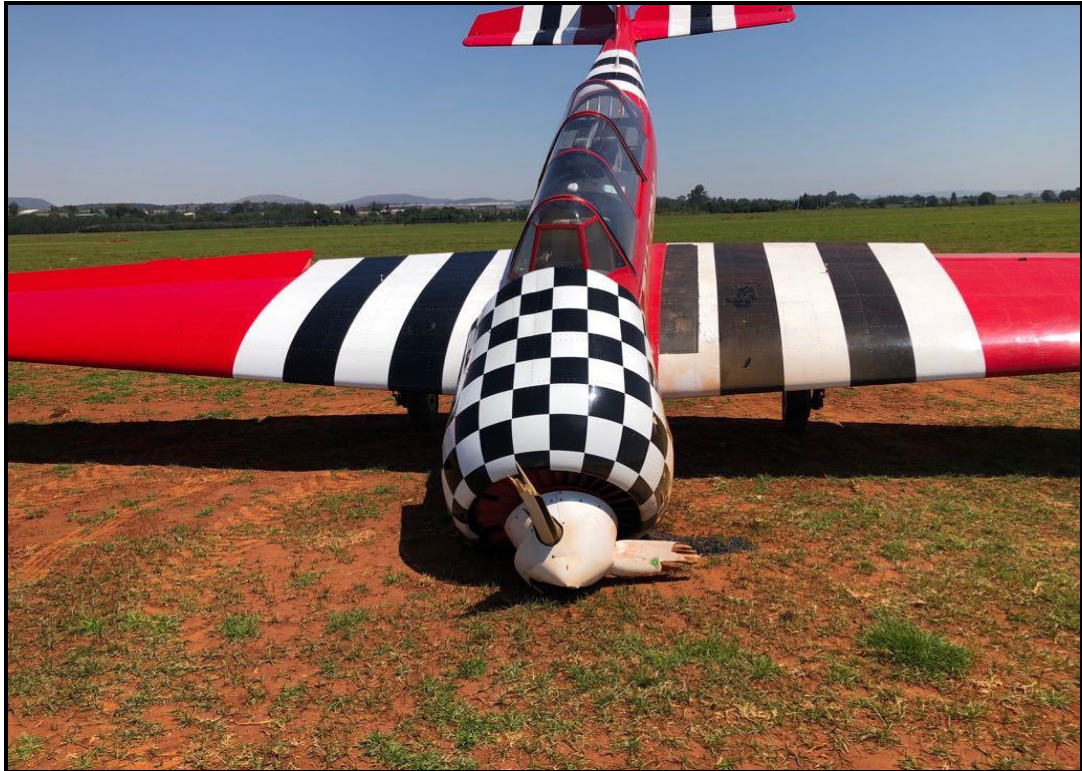
**Figure 2:** The damaged aircraft.

1.3.2 The front view (Figure 2) of the aircraft shows the nose section bending upwards and to the left-hand side.

- 3.2.4 The AP who conducted maintenance on the aircraft was issued a licence on 4 October 2018 with an expiry date of 31 October 2020.
- 3.2.5 The aircraft sustained damage on the nose gear, propeller and front of the fuselage.

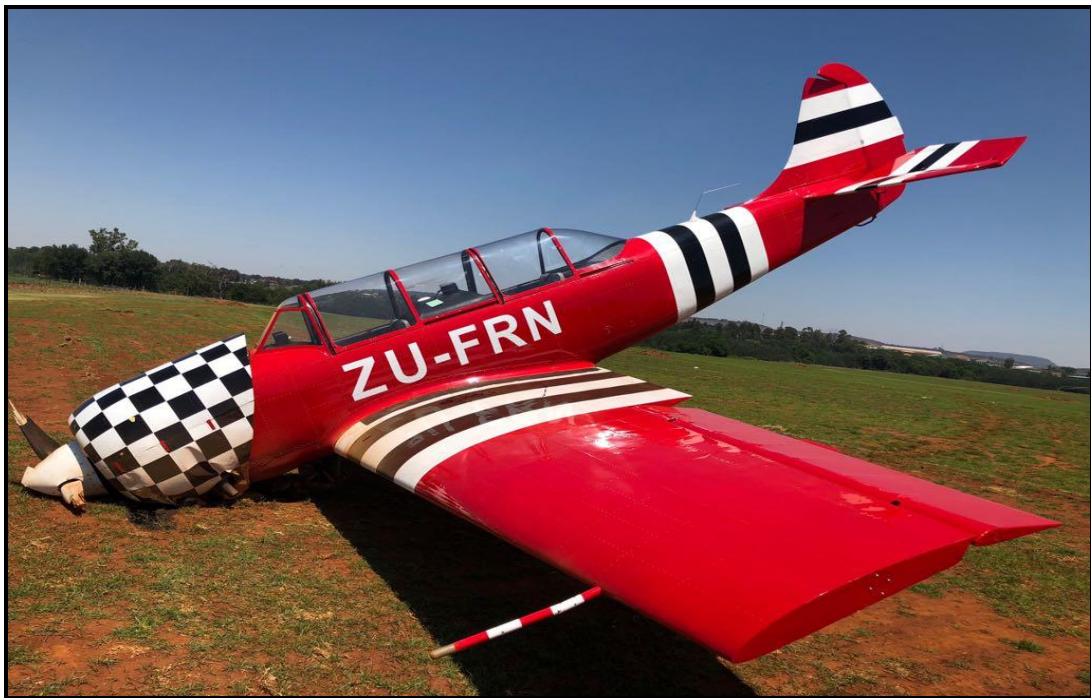
1.12.1 The aircraft approached the landing area from the north-west direction. Upon landing, the nose gear collapsed and the aircraft turned towards the right-hand side whilst skidding. All three wooden blades of the propeller were shattered during the incident sequence. This indicates that the damage was sustained whilst the propeller was turning.

**Figure 3:** The aircraft at the accident site.

- 3.3.1 The aircraft was landed on an uneven terrain, resulting in the nose gear collapsing and the propeller striking the ground before the aircraft came to a stop.

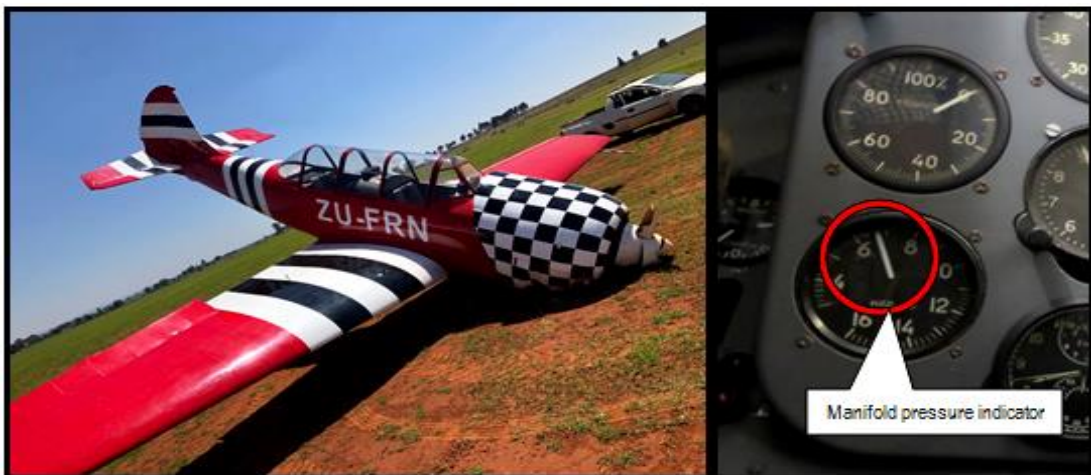
1.12.2 The manifold pressure indicator showed 660 millimetre of mercury (mmHg) reading post incident and was stuck in that position, indicative of an engine being under power.

**Figure 4:** The aircraft after the incident and (inset) the manifold pressure indicator.

- 2.2.4 Although the pilot reported engine power loss, all three propeller blades were shattered during the incident, indicating that the engine was operating at a high-power setting. The fact that the propeller blades were shattered indicated an engine operating at high power setting; this is also supported by the manifold pressure which was found stuck on 660mmHg, a setting indicative of an engine operating just above cruise power. It is, therefore, likely that the engine was operating at a high-power setting during the nose gear collapse.

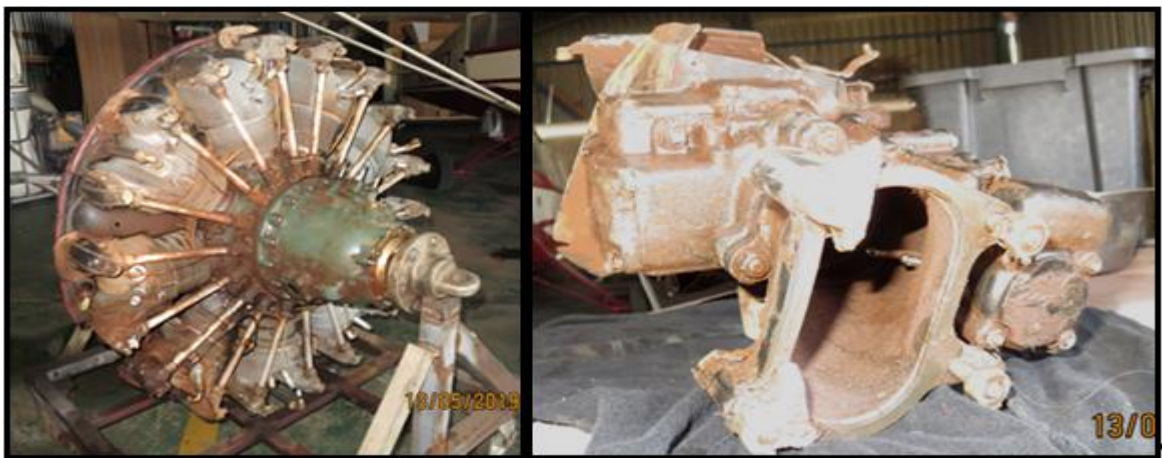
1.16.1 Following the incident, a post-engine inspection was conducted and no anomalies were found. The aircraft engine had 13 hours of operational after an overhaul service.

- All three propeller blades were completely damaged during impact. (This is an indication that the engine was turning at high power settings)
- Indication by the manifold pressure gauge showing 660mmHg (take-off power of the aircraft is 99% at 750mmHg; cruise power is 64% at 600mmHg). Also, it is possible that the high indication of the manifold pressure could be a result of the impact forces
- All engine controls were connected and locked
- Fuel filters and oil filters were found clean and in order
- The carburettor air filter was clean with no signs of debris

Suspected failure units that can cause the reported engine power loss are likely to be:

- Carburettor needle jamming
- Propeller governor failure causing power loss
- Fuel pumps reduction valve failure, creating low fuel pressure before carburettor

Figure 5: The engine and the carburettor at the maintenance hangar.
