AIRCRAFT INCIDENT SHORT REPORT

CA18/3/2/1227: ZU-EMI, Blade flapping due to a gust of wind.

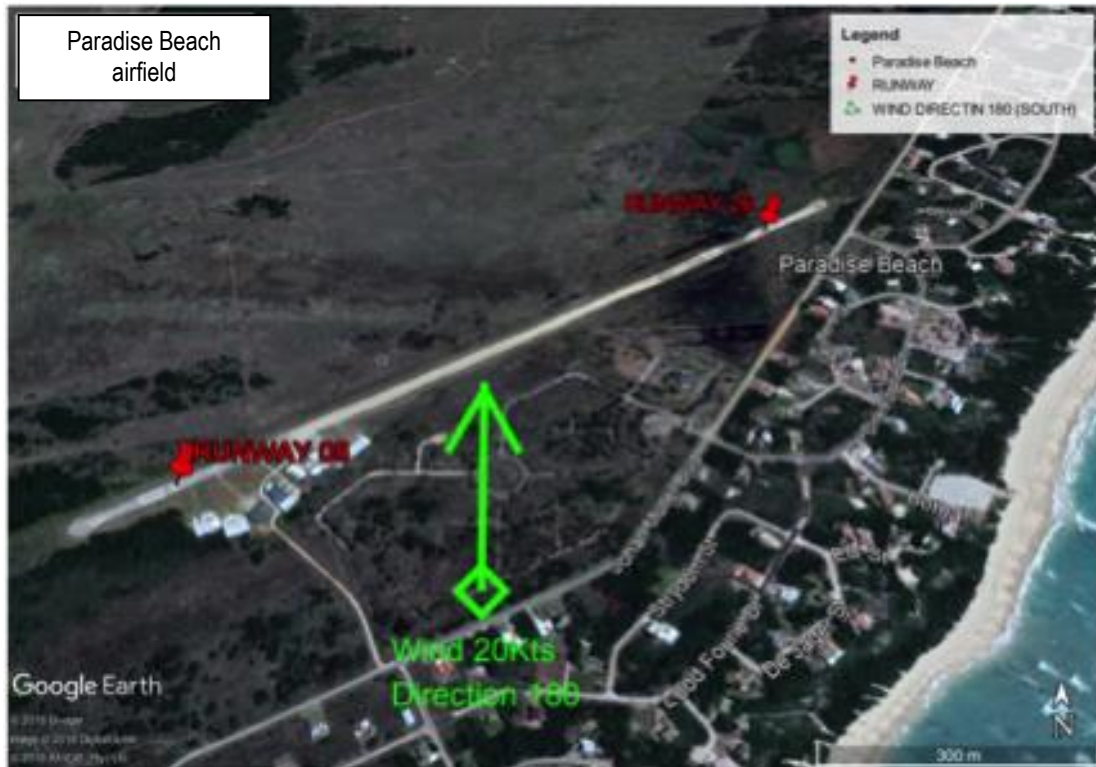
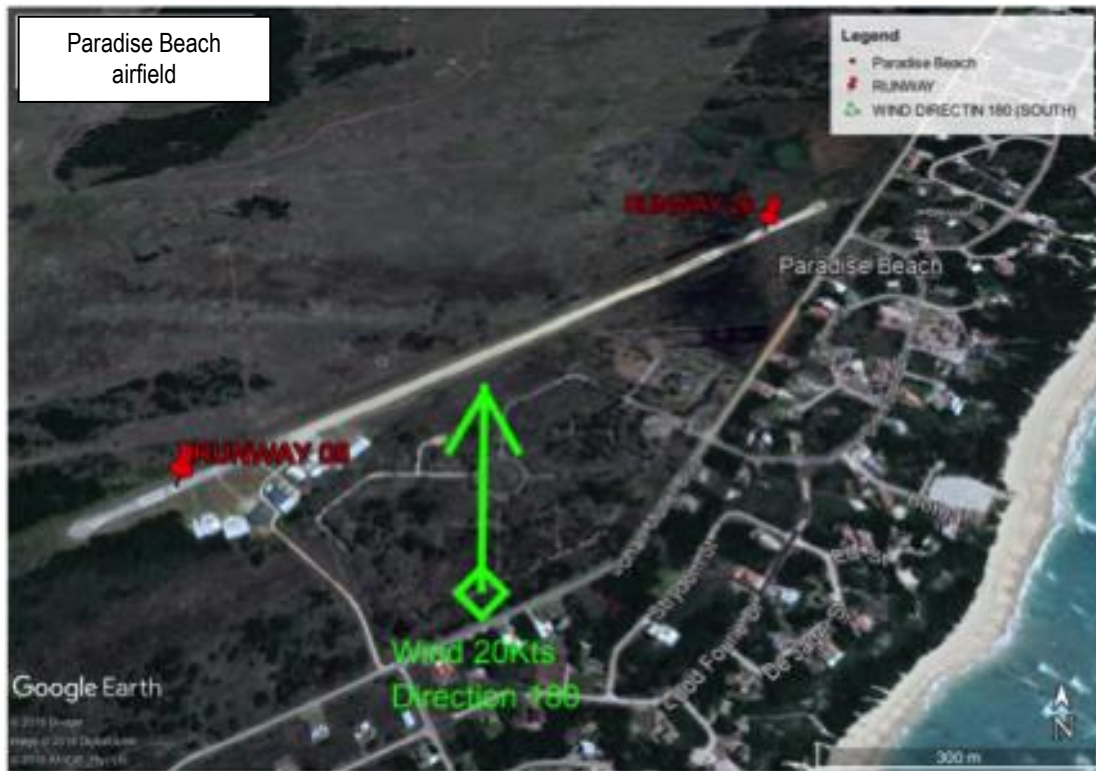
- 2.5 An official weather report was requested from the South African Weather Service. The reported weather for St Francis Bay at 1300Z on the day of the incident reported that the temperature was 21°C with the prevailing wind conditions at 110°/12 kt gusting 23 Kt. St Francis Bay is situated about 11 km south-west of the Paradise Beach airfield. The pilot reported that the accident occurred around 1300Z.

Figure 1: Google Earth map of runway 08 at Paradise Beach airfield, indicating wind direction on the incident day

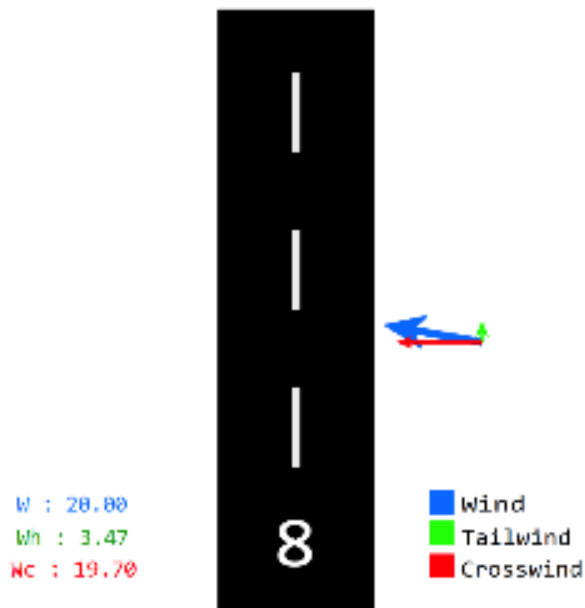
- 2.6 Based on the pilot report the wind condition was 180°/20 kt. For the reported wind condition the aircraft was operated at a calculated crosswind component of 19.70 kt and a tailwind component of 3.47 kt.

- 3.5 The maximum crosswind component as stipulated by the POH is 16 kt, and the actual crosswind at the time of the accident was calculated to be 19.7 kt; therefore the aircraft was being operated in crosswind conditions exceeding the limitations provided in the POH.

Figure 2: Schematic depicting the crosswind and tailwind components on the incident day
(Source: <https://www.e6bx.com>)

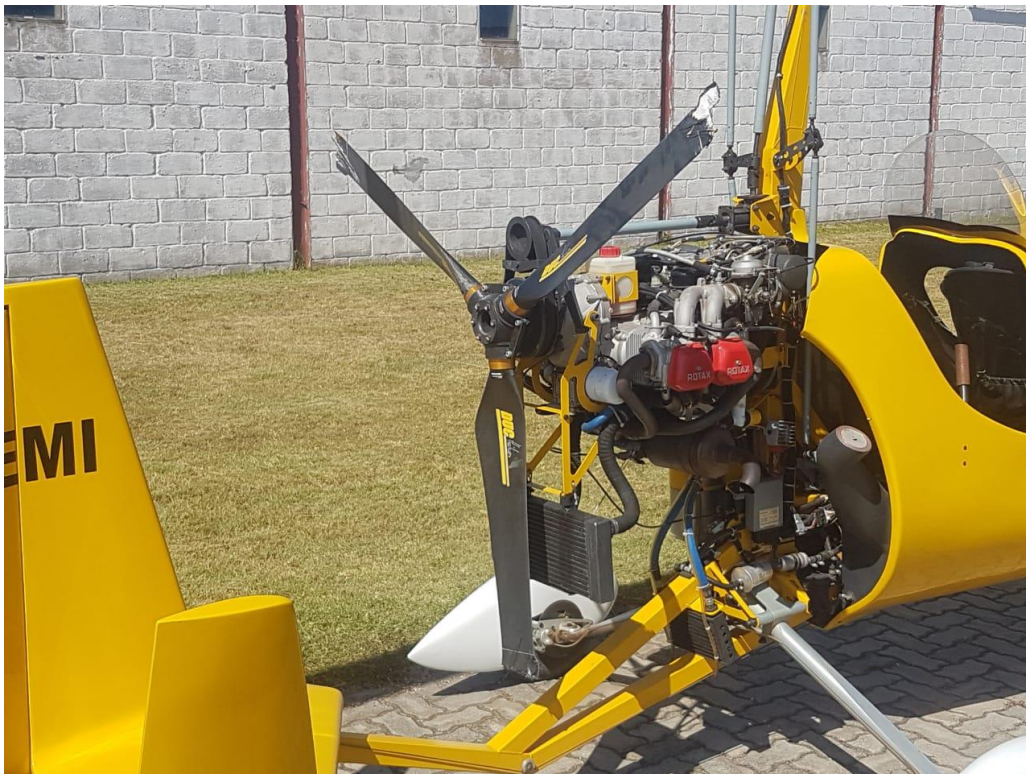
- 3.6 The aircraft sustained damage to the main rotor, propeller, tail section and rudder.
- 3.7 The incident ELA-08 gyrocopter was being operated using the ELA 07-07S (V07-05) POH because the ELA-08 model had been discontinued by the manufacturer. The manufacturer was approached to confirm whether it is acceptable to use the alternative POH; the response from the operator was positive. The ELA 07-07S (V07-05) is the latest update of the POH for ELA-08 aircraft.

Figure 4: Damage to the propeller
(Source: aircraft owner)

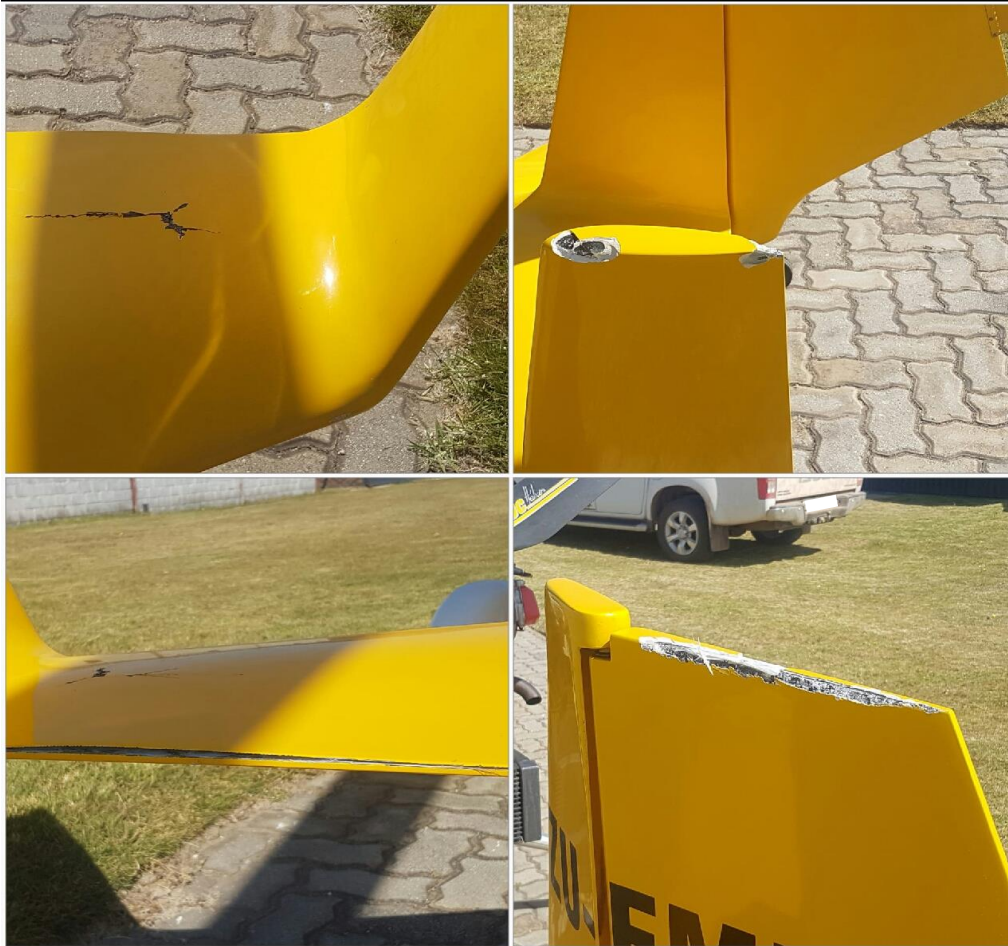
Figure 5: Damage to the rudder and tail section
(Source: aircraft owner)
