AIRCRAFT INCIDENT SHORT REPORT

CA18/3/2/1229: ZS-VRA, Nose landing gear collapse during landing because the emergency landing gear extension T-handle was not pulled as required by POH.

Date and time : 10 November 2018, 0758Z
Location : Progress Aerodrome, Port Elizabeth (FAPZ)
Aircraft registration : ZS-VRA
Aircraft manufacturer and model : Vulcanair P.68R
Last point of departure : Progress Aerodrome, Port Elizabeth (FAPZ)
Next point of intended landing : Progress Aerodrome, Port Elizabeth (FAPZ)
Location of incident site with reference to easily defined geographical points (GPS readings if possible) : Progress Aerodrome, Port Elizabeth (FAPZ)
: 33°55'30"S 025°22'20"E elevation 740,feet AMSL
Meteorological Information : Surface wind: 250°/10 kt, temperature: 20°C, visibility: +10 km
Type of operation : Training (Part 141)
Persons on board : 1+2
Injuries : None
Damage to aircraft : The aircraft sustained minor damage.

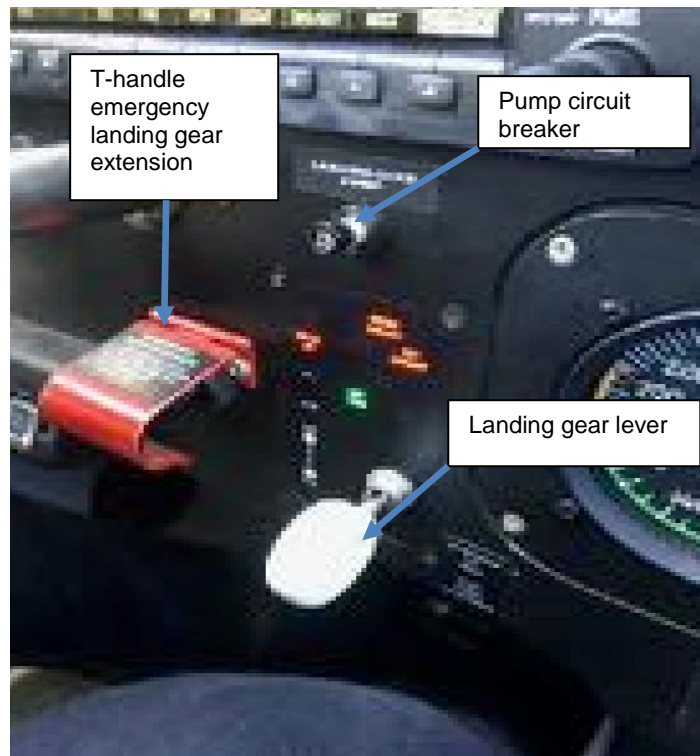
2.5 The before-landing checklist in the POH requires the crew to ensure that the 3 green landing gear position indicator lights are on and that the red light is off. If the landing gear does not extend the landing gear emergency procedures in the POH instruct that the landing gear lever must be in the down position and the hydraulic circuit breaker must be pulled. The pilot must then lift the emergency T-handle safety guard and pull the emergency gear extension T-handle. To ensure the landing gear is down the pilot must check that the 3 green landing gear position indicator lights are on and that the red light is off. Before the landing the indication in the cockpit was one green only. The LKD indication was also red. The emergency gear extension T-handle was not pulled for the landing.

Fig. 1: Picture of the landing gear indication prior to landing (Picture courtesy of the Pilot)

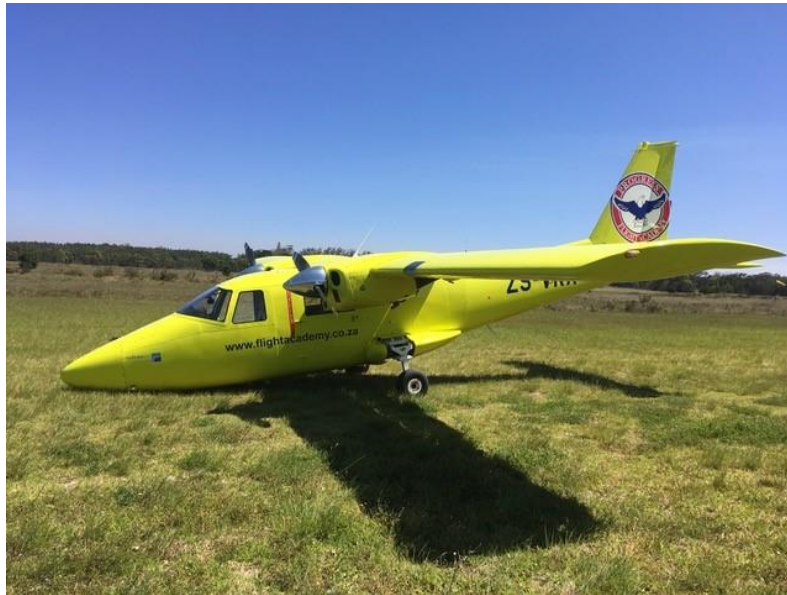
2.6 According to the instructor a normal approach was carried out at 0758Z for runway 25 at FAPZ, and on touchdown the nose landing gear collapsed back into the wheel well as the nose wheel came into contact with the runway surface. The aircraft skidded on the underside of the nose until it came to a halt a short distance from the point where the nose gear failed. The aircraft incurred minor damage to the landing gear door and rod ends. No occupant sustained any injuries.

Fig. 2: Aircraft as it came to rest (Photograph courtesy of Progress Flight Academy)

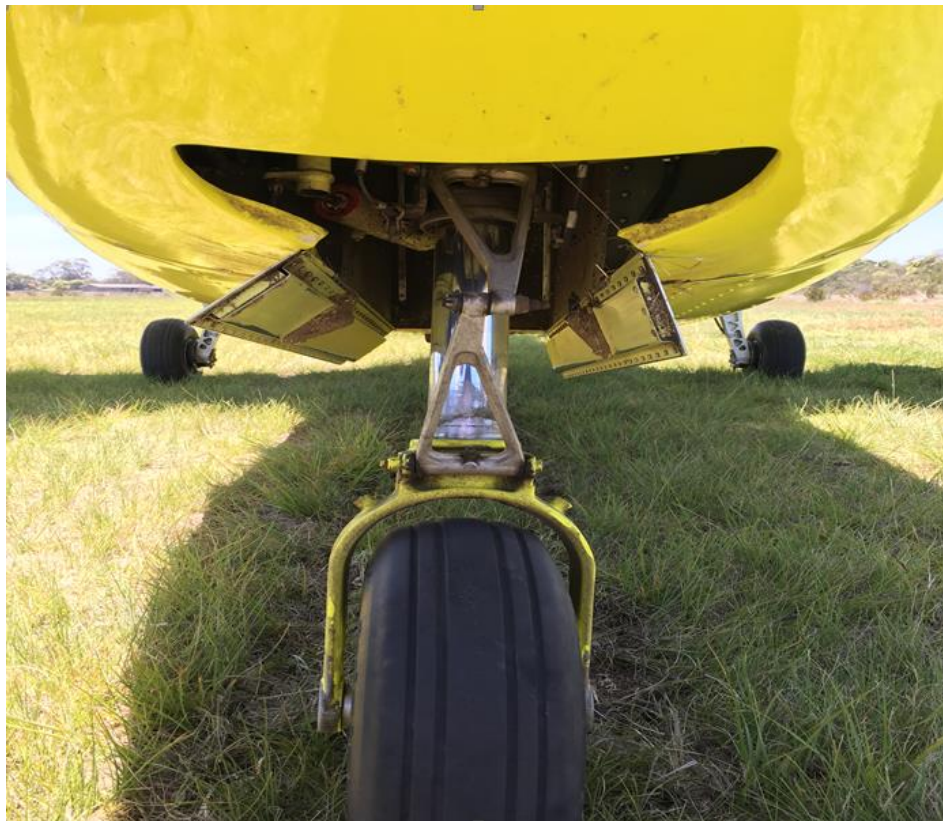
- 2.10 Post-incident inspection by the AMO revealed no malfunctions with the hydraulic landing gear system. No leaks were visible during the operation of the landing gear. The damage sustained by the aircraft was minor which was limited to the nose landing gear doors and rod ends.

- 4.1 The nose gear collapsed on landing as a result of the extended nose gear not locked. The failure of the down lock mechanism was undetermined as the system operated normal during testing.

Fig. 3: Minor damage to the nose landing gear doors and rod ends (Photograph courtesy of Progress Flight Academy)

7.1 Safety Message: The Aircraft Maintenance Organisation need to ensure that maintenance performed by their personnel complies with manufacturer's maintenance instructions and Civil Aviation Maintenance Requirements as outlined in CAR Part 43. The landing gear defects occurred three times prior to the accident, and it does appear that the defect was not cleared.

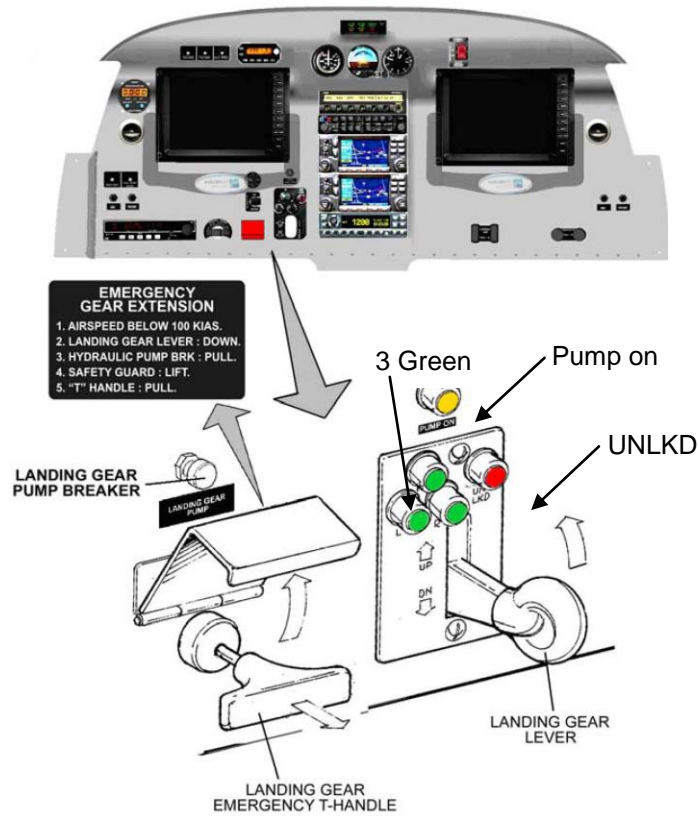
- 3.5 The emergency landing gear extension was never activated as required by the Pilot Operating Handbook when an unsafe landing gear warning indication was displayed in the cockpit.

- 5.1 The emergency gear extension was not activated as required by pilots operating handbook (POH).

Figure 4: Cockpit layout with landing gear indication and normal/emergency extension (Source: Vulcanair P.68R POH)

7.2 Pilots to adhere to the manufacturer's requirements when they are faced with emergency during the operation of the aircraft.
