AIRCRAFT SERIOUS INCIDENT SHORT REPORT

CA18/3/2/1233: ZS-PHX, un-commanded auto feather of the left hand propeller while passing FL110 during the climb phase

Date and time : 22 November 2018, 0854Z
Location : 8.8 nm east of O.R. Tambo International Airport
Aircraft registration : ZS-PHX
Aircraft manufacturer and model : Beechcraft (Textron) B1900D
Last Point of departure : O.R. Tambo International Airport (FAOR), Gauteng
Next point of intended landing : Londolozi Aerodrome (FALD), Mpumalanga
Location of incident site with reference to easily defined geographical points (GPS readings if possible) : 8.8 nm east of O.R. Tambo International Airport (FAOR), overhead Petit Airfield in Bronkhorstspuit, Gauteng: S26°05'06" E028°23'24"
Meteorological Information : FAOR METAR at 0930Z: temperature: 23°C, dew point: 2°C wind: 280°/6 kts, variable between 240° and 360°, Ceiling and visibility OK, QNH: 1020 hPa
Type of operation : Commercial (Part 135)
Persons on board : 2 + 9
Injuries : None
Damage to aircraft : None

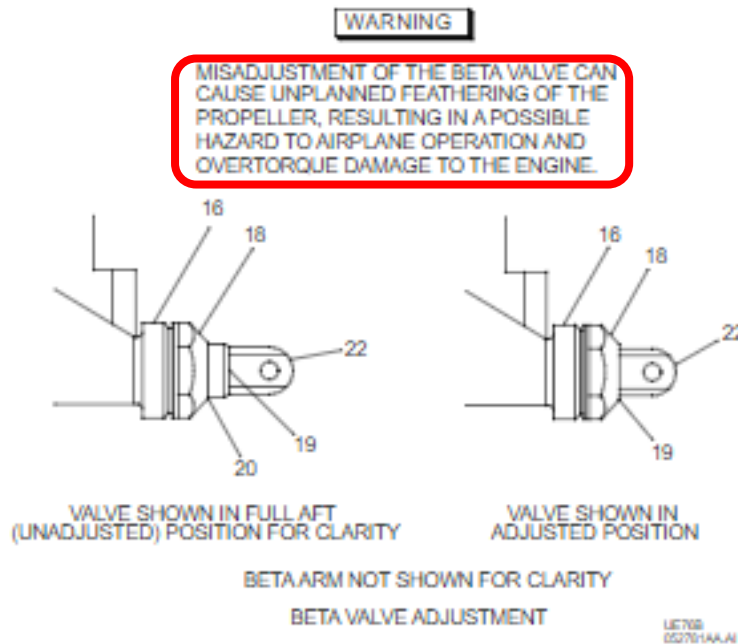
- 3.13 During the reverse/beta system investigation, it was noted that when pulling on the beta cable towards the propeller the clearance limits were exceeded by 3-4mm. This could result in the beta valve internal piston being pulled to the open position and that will force the propeller to go into the feathered position. See appendix B below.

- 3.14 The aircraft experienced an inflight un-commanded feathering of the left engine propeller while on a climb phase due to an incorrect rigging of the reverse/beta cable which caused the beta valve to open resulting in the propeller entering an un-

Figure 6: A warning stipulated in the B1900D AMM (Source: B1900D AMM Figure 204: Sheet 1: Fig 204 - Propeller Reversing and Beta Valve Adjustment)

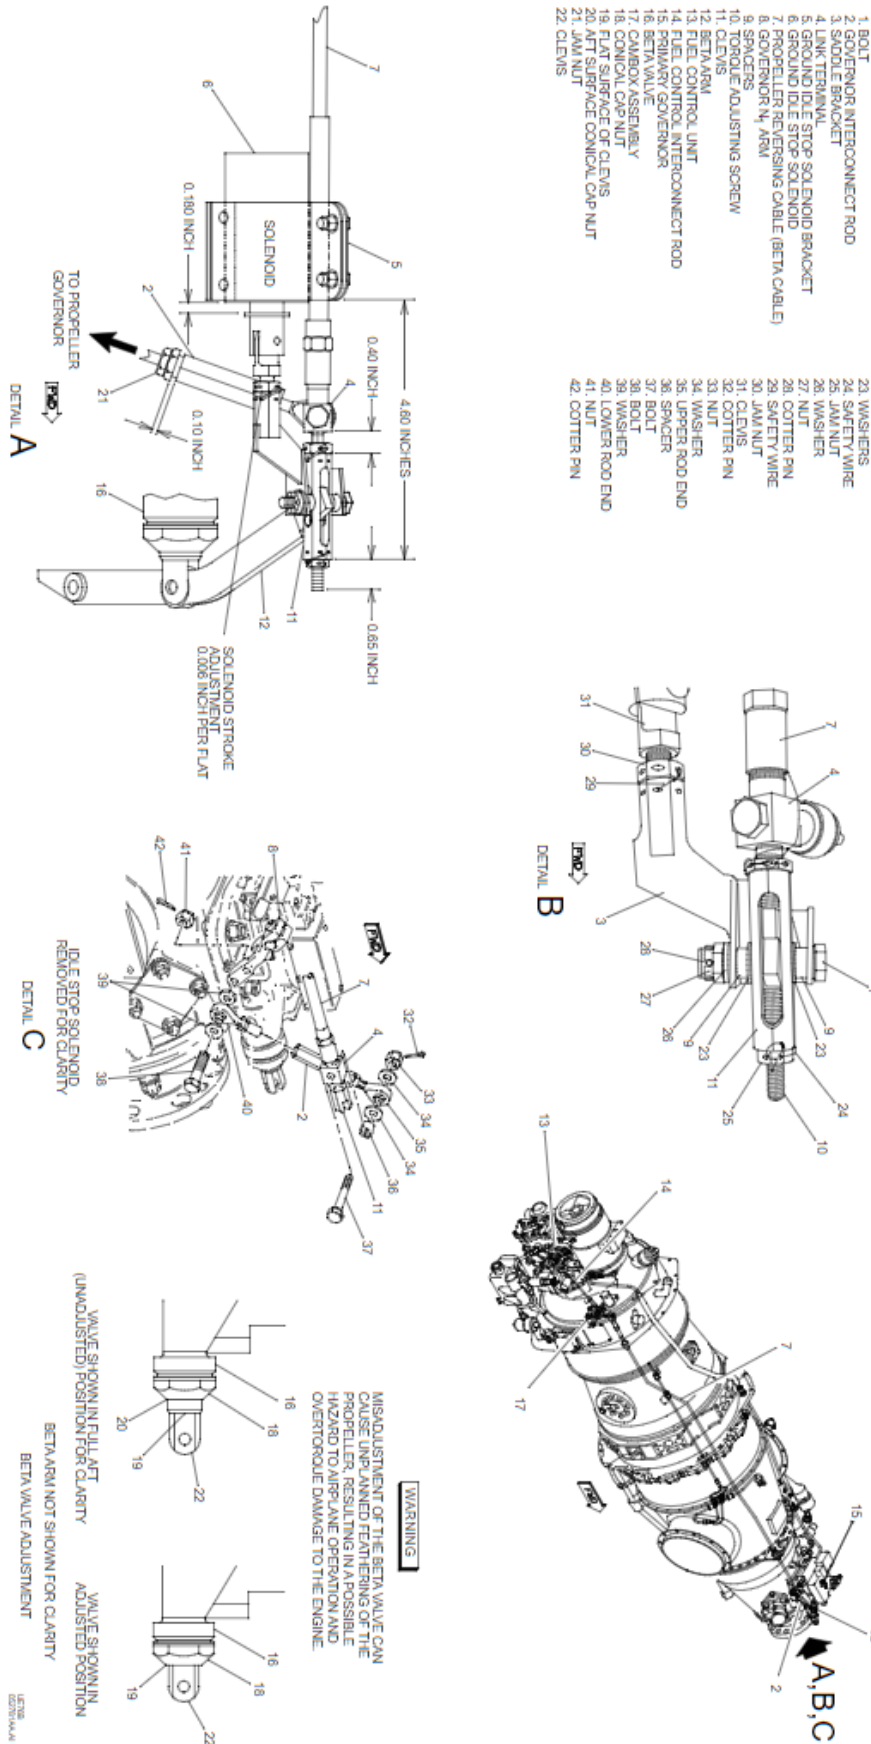
Figure 204 : Sheet 1 : Fig 204 - Propeller Reversing and Beta Valve Adjustment

- 2.6 During the reverse/beta system investigation it was noted that when pulling on the beta cable towards the propeller the clearance limits were exceeded by 3-4mm. This could result in the beta valve internal piston being pulled to the open position and that will force the propeller to go into the furthering position. See appendix B below.

- 5.1 The beta valve had an excessive clearance of 3-4mm. (see appendix B)
- 5.2 Beta/reverse system rigging/adjustment not properly done.

- 7.1 Safety Message: The Aircraft Maintenance Organisation need to ensure that maintenance performed by their personnel complies with manufacturer's maintenance instructions and Civil Aviation Maintenance Requirements as outlined in CAR Part 43. The flight controls of the aircraft were disturbed and there was no evidence of duplicate inspection carried out by the maintenance engineers involved.

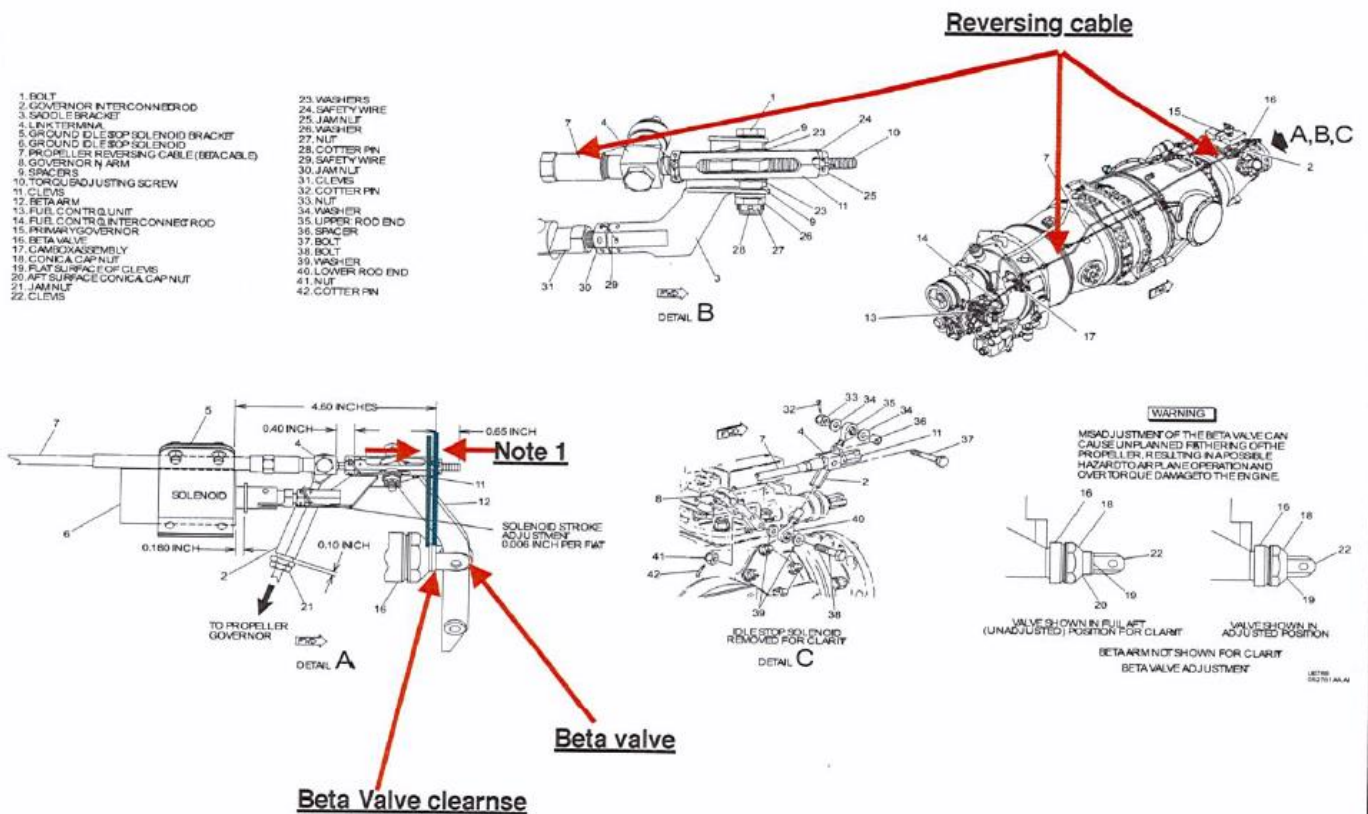
1. The Components fitted to the engine were correct and correctly installed.
2. All linkages were secured with wire locking and split pined as required.
3. The Fuel topping governor had the correct clearance of 0.10 inches
4. The Solenoid was rigged and in working order at the time of the incident
5. Adjustments were in specification.
6. It was noted that when pulling forward on the reversing cable towards the propeller, that the clearance as per **Annexure A, NOTE 1** increased to 3-4 mm. This could have pulled the internal piston of the beta valve to the open position. This action in turn would force the propeller to go into the feather position.
7. It was noted that the feather cable was stretched. The cable could be adjusted shorter by 1.5 turns at the front and 4 turns at the AFT attachment.
