AIRCRAFT INCIDENT REPORT AND EXECUTIVE SUMMARY

Reference:	CA18/3/2/1240	
Aircraft Registration	ZS-ARI	Date of Incident	6 January 2019		Time of Incident	0523Z
Type of Aircraft	Cirrus SR22T		Type of Operation	Private Part 91		
Pilot-in-command Licence Type	Private Pilot Licence	Age	74		Licence Valid	Yes
Pilot-in-command Flying Experience	Total Flying Hours	1585		Hours on Type	700	
Last point of Departure	Lanseria Aerodrome (FALA), Gauteng Province					
Next Point of Intended Landing	Lanseria Aerodrome (FALA), Gauteng Province					
Location of the incident site with reference to easily defined geographical points (GPS readings if possible)						
Lanseria International Aerodrome (FALA) Runway 07, S25°56.64' E 027°55.30'						
Meteorological Information	Wind:100/03KT; Visibility: CAVOK; Temperature: 19°C; Dew point: 14°C: QNH: 1020					
Number of People On-board	1 + 1	No. of People Injured	0		No. of People Killed	0
Synopsis	<p>The aircraft took off from Lanseria International Aerodrome (FALA) on Runway (RWY) 07 at 0520Z with a pilot and a passenger on-board for exercises within the circuit in relation to the private pilot licence (PPL) renewal. The first circuit was completed without a

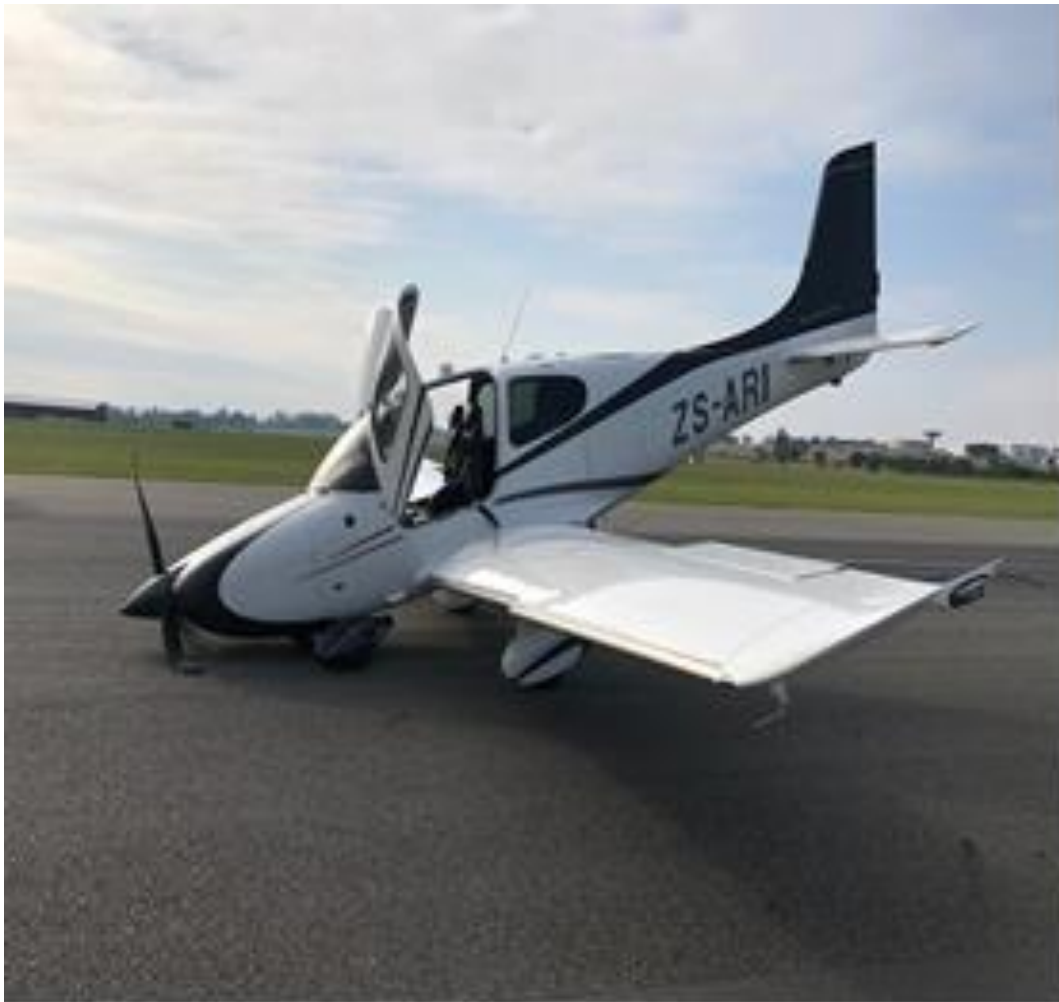
- 1.3.1 The aircraft sustained minor damage.

Figure 1: The damaged aircraft.

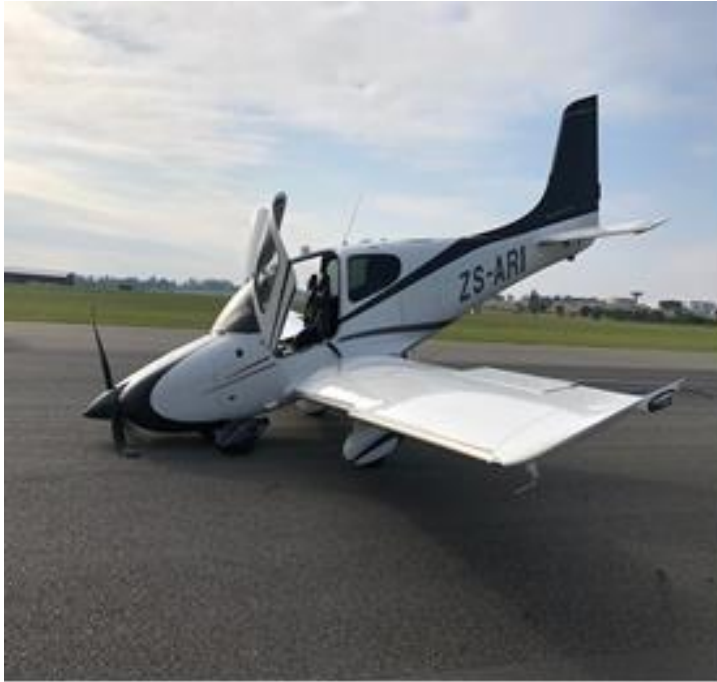
Figure 2: Damage sustained on the nose wheel.

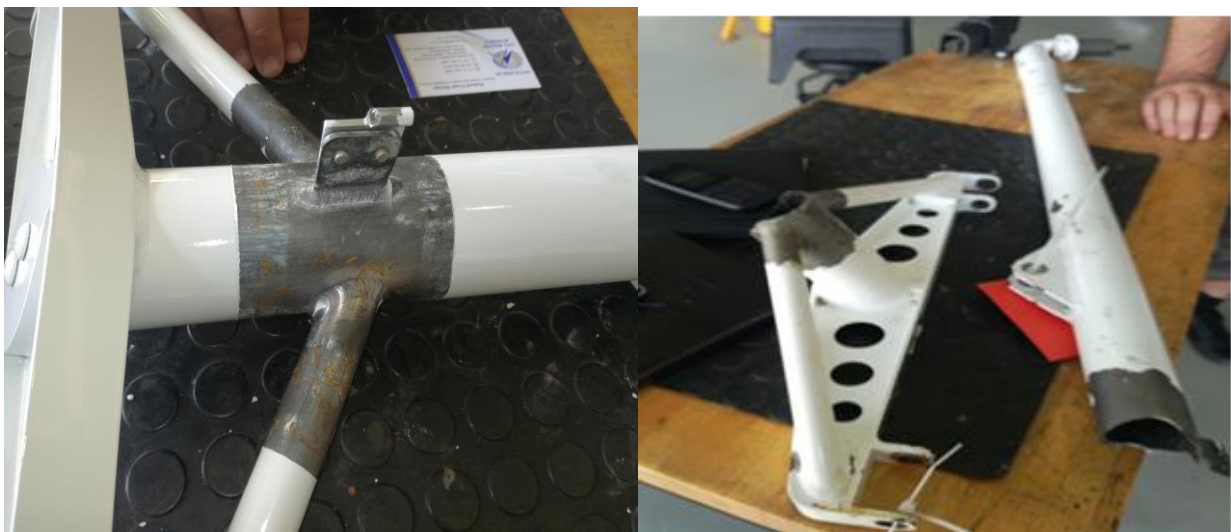
1.12.1 The aircraft landed on RWY07 at 0523Z. The aircraft's nose gear had collapsed during the landing roll; the propeller struck the runway surface and the aircraft skidded 30m before coming to a stop. The aircraft had remained on the runway centre line throughout the sequence of events. On site examination revealed that the nose gear collapsed, and the propeller blades struck the runway. The nose gear strut tube had failed below the gusset tubes welds (see Figures 3 and 4).

Figures 3 and 4: A failed strut tube (right) and a normal strut tube (left).

- 2.2.6 The investigation revealed that the nose landing gear (NLG) strut assembly collapsed during the landing roll as a result of a fractured strut tube adjacent to the forward edge of the gusset tube attachment welds. It is probable that the cause of the fracture was as a result of an undetected fatigue crack.

- 3.3.1 The nose landing gear (NLG) strut assembly collapsed during the landing roll as a result of a fractured strut tube adjacent to the forward edge of the gusset tube attachment welds. It is probable that the cause of the fracture was a result of an undetected fatigue crack.

- 4.2.1 The manufacturer to review SB number SB2X-32-22R2 to include a requirement for a non-destructive testing (NDT) inspection of the NLG strut tube for cracks.
- 4.2.2 The Director of Civil Aviation to consider issuing an Airworthiness Directive (AD) to all aircraft type Cirrus SR22T to conduct NDT inspection on the NLG strut assembly at their next 100-hour inspection and thereafter at a reasonable repeated interval until such time the manufacturer consider necessary actions to prevent future failures of Nose landing gear.

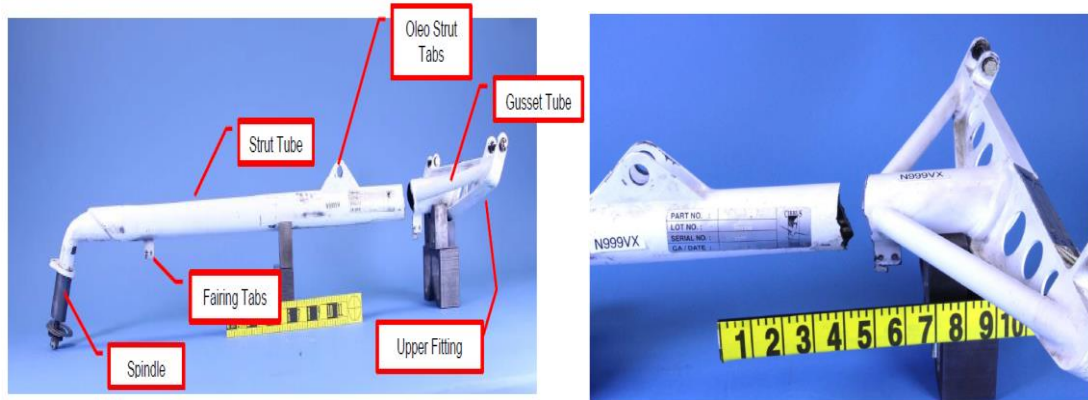
1.16.4 The USA report concluded that the cause of failure/crack was due to an unanticipated fatigue load. See Appendix 3.

Figures 5 and 6: Investigated failed strut tubes by NTSB.

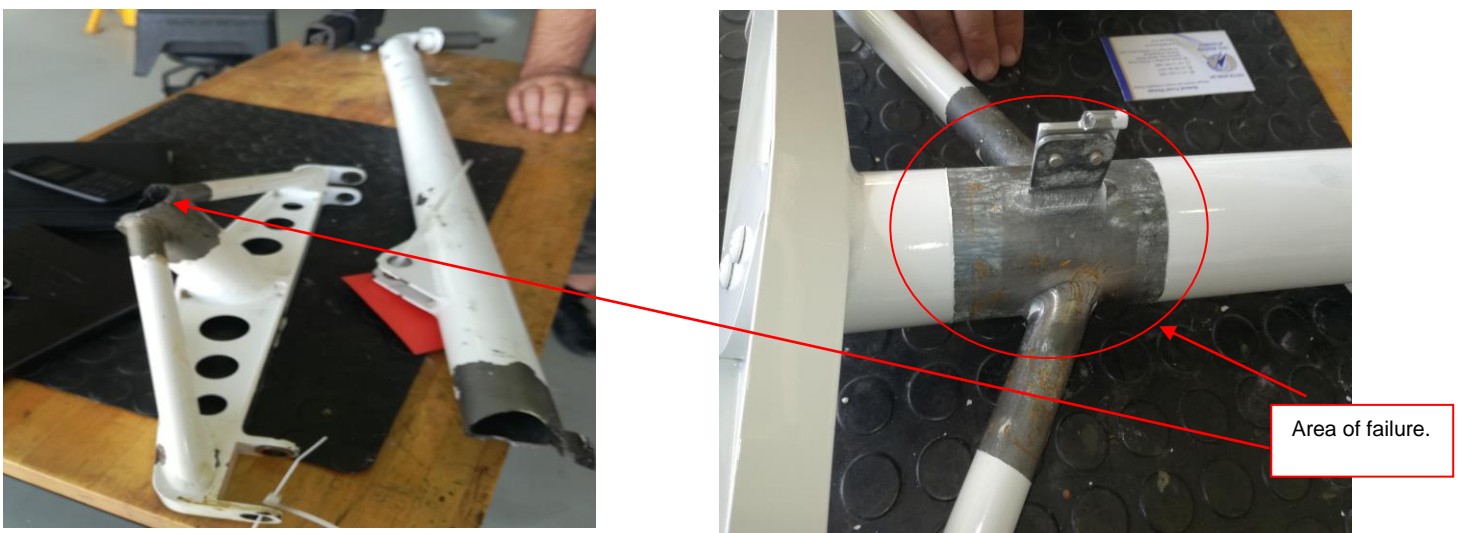
Figures 7 and 8: A failed strut tube (left) and a normal strut tube (right).

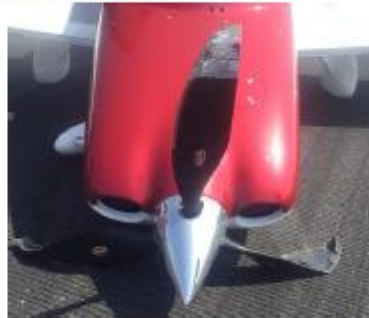
| (2) Propeller | : Blades (all three blades) damage |

Photo 1 Propellers and its periphery

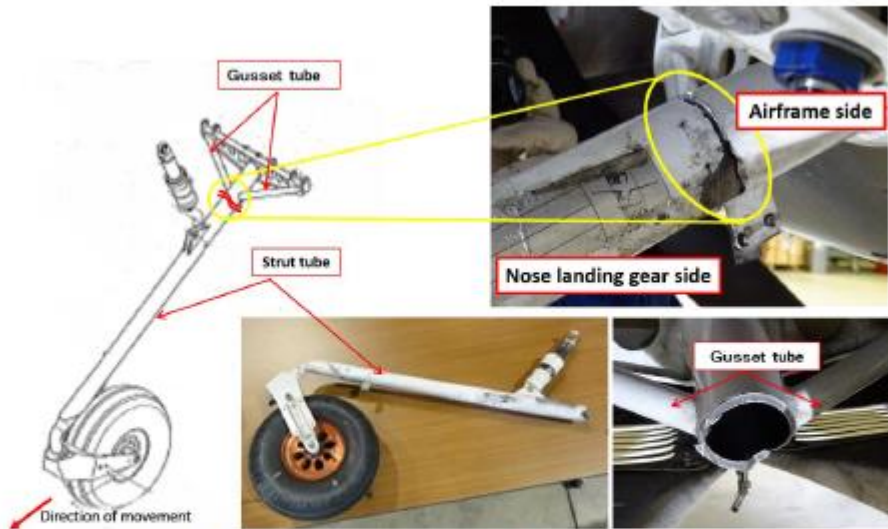
Regarding the fracture of the nose landing gear strut tube, it is probable that because undetected fatigue crack which had been generated at the forward toe of the Gusset tube weld bead of the strut tube prior to the occurrence of the serious incident progressed and the strength of the nose landing gear strut tube was decreased significantly, the load which was applied on the nose landing gear at landing of this serious incident resulted in the fracture.

| (3) Nose Landing Gear | : Fracture of the Strut tube |

Figure 2 Nose landing gear and the Fractured Strut tube

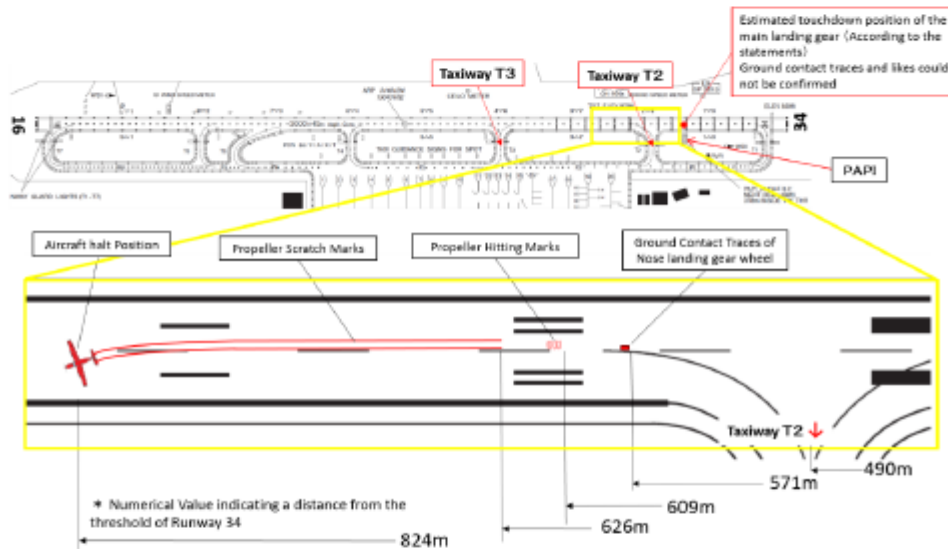
- (1) The Aircraft halted at 824 m inside of the runway 34 threshold.
- (2) Dark and short-stroked contact traces which is matching width of tire (10 cm) of the nose wheel was at 571 m inside of the runway 34 threshold, but the tire marks of the main landing gear wheel could not be identified.
- (3) Hitting marks by the propellers were left on the runway 34 from 609 m inside of the threshold for about 8 m intermittently. Furthermore, the scratch marks by the propellers were left from the 626 m inside of the runway 34 threshold to the Aircraft halt position.

Figure 3 Traces on the runway

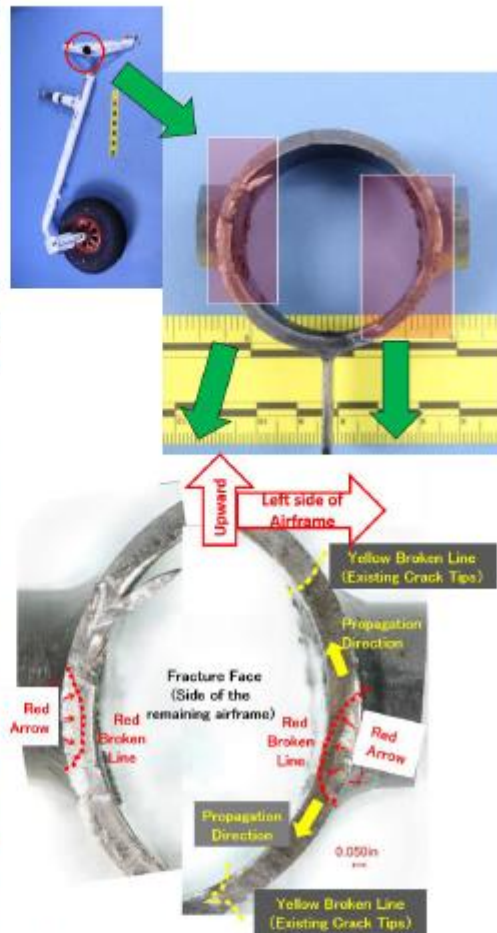
- (1) The strut tube had a fatigue crack that generated prior to the occurrence of the serious incident.
- (2) The left side of the fracture surface (the right side in Figure 4);

- ① The red broken lined parts indicates the progress of the crack which was generated at the forward toe of the Gusset tube weld bead of the strut tube (hereinafter referred to "the Edge of the strut tube").
- ② The red arrow indicates the progress of the generated multiple cracks starting from the Edge of the strut tube.
- ③ The crack which penetrated the wall of the strut tube in the red broken lined parts indicates the occurrence of repeated stress in this part.
- ④ The yellow arrow indicates further progress of the penetrating crack to the top and bottom direction along the circumference of the strut tube and the advancement of the crack to the yellow broken line right before the fracture.

Figure 4 Fracture Surface Analysis of the nose landing gear strut tube

- (3) The right side of the fracture surface (the left side in Figure 4):

As same as the left side of the fracture surface, the red broken line parts had the traces of the progressed crack starting from the multiple places at the Edge of the strut tube due to a fatigue. However, there was no penetration nor progress along the circumference direction due to cracks.

(4) The electron microscopic observations indicated the traces associated with repetition of the opening and closing of the crack on the fracture surface, and the welded part had even more small cracks at the Edge of the strut tube where the fatigue originated.
