AIRCRAFT INCIDENT SHORT REPORT

CA18/3/2/1241: Forced landing following an engine failure on final approach

Date and time : 12 January 2019 at 1210Z
Aircraft registration : ZS-IIL
Aircraft manufacturer and model : Cessna Textron, C182N
Last Point of departure : Grand Central Aerodrome (FAGC)
Next point of intended landing : Iwamanzi Game Lodge, Koster, North West
Location of incident site with reference to easily defined geographical points (GPS readings if possible) : S25°52'52" E026°59'41", 6nm east of Koster
Meteorological information : FARG METAR: wind: 330°/5kt; temperature 32°C; dew point: 18°C; QNH: 1012 hPa
Type of operation : Private (Part 91)
Persons on board : 1 + 1
Injuries : None
Damage to aircraft : Substantial

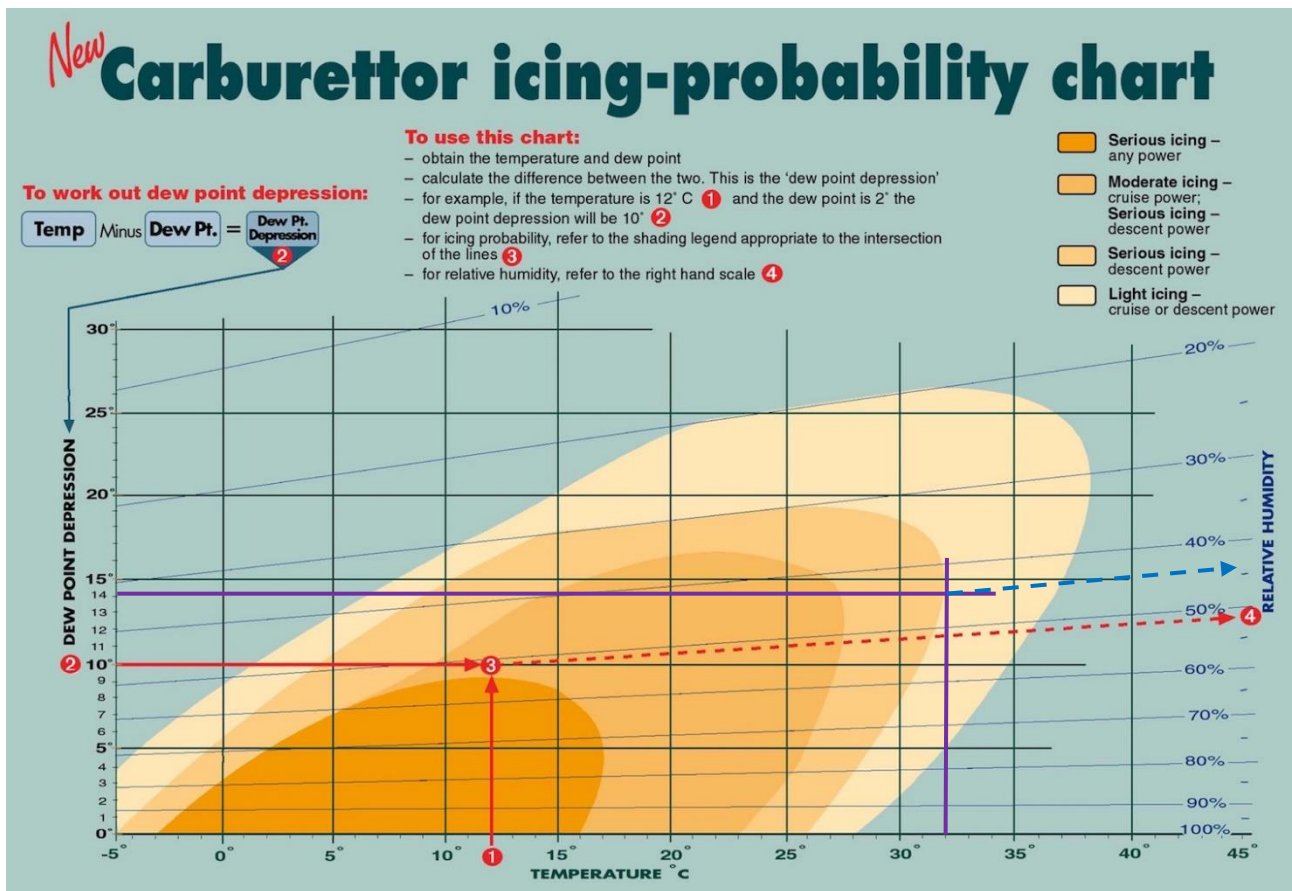
2.9 The Meteorological Terminal Aviation Routine (METAR) Weather Report for Rustenburg Aerodrome (FARG) (which is the closest aerodrome to the accident site) at the time of the incident was—wind: 330°/5kt; temperature: 32°C; dew point: 18°C; QNH: 1012 hPa. A light risk of carburettor icing was present at the time of the incident.

Figure 2: The conditions the aircraft was operating in prior to the shutdown. (Source: Australian Government Civil Aviation Authority)

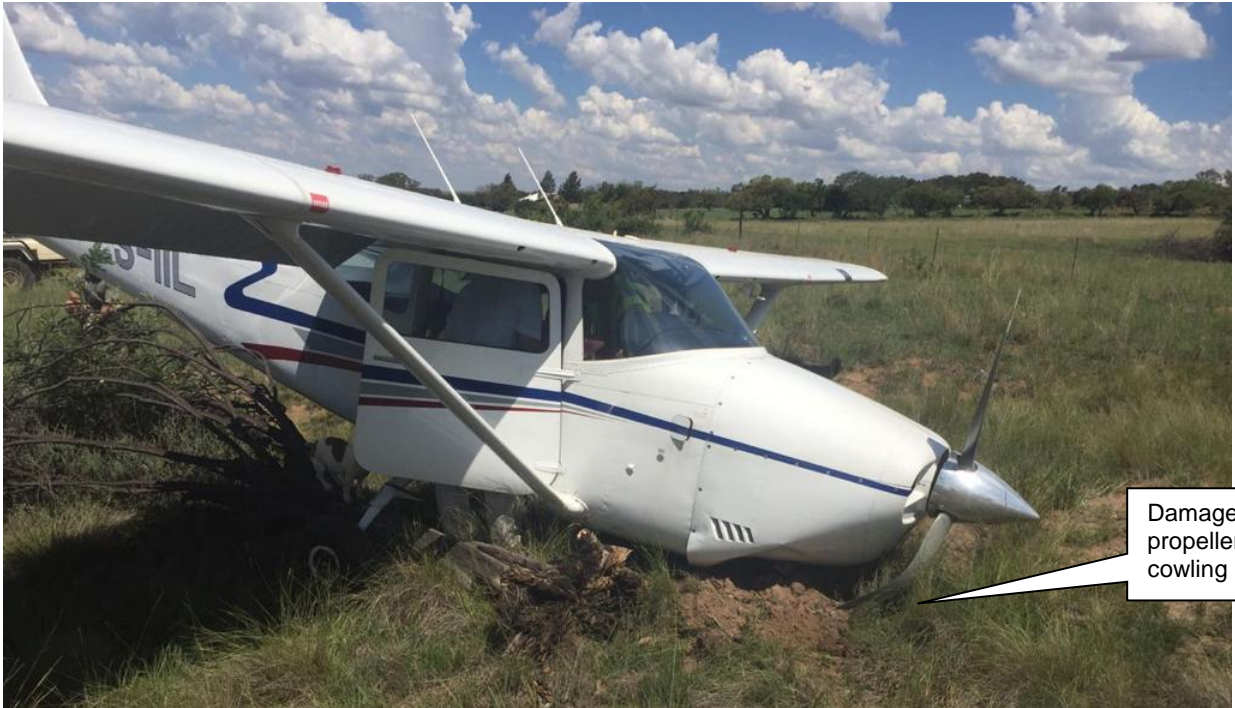
- 2.5 The aircraft sustained damage to the nose gear, lower fuselage, propeller and engine cowling; both occupants reported no injuries. A local farmer was the first person on site and assisted the occupants of the aircraft.

Figure 3: Damage to the propeller and cowling
(Source: J de Reuck)

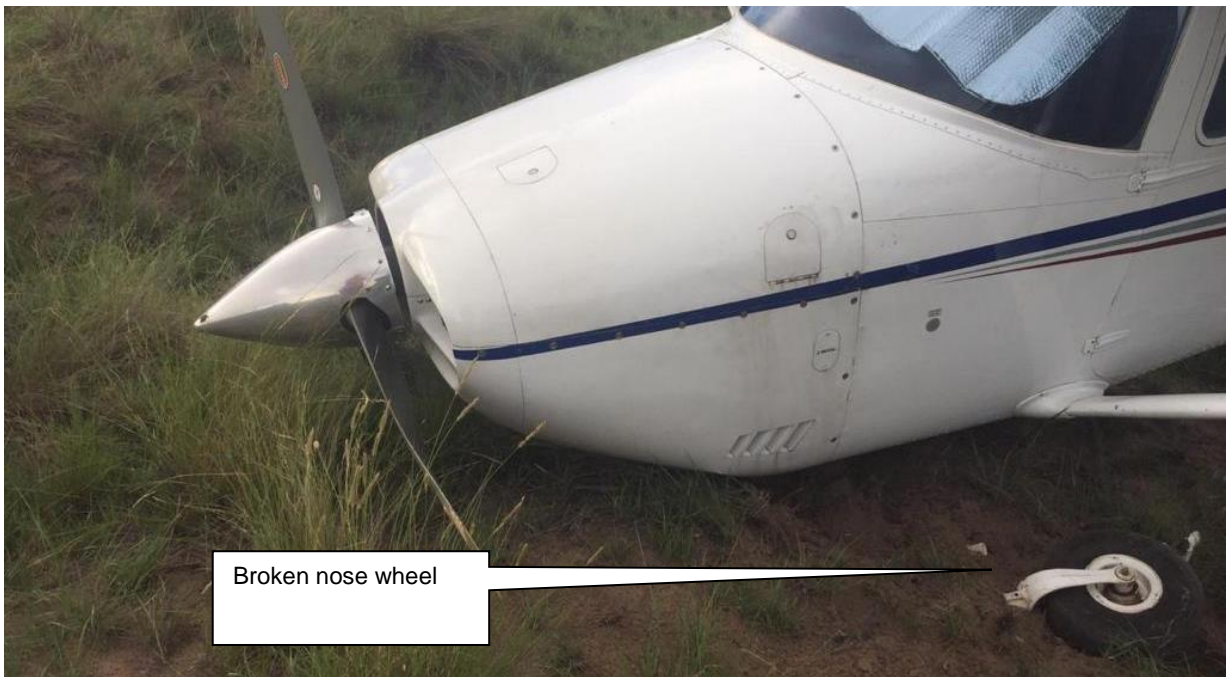
Figure 4: Damage to the nose gear
(Source: J de Reuck)
