AIRCRAFT ACCIDENT SHORT REPORT

CA18/3/2/1245: ZS-LCU, Nose gear collapse during take-off roll

Date and time	: 19 January 2019, 0830Z
Location	: Potchefstroom, North West
Aircraft registration	: ZS-LCU
Aircraft manufacturer and model	: Cessna Textron, C210N
Last Point of departure	: Potchefstroom Aerodrome (FAPS)
Next point of intended landing	: Potchefstroom Aerodrome (FAPS)
Location of incident site with reference to easily defined geographical points (GPS readings if possible)	: S26°40'17" E027°04'44", Potchefstroom Aerodrome (FAPS)
Meteorological Information	: Wind: 290°/04 kt, Temperature 23 °C, Dew point: 12°C, QNH: 1015 hPa, CAVOK
Type of operation	: Private (Part 91)
Persons on board	: 1 + 3
Injuries	: None
Damage to aircraft	: Substantial

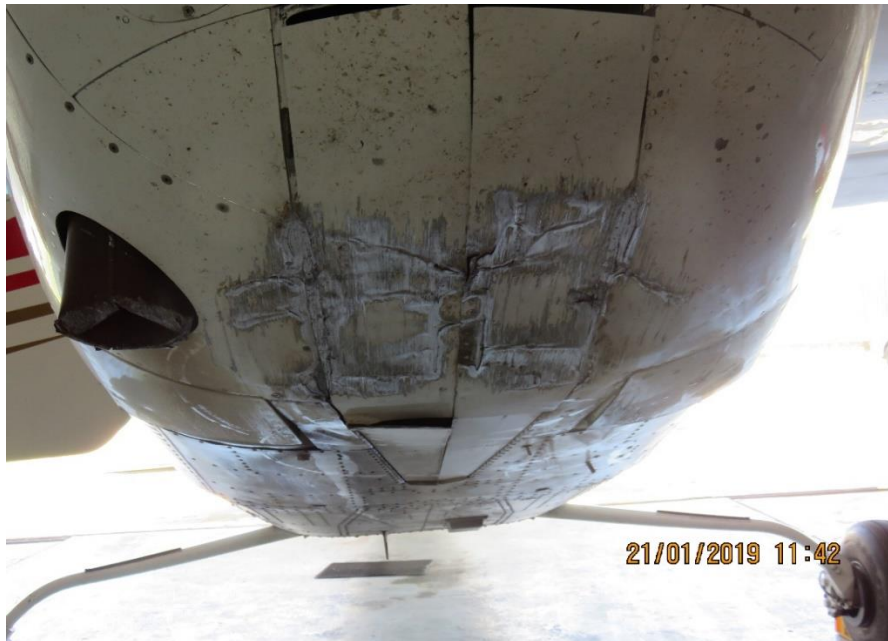
- 2.4 The aircraft sustained damage to the nose gear doors, propeller and cowling, and none of the occupants on-board reported any injuries.
- 2.5 The flight was conducted in visual meteorological conditions (VMC) by day.

Figure 2: Damage to the nose gear doors, cowling and exhaust

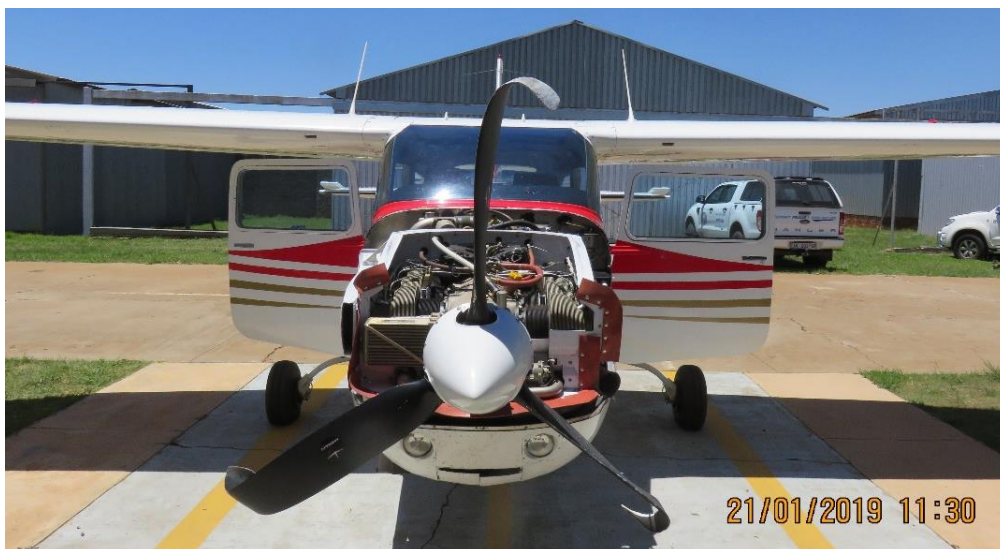
Figure 3: Damage to the propeller
