AIRCRAFT INCIDENT SHORT REPORT

CA18/3/2/1248: Omission to lock the landing gear lever, resulting in the inadvertent landing gear-up selection.

Aircraft registration : ZU-ECE

Aircraft manufacturer and model : Nanchang Dragon C J6-A

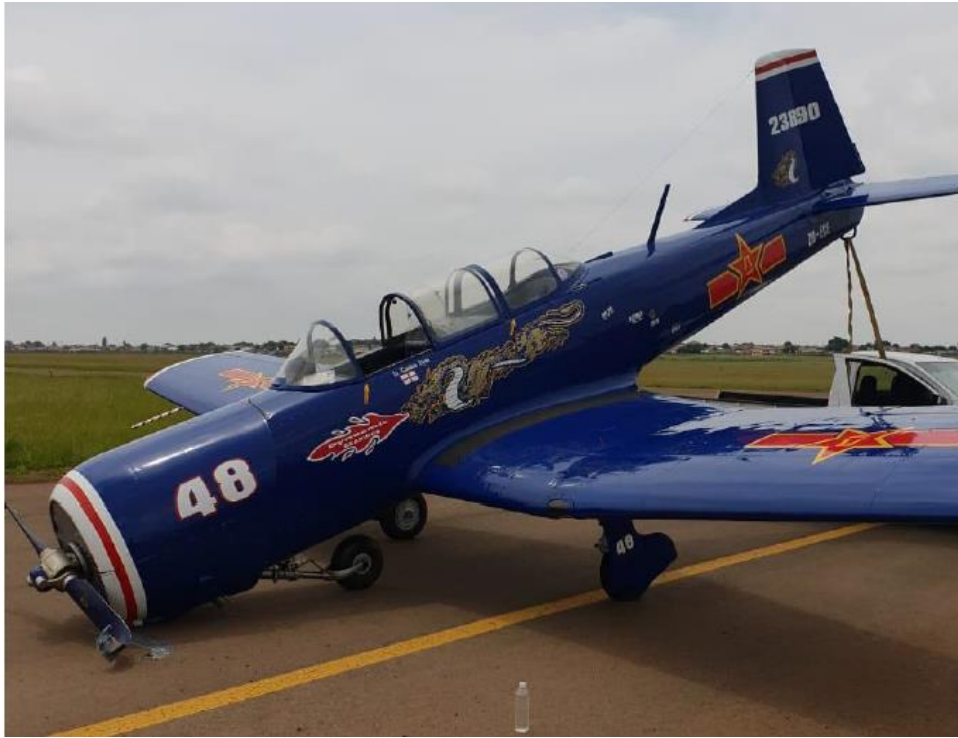
- 1.3 It is likely that the pilot inadvertently moved the landing gear lever up after omitting to push the latch to the left (locked position). This resulted in the nose gear collapsing when the aircraft was moved forward. The reason the main gears did not collapse is that they retract inwards whilst the nose gear retracts rearwards.

Figure 1: The aircraft after the nose gear collapsed.
(Photo courtesy of the pilot)

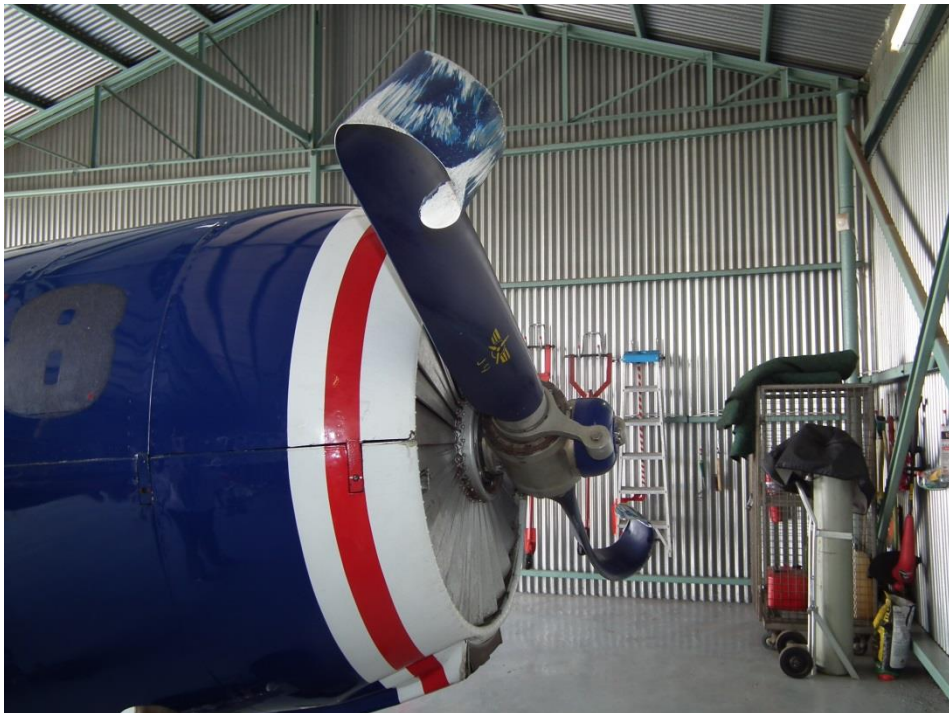
Figure 2: View of the bent propeller blades.
(Photo courtesy of the pilot)

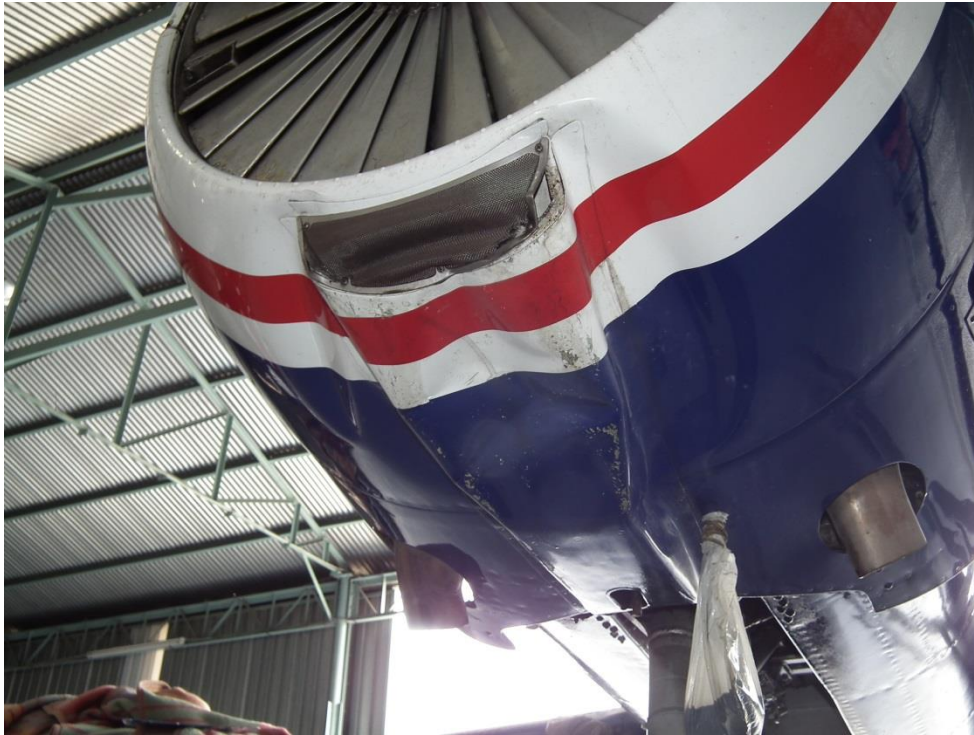
Figure 3: Damaged nose cowling.
(Photo courtesy of the pilot)

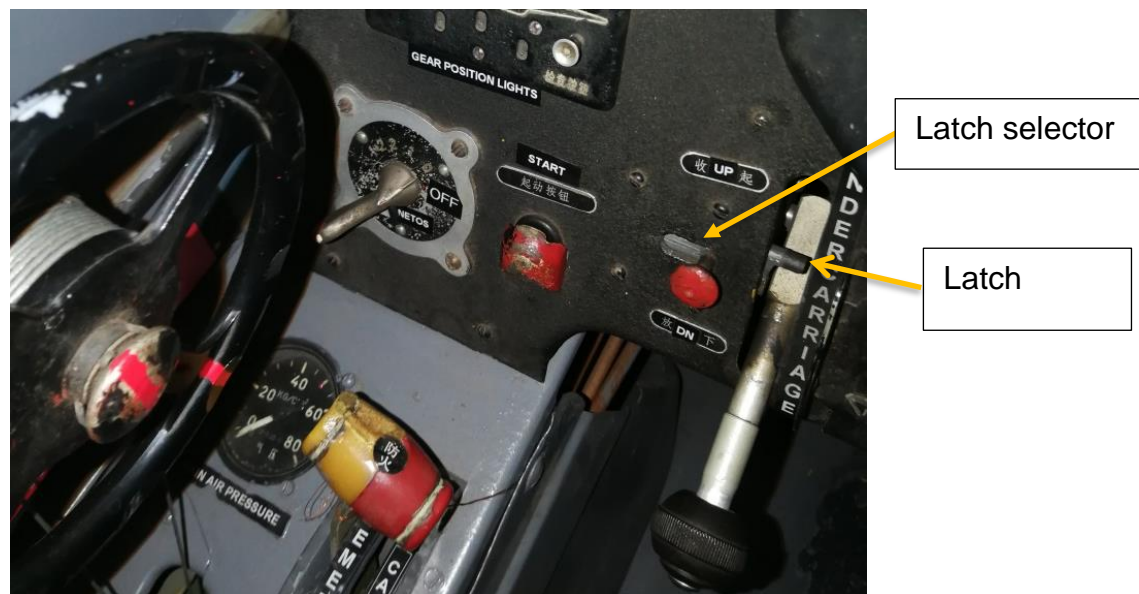
A latch (landing gear lever lock) prevents the gear lever from being moved to the “up” position. This latch is slid leftwards before the gear lever can be moved up. Normal procedure calls for this latch to be slid left (i.e. out) when the aircraft is lined up immediately prior to take-off, and slid right (i.e. in) only after landing. There are two good reasons for this procedure. Firstly, on take-off, it is not desirable to be fumbling with the latch while close to the ground, as there is an observed tendency for the pilot thus engaged to drop the nose. Secondly, the arrangement is designed to prevent inadvertent or accidental gear retraction on the ground...

Figure 6: Landing gear lever and latch.

- 3.8 It is likely that the pilot inadvertently moved the landing gear lever up after omitting to push the latch to the left (locked position). This resulted in the nose gear collapsing when the aircraft was moved forward. The reason the main gears did not collapse is that they retract inwards whilst the nose gear retracts rearwards.
