AIRCRAFT INCIDENT REPORT AND EXECUTIVE SUMMARY

Reference:	CA18/3/2/1256	
Aircraft Registration	ZU-BJY	Date of Incident	21 March 2019		Time of Incident	05:15Z
Type of Aircraft	Tecnam P92 Echo		Type of Operation	Training (Part 141)		
Pilot-in-command Licence Type	Commercial Pilot		Age	36	Licence Valid	Yes
Pilot-in-command Flying Experience	Total Flying Hours		1220.1		Hours on Type	666.8
Last point of departure	Aeropark Zyn Kraal Aerodrome-Gauteng Province					
Next point of intended landing	Aeropark Zyn Kraal Aerodrome-Gauteng Province					
Location of the incident site with reference to easily defined geographical points (GPS readings if possible)						
At Aeropark Zyn Kraal Aerodrome during landing roll collision with perimeter fence with GPS (S 25°54'15" 5, E 028°32'34") with a field elevation of 4900 ft.						
Meteorological Information	Wind direction: 350° Wind speed: 05kt; Visibility: 9999m, CAVOK					
Number of people on board	2+0	No. of people injured	0	No. of people killed	0

Reference Number : CA18/3/2/1256
Name of Owner/Operator : Accolade Flying School
Manufacturer : Amateur Build Wing
Model : Tecnam P92 ECHO
Nationality : South African
Registration Marks : ZU-BJY
Place

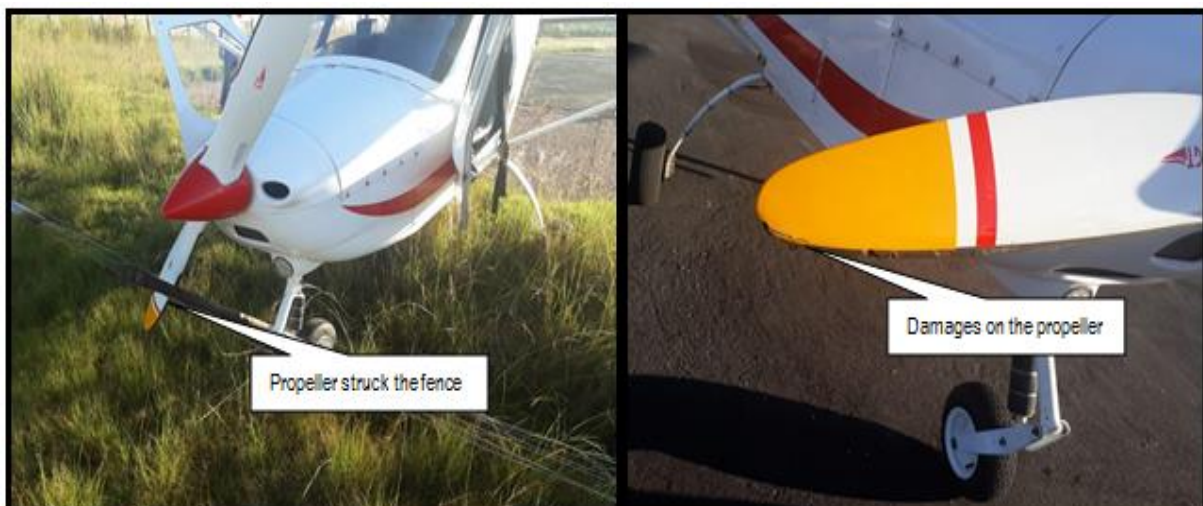
- 1.3.1 The aircraft sustained damage on the propeller blades during collision.

Figure 1: Damage on the propeller after the incident.

- 1.12.1. The aircraft overshot Runway 27 and was brought to a stop by the parameter fence. The aircraft sustained damage to the propeller blades when they got entangled with the fence wire.
