AIRCRAFT ACCIDENT SHORT REPORT

CA18/3/2/1257: The aircraft was forced landed on a dirt road due to fuel mismanagement.

Date and time :26 April 2019, 0700Z
Aircraft registration :ZU-DLW
Aircraft manufacturer and model :Beech Aircraft Corporation, Beech A35 (Veteran)
Last point of departure :Wesselsbron Aerodrome (FAWS), Free State Province
Next point of intended landing :Wesselsbron Aerodrome (FAWS), Free State Province
Location of accident site with reference to easily defined geographical points (GPS readings) :GPS co-ordinates S28°0'59.20"
E026°18'9.36"
Meteorological information :Surface wind: 360° at 2kts, temperature: 14°C, dew point: 10°C, QNH: 1022, CAVOK
Type of operation :Private (Part 94)
Persons on-board :1 + 2
Injuries :None
Damage to aircraft :Substantial

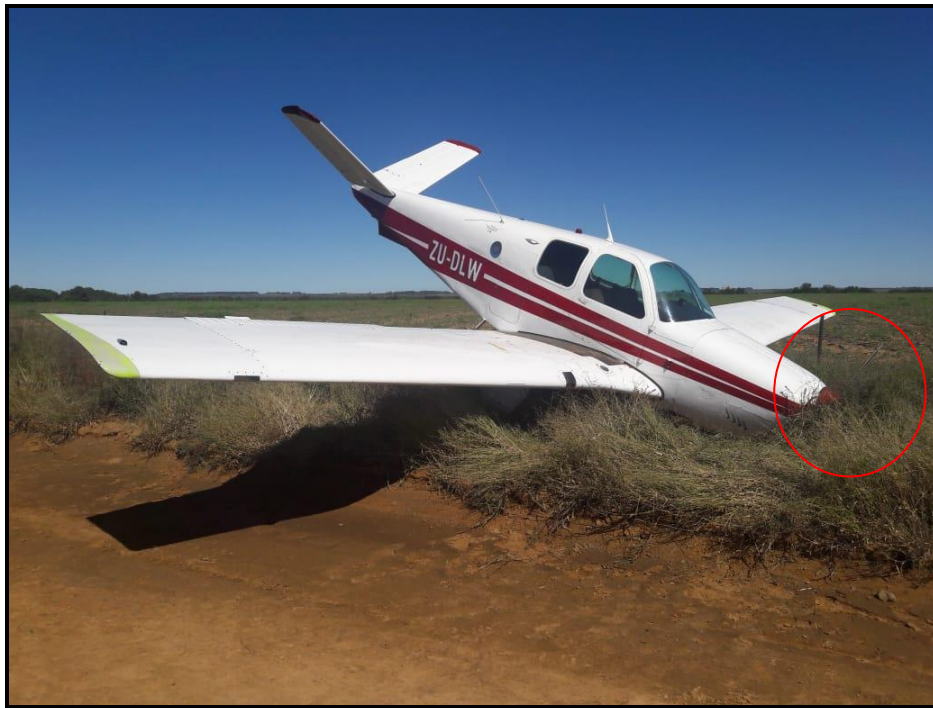
Figure 1: The aircraft as it came to rest with the blade lodged under the nose section.

- 2.4 Post-accident inspection revealed that one propeller blade was not damaged, but the other propeller blade was bent towards the hub and the nose gear collapsed. Figure 1 shows the blade that was lodged under the nose section while the other blade was not damaged.

- 3.8 Only one propeller blade was damaged during the accident sequence (when the propeller struck the ground), an indication that the engine was not functioning when the accident occurred.

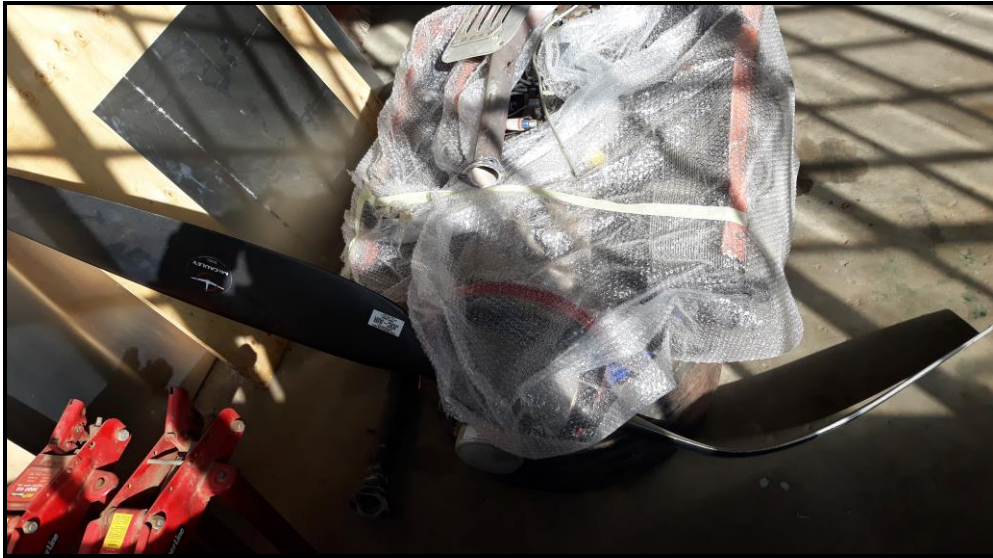
Figure 2: The condition of propeller blades as they were recovered from the accident site.

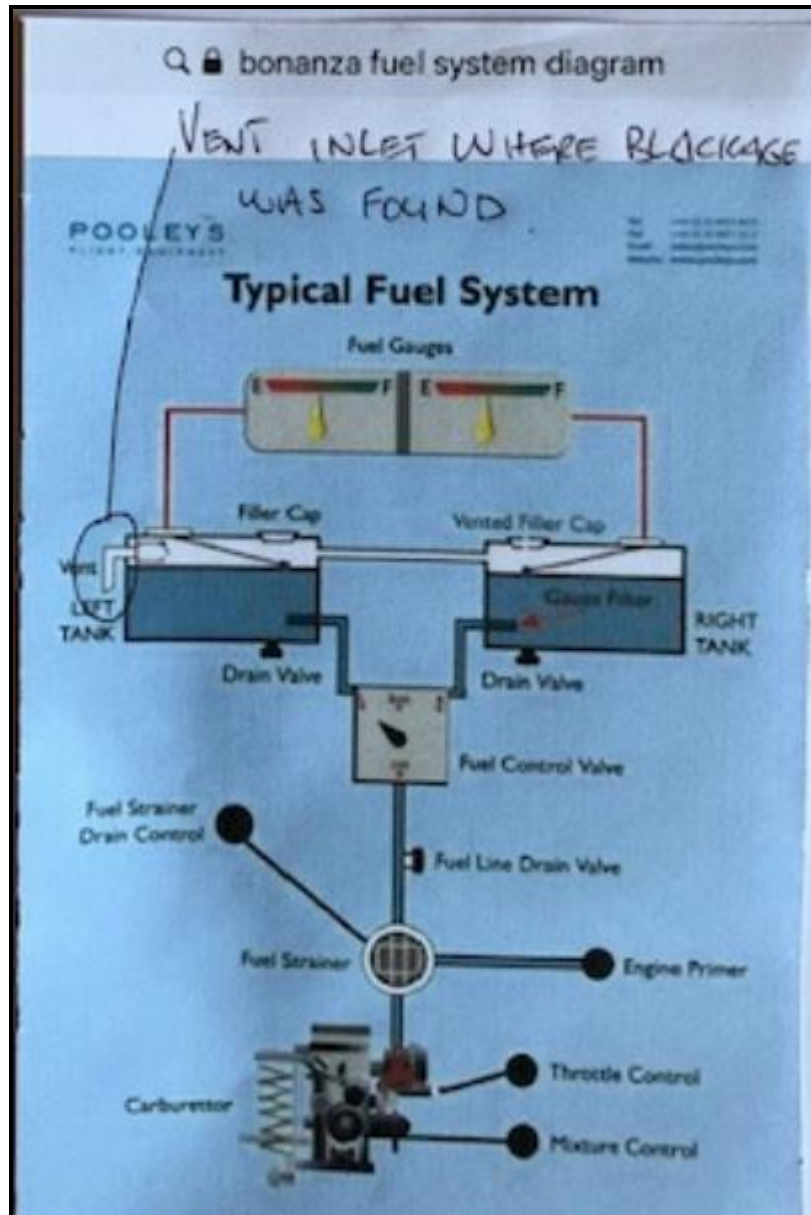
2.9 Post-accident inspection of the aircraft was conducted by the AME who recovered the aircraft. The AME stated that he discovered that the left fuel tank vent system was blocked by what seemed like insect nest deposits. The AME then flushed the system with compressed air to clear it (Figure 3).

Figure 3: Schematic of the Beechcraft A35 fuel system.
