AIRCRAFT SERIOUS INCIDENT REPORT AND EXECUTIVE SUMMARY

Reference:	CA18/3/2/1259	
Aircraft registration	ZS-SSJ	Date of incident	27 March 2019		Time of incident	1330Z
Type of aircraft	Avro 146-RJ85		Type of operation		Air Transport Operations (Part 121)	
Pilot-in-command licence type	Airline Transport	Age	55	Licence valid	Yes	
Pilot-in-command flying experience	Total flying hours	21 300		Hours on type	2 676	
Last point of departure	O.R. Tambo International Aerodrome (FAOR): Gauteng Province					
Next point of intended landing	Upington Aerodrome (FAUP): Northern Cape Province					
Location of the incident site with reference to easily defined geographical points (GPS readings if possible)						
Radial 030 at 3 DME JSV (GPS position: 26°09'25.63" South 028°13'51.70" East)						
Meteorological information	Wind: 280°V010° at 08kts, Visibility: 9999, Clouds: BKN at 3600ft, Temperature: 23°C, Dew point: 15°C and QNH: 1027					
Number of people on-board	4 + 25	No. of people injured	0	No. of people killed	0

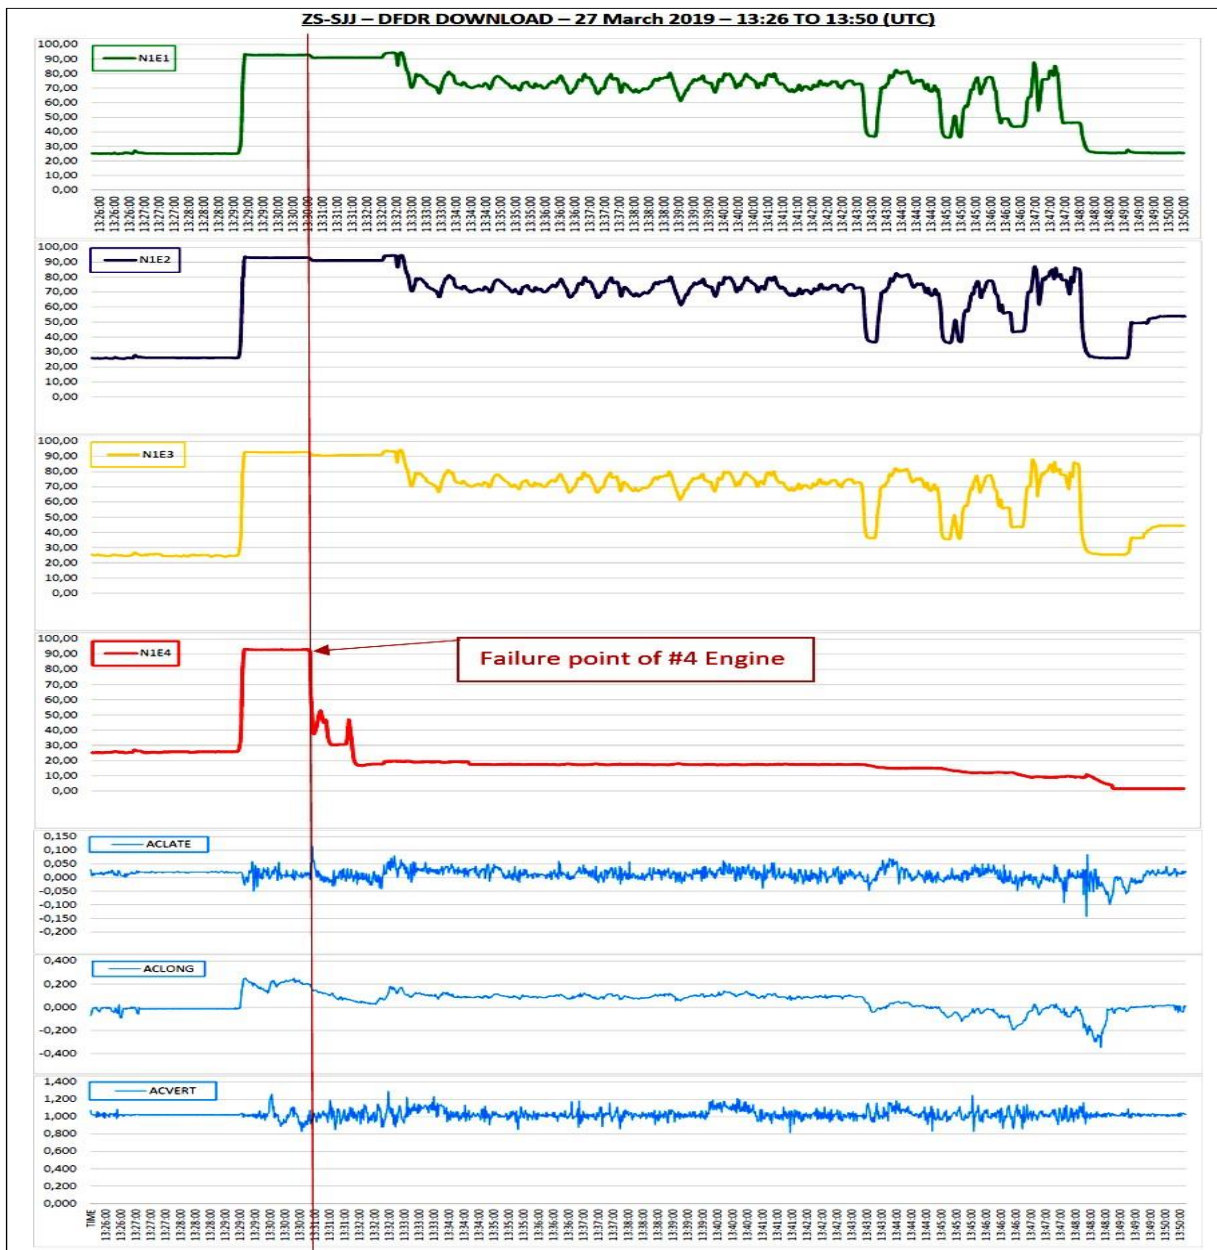
- 1.11.3. According to Figure 2, the D-FDR recording started at 13:26:00 with all four engines indicating similar N1 speeds (low-pressure compressor rotational speed). All four engines stabilised at 93% N1 after the pilot applied take-off power. At 13:30:00, the number 4 engine N1 suddenly dropped below 40%. The remaining three functional engines experienced a slight drop in N1, but then stabilised at 91%. The N1 speed for number 4 continued to decay until it recorded a zero value. At the time when the number 4 engine experienced the sudden drop in N1 speed, the lateral accelerometer indicated an instantaneous increase in vibration from 0.008 to 0.115 units for a short time. The vertical and longitudinal accelerometers did not record any significant changes in vibration attributed to the engine failure.

Figure 2: A copy of the DFDR download graph showing engine N1 and accelerometer parameters.

- 2.1.10. The aircraft was fitted with a Honeywell D-FDR. The unit was downloaded by an approved facility. From the data, the number 4 engine N1 suddenly spooled down at the same time the aircraft lateral accelerometer recorded an instantaneous increase in vibration levels from 0.008 to 0.115 units for a short time.

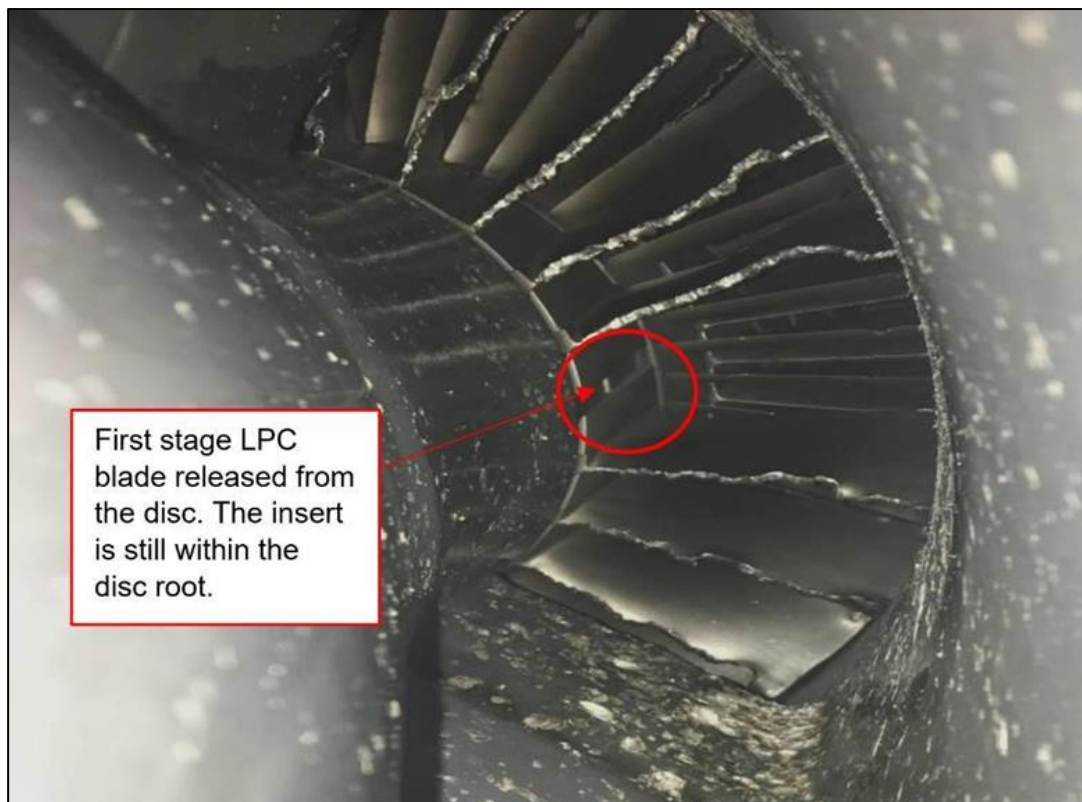
Figure 3: First stage LPC blade released from the disc with inset still within the disc root.
(Source: Standard Aero)

- 2.1.11. The investigation revealed that the serious incident occurred because of failure of one of the first stage compressor blades which had cracked at the root before it separated. The blade travelled to the rear of the compressor section, damaging the LP and HP compressors and some internal engine components in the compressor section of the engine.

- 2.1.12. The first stage compressor blade failed at 230.16 hours following the last shop visit where the compressor section was inspected; no defects were noted during that inspection. It is likely that the crack on the blade root was due to fatigue given that it failed at 230.16 hours after the last shop visit.

- 3.4.1. The number 4 engine failure was due to the failure of one of the first stage compressor blades, likely caused by a fatigue crack at the root of the blade.

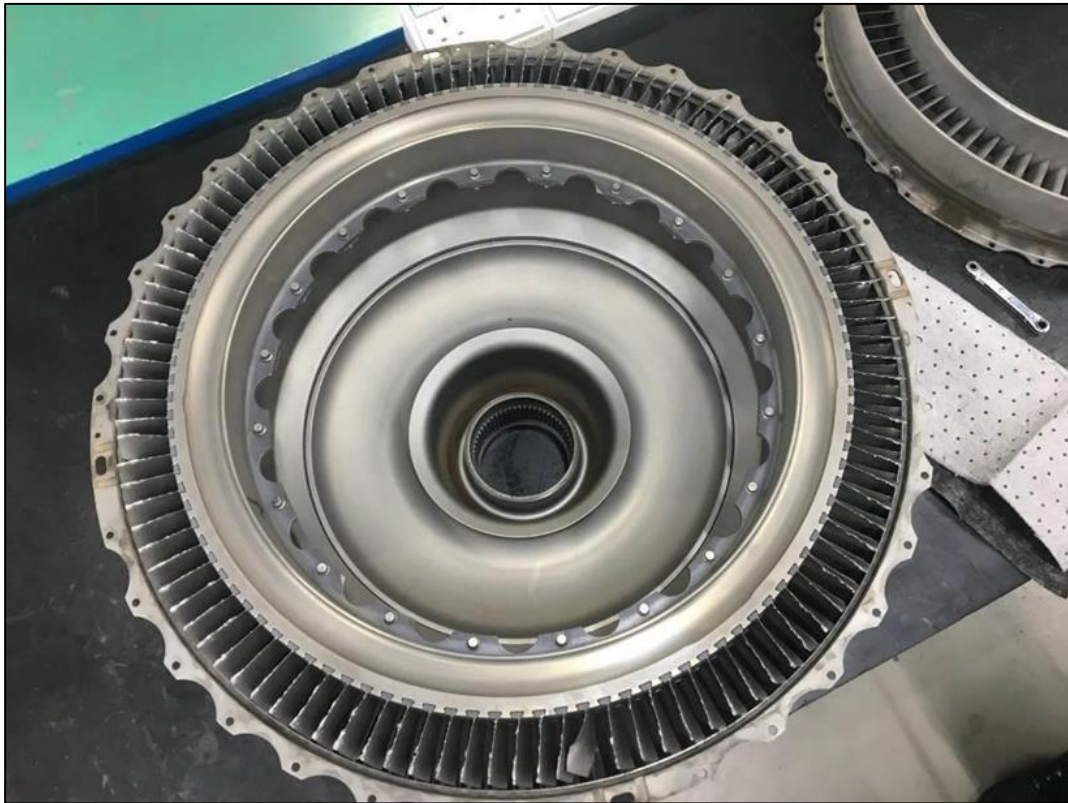
- 1.16.2. During the borescope inspection, indications showed that impact damage had occurred to the LP compressor rotor blades, vanes and the compressor rotor. During the initial disassembly of the engine, focus was on the fan module to investigate any potential cause for the failure mode. Inspections revealed that the fan blades did not have any damage or indications to the leading edges or airflow surfaces that could have been attributed to a foreign object being ingested. When LP compressor was disassembled from the fan exit vane assembly, damage was identified on the LP compressor blades and the stator vane assemblies.

Figure 4: Impact damage to the second stage LPC blades. (Source: Standard Aero)

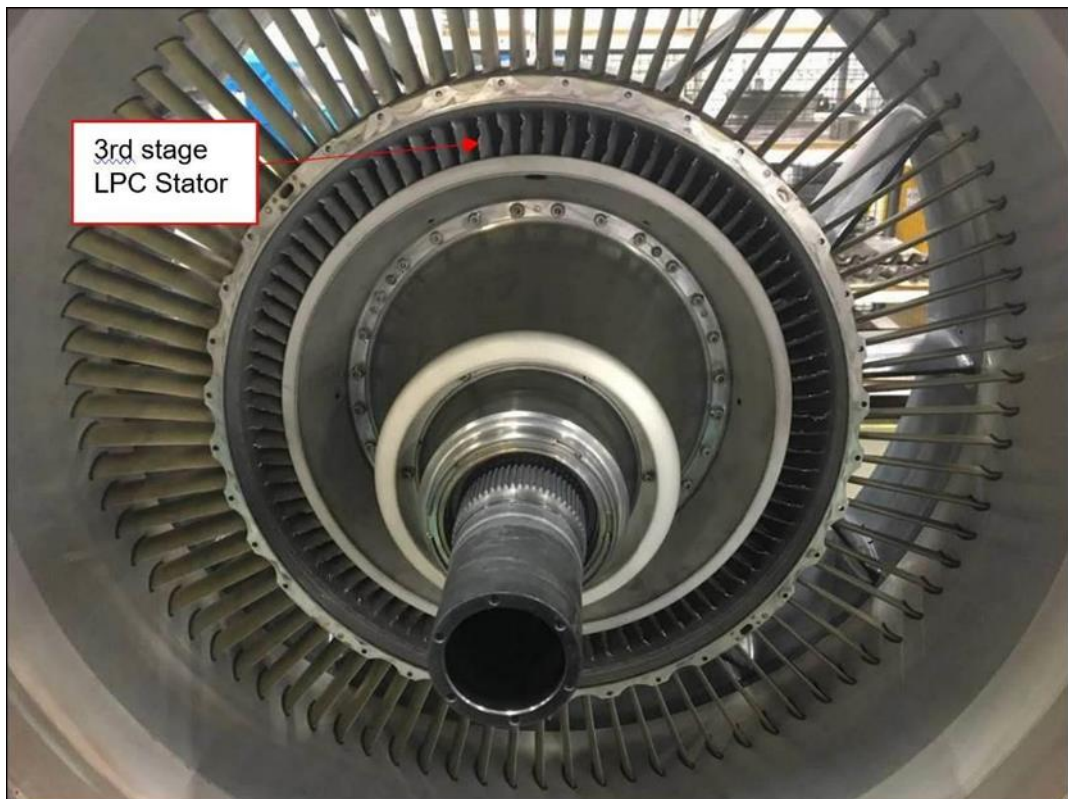
Figure 5: Impact damage to the third stage LPC stator vanes. (Source: Standard Aero)

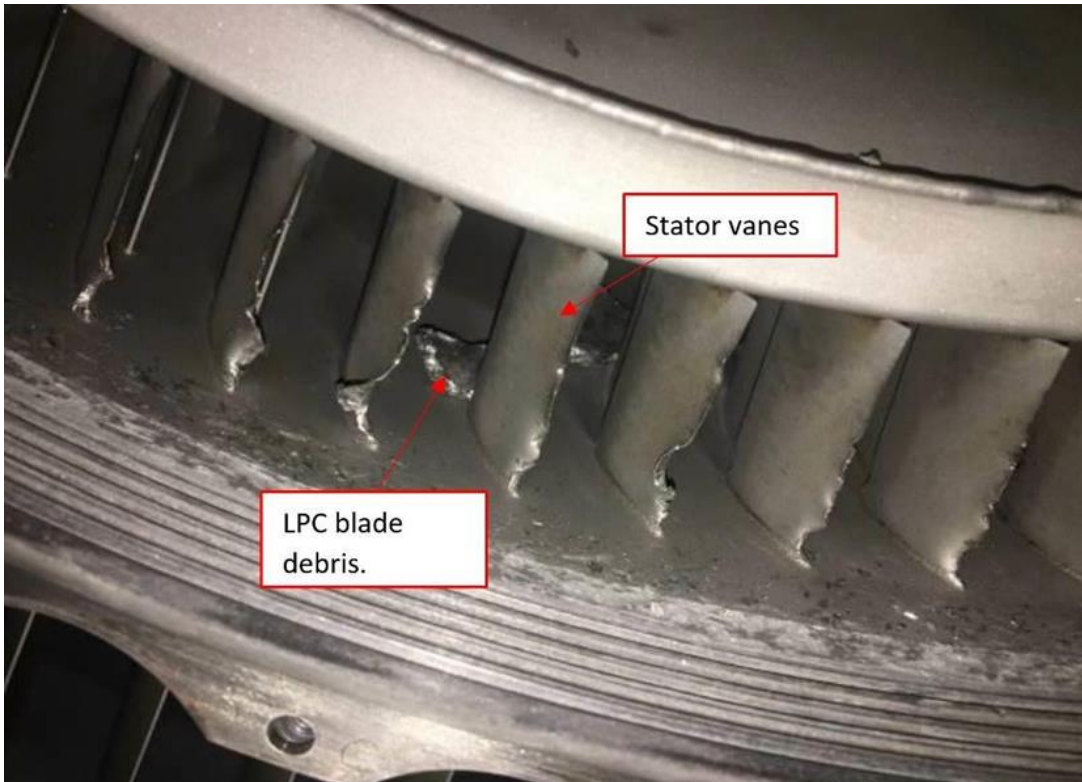
- 1.16.3. Debris of a compressor blade was located within the stator vane assemblies and on the fan frame struts. The fan frame inner shroud and struts had impact damage. The first stage compressor blades showed impact damage and deformation to the blades, along with one blade that had detached from the first stage compressor disc root. The blade inset was still within the disc root. The stub frame inner shroud and vanes had impact damage. The inspection showed that the compressor blade that was released into the compressor core caused impact damage to the compressor blades. Several first stage LPC blades had moved rearwards, causing the front tab of the inset to straighten from the original position. The compressor housing blade was impacted and worn out. Impact damage was evident to the impeller vane along the leading edges.

Figure 6: Low-pressure compressor blade debris. (Source: Standard Aero)

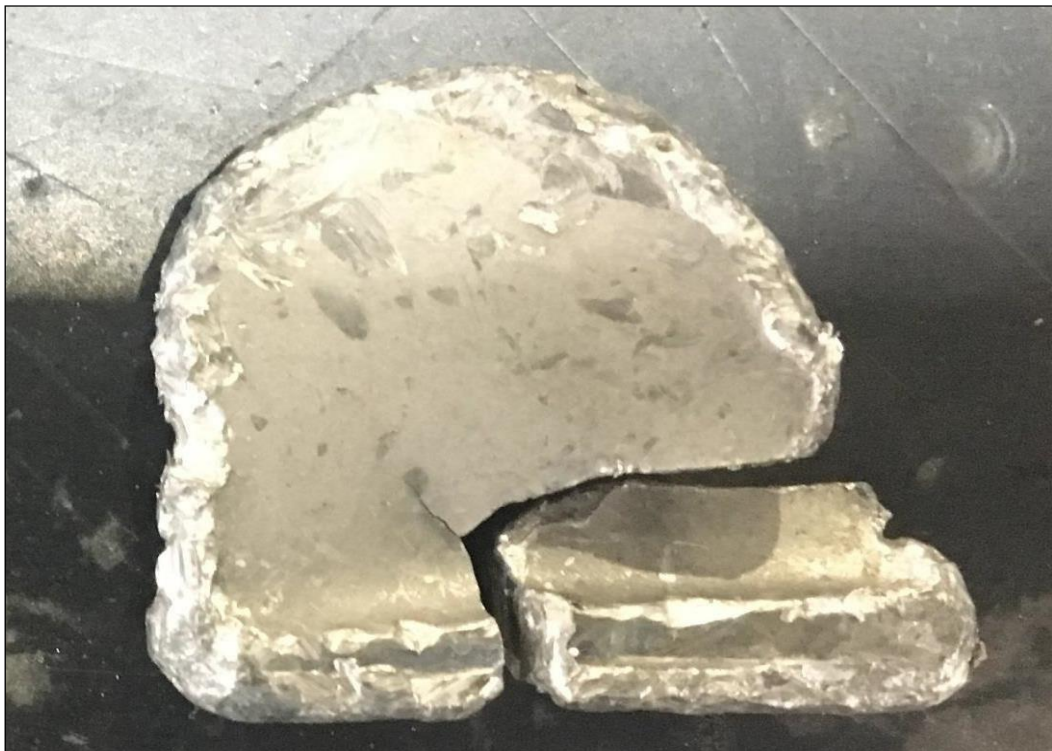
Figure 7: Fragments of the detached compressor blade. (Source: Standard Aero)

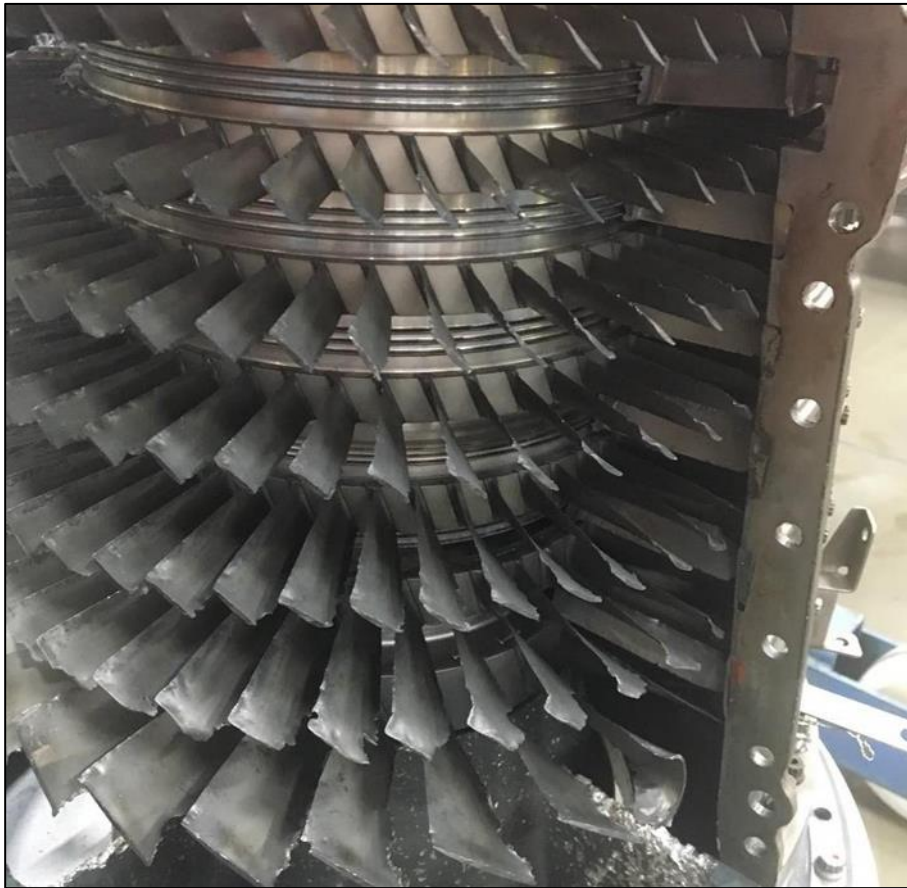
Figure 8: Impact damage to the compressor rotor blades. (Source: Standard Aero)

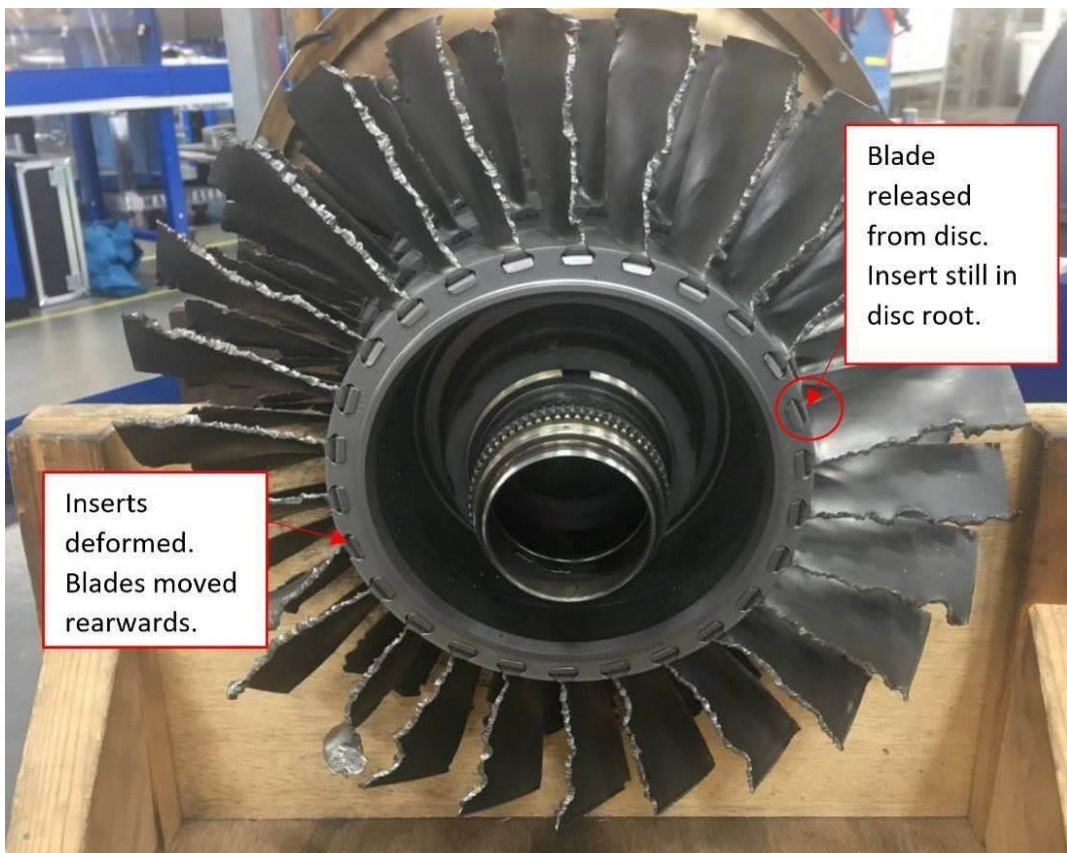
Figure 9: Compressor blade inserts deformed as the blades have moved rearwards. (Source: Standard Aero)

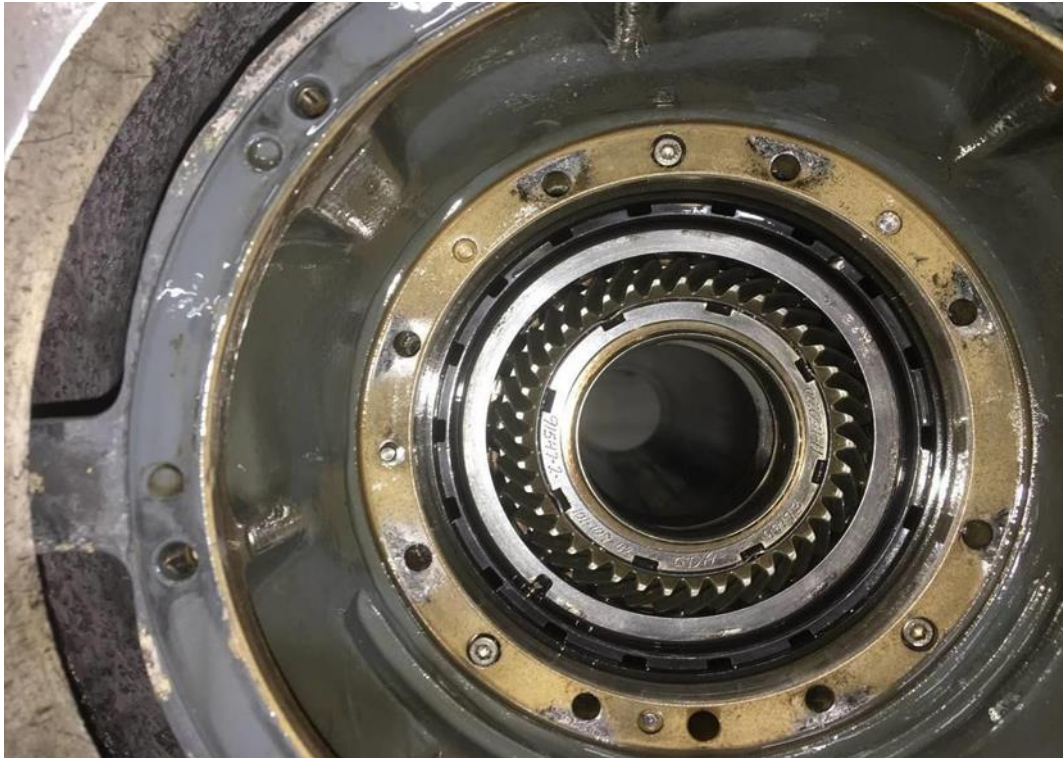
1.16.4. During removal of the number 3 bearing package assembly (which supports the forward end of the third turbine rotor shaft assembly) and the accessory drive gear assembly (which provides the rotational mechanical energy to drive the gears in the angle gear box [AGB] module via the tower shaft), it was found that two of the three bolts that position the number 1 bearing housing assembly were loose. The bolts were retained within the bolt holes due to the aft face of the accessory drive gear assembly contacting the stub frame. This prevents the bolts from fully backing out of their positions. The aft face of the number 3 bearing support had worn out, causing a 'lip' on its surface. Spalling to the forward face on the outer race of the number 1 bearing was also identified. The number 1 bearing pump housing (which contains the number 1 bearing and provides the oil feed for the aft side of the bearing) had rotated approximately 45° anticlockwise from the original installation location. The oil transfer tube and the anti-rotation pin had fractured.

Figure 10: Two of the loose bearing house assembly bolts. (Source: Standard Aero)

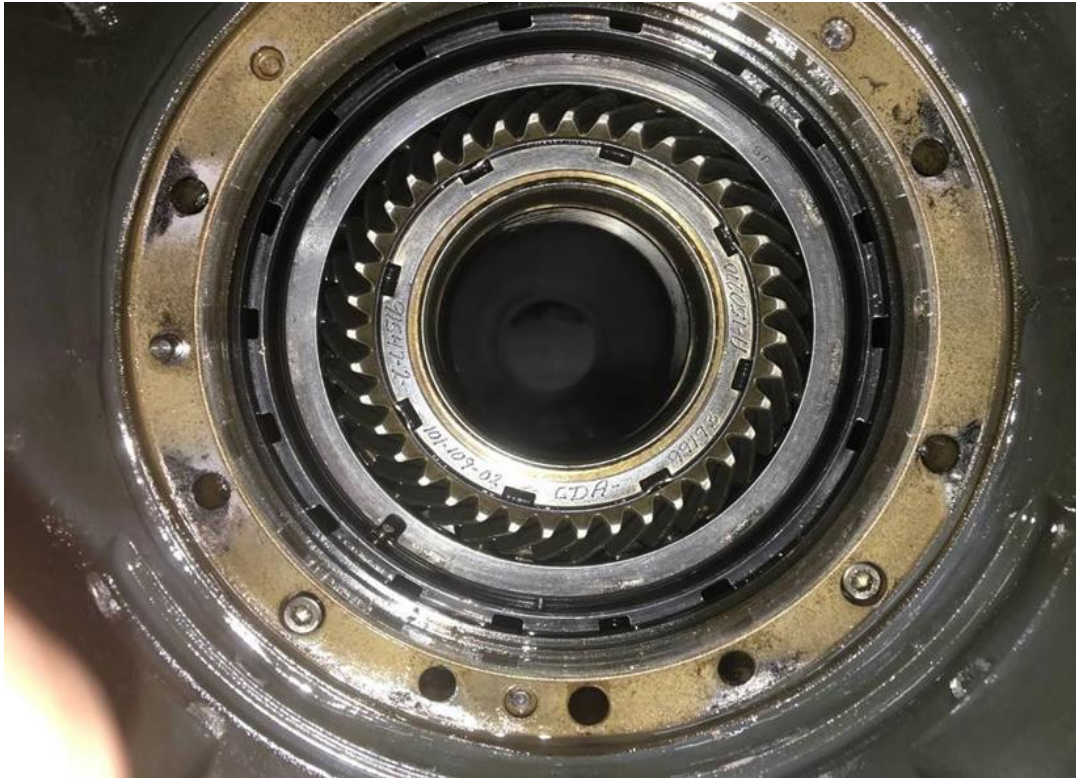
Figure 11. Spalling to the No. 1 bearing race. The pump housing has rotated anticlockwise. Note the location of the oil feed tube. (Source: Standard Aero)

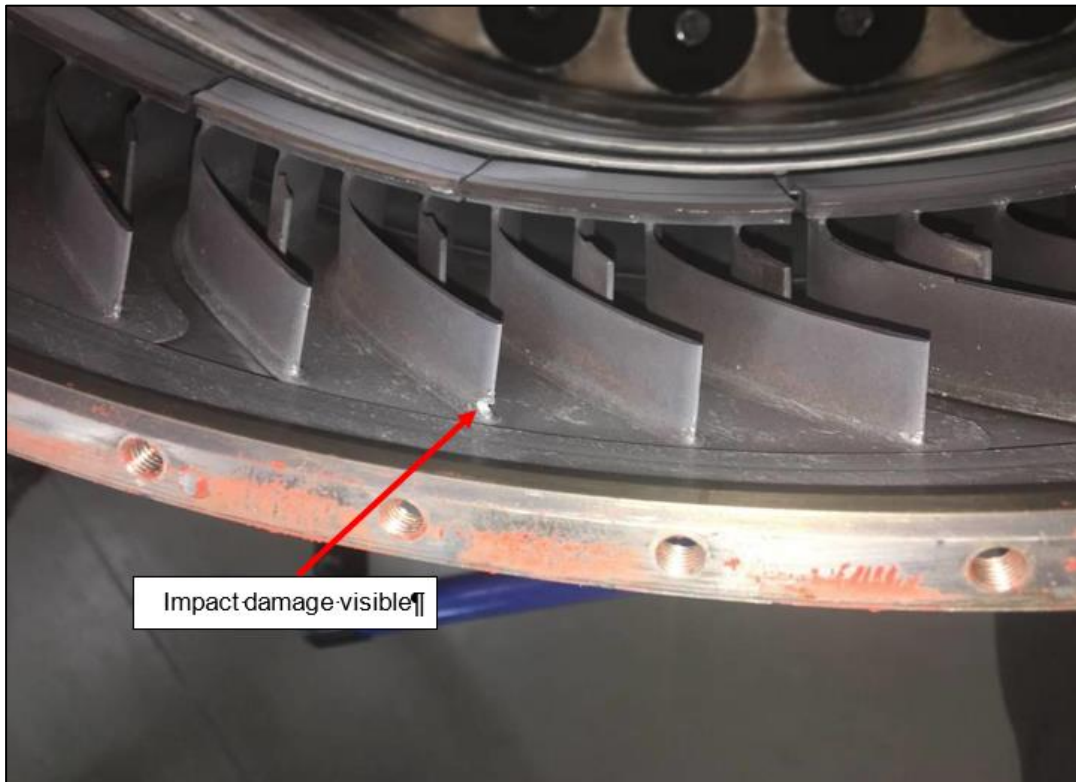
1.16.5. Further inspection of the engine showed that the combustor turning vane assembly (which converts the high energy velocity air from the impellor into high static pressure) had impact damage to the leading edges of the vanes (see Figure 12). The combustor liner had debris within the cooling holes.

Figure 12: Impact damage to the combustor turning vanes. (Source: Standard Aero)

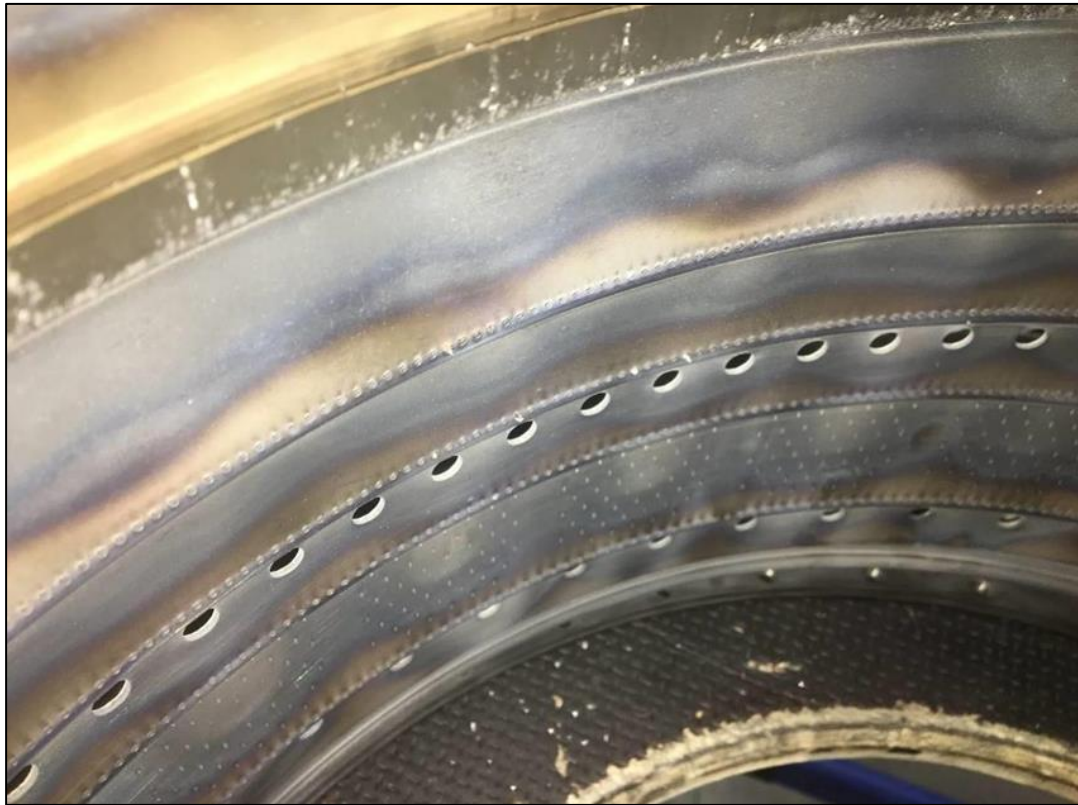
Figure 13: Debris within the cooling holes of the combustor liner. (Source: Standard Aero)

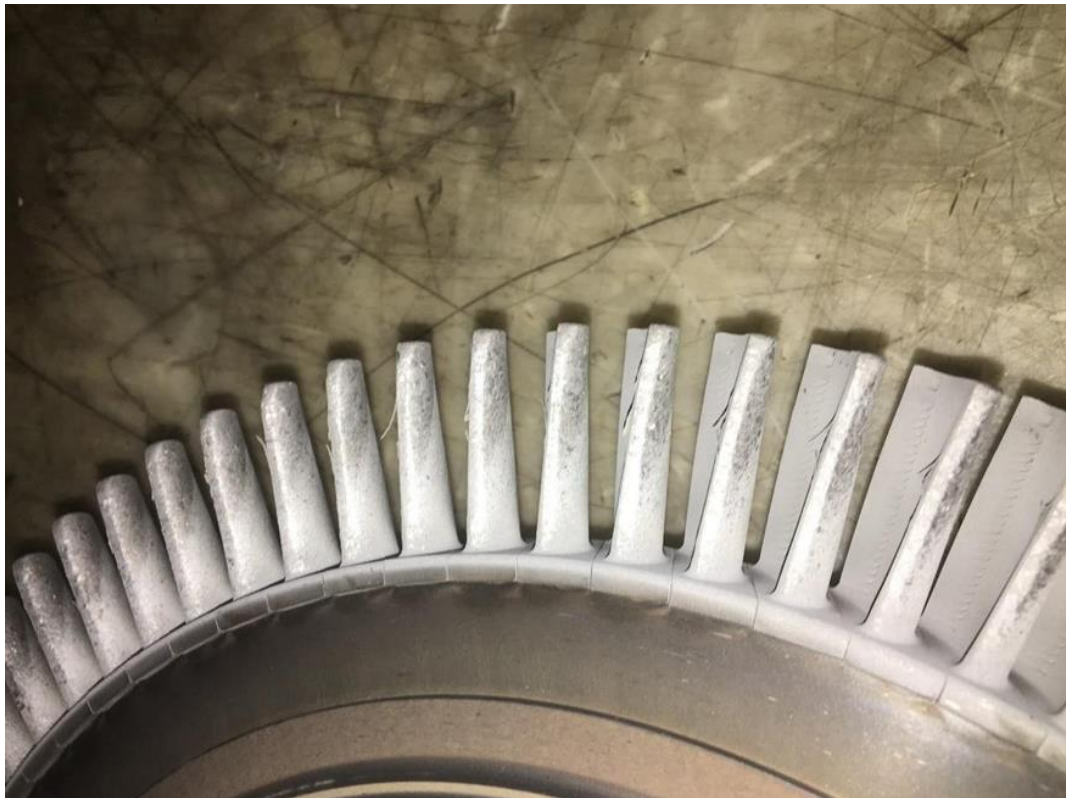
- 1.16.6. Inspection of the high-pressure turbine (HPT) assembly showed metal splatter on all turbine components. The second stage HPT nozzle assembly had debris within the cooling holes of the outer wall. The first stage HPT nozzle assembly guide vanes indicated impact damage and material loss on the trailing edges. The first stage HPT rotor blades had material loss on the trailing edges.
- 1.16.7. Inspection of the LPT sub module showed metal splatter on the airflow surfaces of the components. The labyrinth seal of the third stage LPT rotor was worn out from contact with the internal diameter of the compressor shaft.

Figure 14: Metal splatter on the first turbine blades. (Source: Standard Aero)
