AIRCRAFT INCIDENT REPORT AND EXECUTIVE SUMMARY

Reference:	CA18/3/2/1261	
Aircraft Registration	ZS-SJH	Date of Incident	19 April 2019		Time of Incident	1430Z
Type of Aircraft	Boeing 737-800		Type of Operation		Commercial (Part 121)	
Pilot-in-command Licence Type		Airline Transport Pilot Licence	Age	49	Licence Valid	Yes
Pilot-in-command Flying Experience		Total Flying Hours	6360		Hours on Type	2307
Last Point of Departure		O.R. Tambo International Aerodrome (FAOR) – Gauteng Province				
Next Point of Intended Landing		Cape Town International Aerodrome (FACT) – Western Cape Province				
Location of the incident site with reference to easily defined geographical points (GPS readings if possible)						
On taxiway "Alpha" where it intersects with taxiway "November" at O.R. Tambo International Aerodrome (FAOR) at GPS co-ordinates: 26° 07' 06.30" South 028° 14' 28.92" East and at an elevation of 5508 feet.						
Meteorological Information		Wind direction: 320°; Wind speed: 14kts; Temperature: 24°C; Visibility: +10km; Dew point: 11°C; Cloud base: 4500ft

Reference Number : CA18/3/2/1261
Name of Owner/Operator : Mango Airlines
Manufacturer : Boeing Aircraft Company
Model : 737-800
Nationali

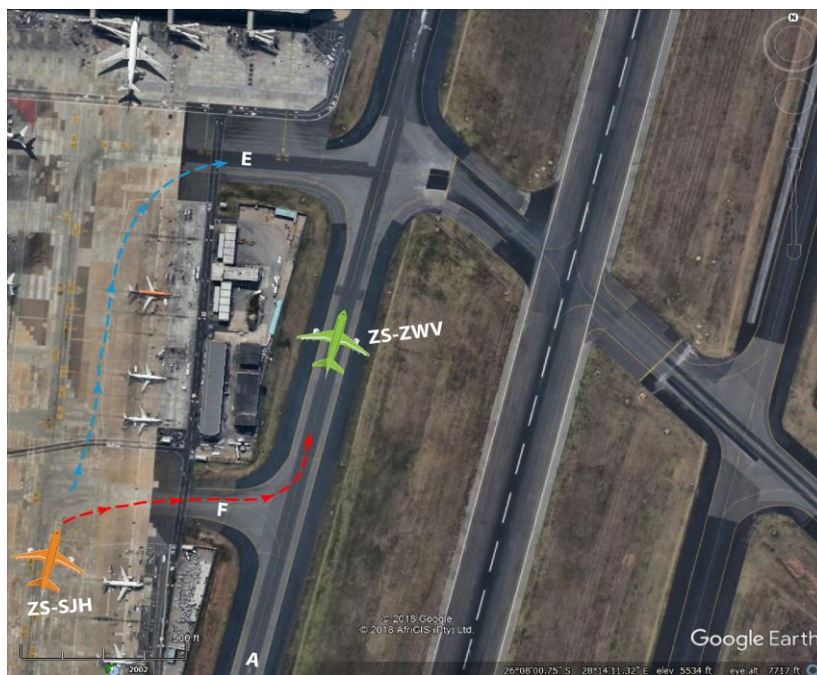
Figure 1: Blue line shows the route that was given to ZS-SJH by the GND ATC and the red line shows the route taken by ZS-SJH.

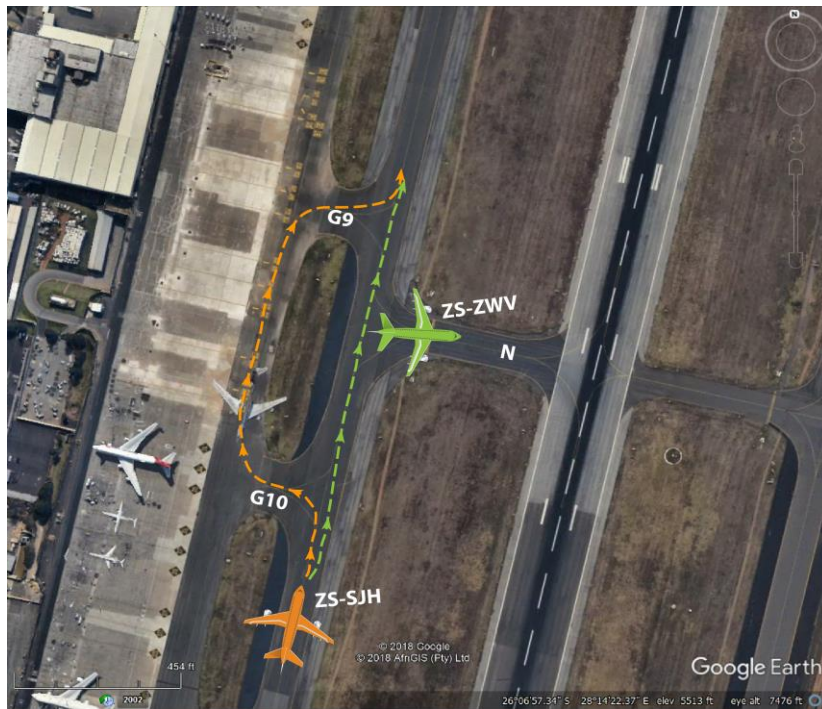
- 1.1.3 To avoid a collision, the ATC advised ZS-SJH to turn on to Golf 10 into Delta ramp then Golf 9 on to taxiway Alpha to holding point Runway 21R, which the crew of ZS-SJH read back, but decided to proceed on taxiway Alpha. To clear ZS-ZWV, ZS-SJH went off the centreline to manoeuvre and pass behind the stationary ZS-ZWV which was holding short on taxiway November and had its tail protruding on taxiway Alpha. It was during this attempt to manoeuvre behind ZS-ZWV that ZS-SJH collided with ZS-ZWV (see Figure 3).

Figure 2: Orange line shows the route that was given to ZS-SJH by the GND ATC as an option and the green line shows the route taken by ZS-SJH, which resulted in a collision with a stationary ZS-ZWV.

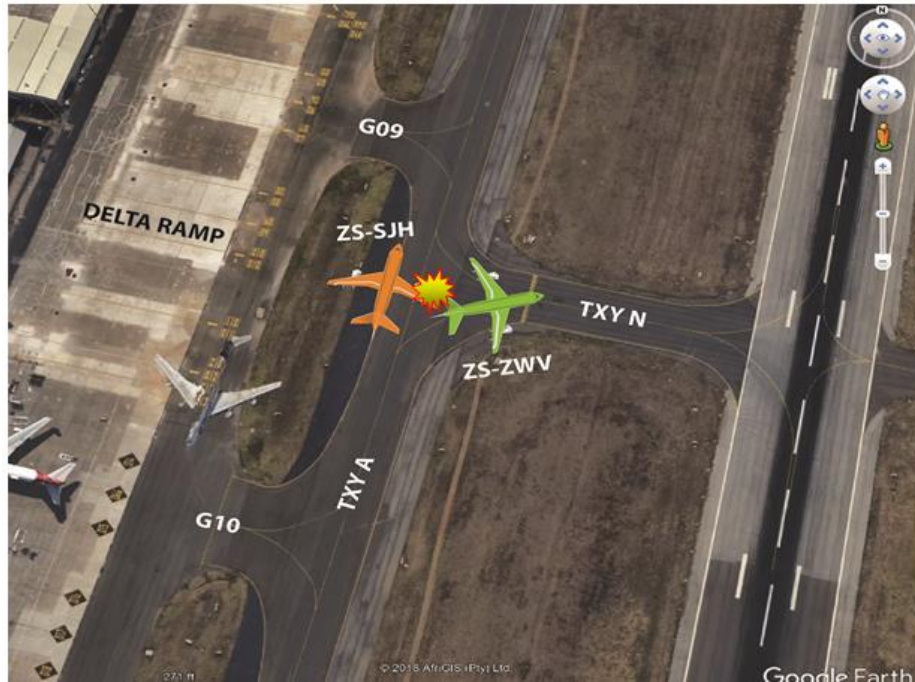
Figure 3: Shows the collision point where ZS-SJH collided with the stationary ZS-ZWV.

1.12.2 The length between the holding point of taxiway November and the left shoulder of taxiway Alpha is approximately 69m. The ZS-ZWV aircraft had taken approximately 40m of that length, leaving a distance of 29m behind it. The wingspan of ZS-SJH is 36m long, which made the crew to manoeuvre the aircraft (ZS-SJH) to the left of the centreline to clear ZS-ZWV, but this was unsuccessful. During this manoeuvre, the ZS-SJH sustained damage to the right-hand winglet and the ZS-ZWV sustained damage to the left horizontal stabiliser.

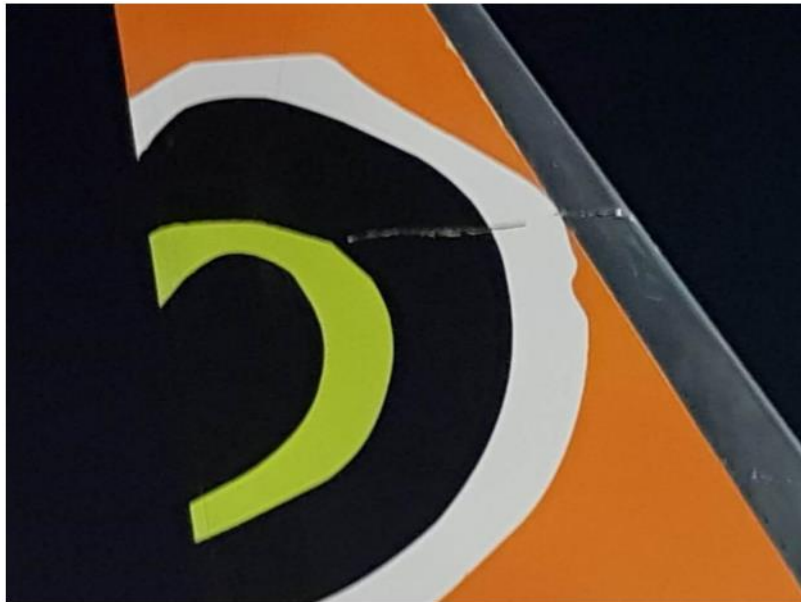
- 1.1.8 During a walk-around with the ground engineer, it was discovered that ZS-SJH had indeed collided with ZS-ZWV, causing damage to the aircraft's right-hand winglet.

1.1.13 No injuries were reported on both ZS-SJH and ZS-ZWV aircraft. The ZS-SJH sustained damage to the right-hand winglet and the ZS-ZWV sustained damage to the left horizontal stabiliser.

Figure 4: Picture of the damaged right-hand winglet on the ZS-SJH. (Picture courtesy of Mango Airlines)

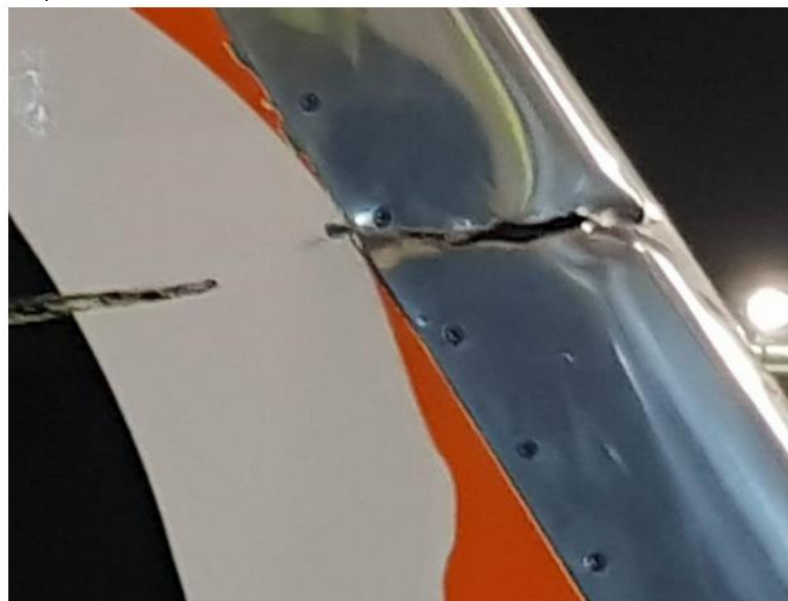
Figure 5: Close-up of the damaged right-hand winglet on ZS-SJH. (Picture courtesy of Mango Airlines)

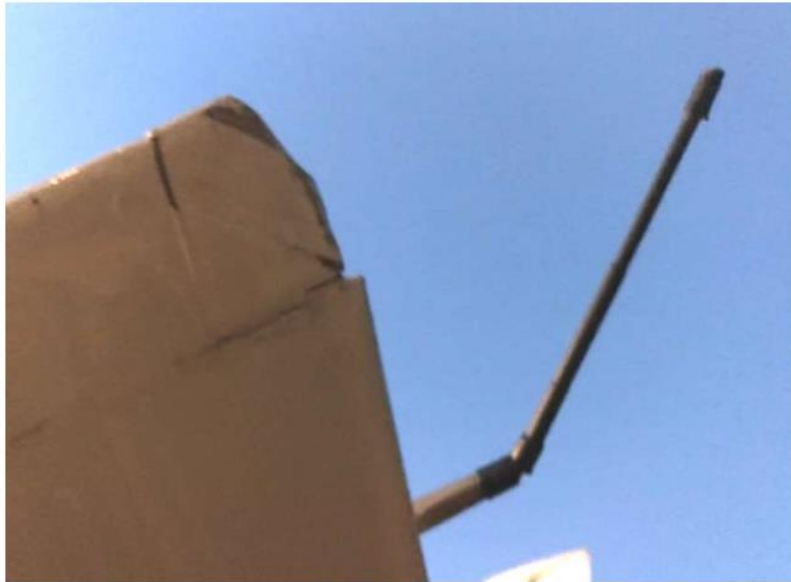
- 1.1.9 ZS-ZWV operated normally throughout the flight to FALE. On approach into FALE, the ATC informed ZS-ZWV crew that ZS-SJH aircraft had returned to the bay at FAOR and the ground engineers had found damage on the aircraft's winglet. After safely landing the aircraft at FALE, ZS-ZWV was also inspected and the engineers found that one static wick on the left elevator was bent and the left aft tip of the horizontal stabiliser was also damaged.

Figure 6: The damaged static wick and the left-hand horizontal stabiliser tip on ZS-ZWV.
(Picture courtesy of Comair Limited)
