AIRCRAFT SERIOUS INCIDENT SHORT REPORT

CA8/3/2/1262: Failure to rotate due to aircraft being operated over its maximum take-off mass, resulting in an aborted take-off.

Aircraft registration : ZU-FSE

Aircraft manufacturer and model : Kitplanes For Africa (Pty) Ltd, Safari LSA

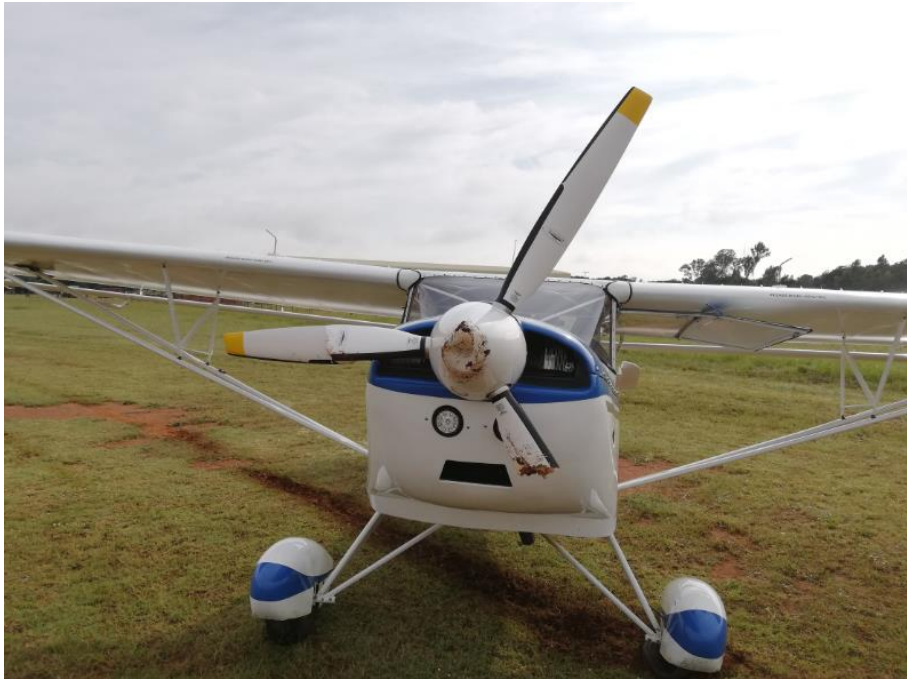
- 1.3. Two of the three blades were damaged by contact with the ground. Both the left- and the right-wing attachment struts were bent while the fuselage structure was still intact. During the incident sequence, the aircraft veered off to the right of the runway, the left wheel assembly separated from the wheel axle, and the aircraft came to a halt 10m from the runway edge. Both occupants of the aircraft did not sustain any injuries.

Figure 2: Aircraft as it came to rest. (Photo courtesy: Owner of the aircraft).

- 4.1 After reaching the rotation speed (45kts), the aircraft failed to rotate due to its weight being more than 19kg above the maximum certified take-off mass of 600kg. The take-off was aborted by braking hard, resulting in the nose section tipping forward and the propeller striking the ground. The aircraft veered off to the right side of the runway, the left wheel and tyre assembly separated, and the aircraft came to a halt 10m from the edge of the runway.

7.1 Safety message: Pilots to properly plan their flights and ascertain that the aircraft is operated within its limits to avoid injuries and property damage.

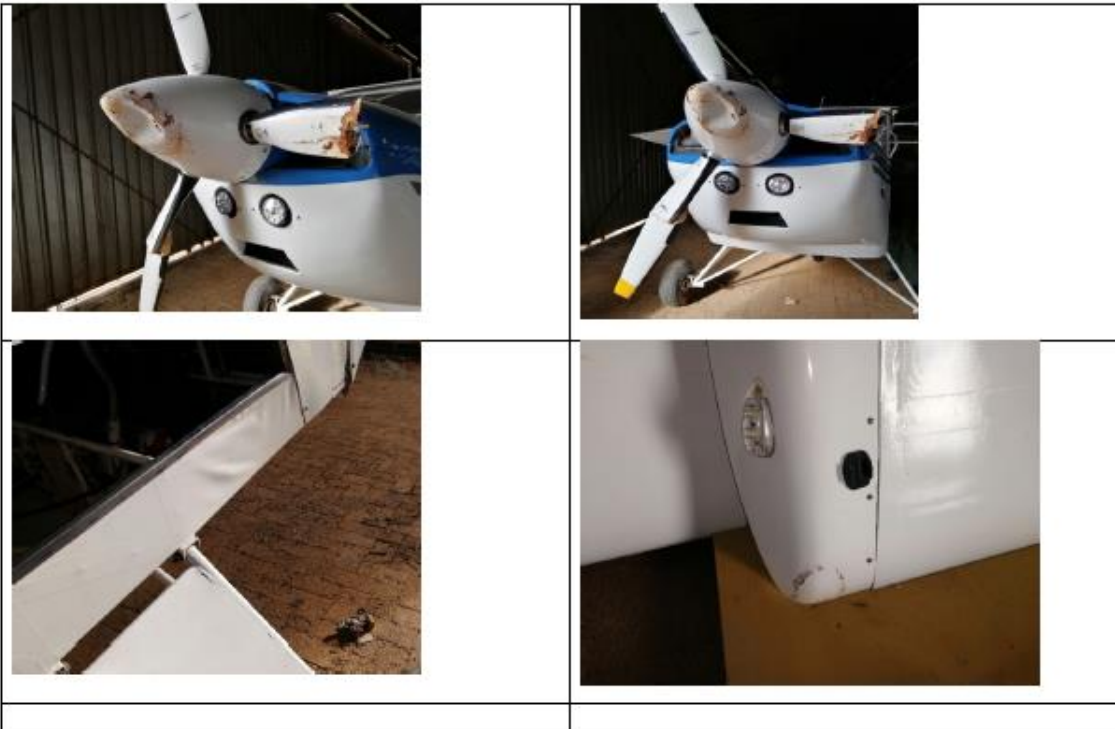
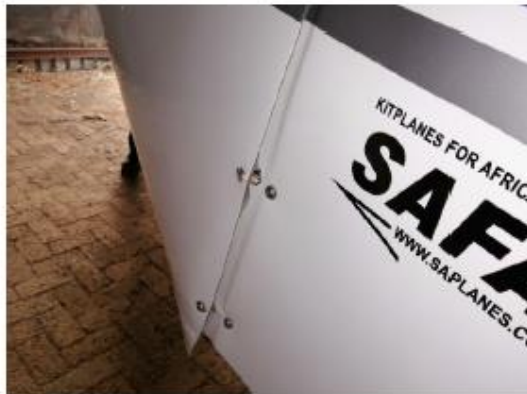
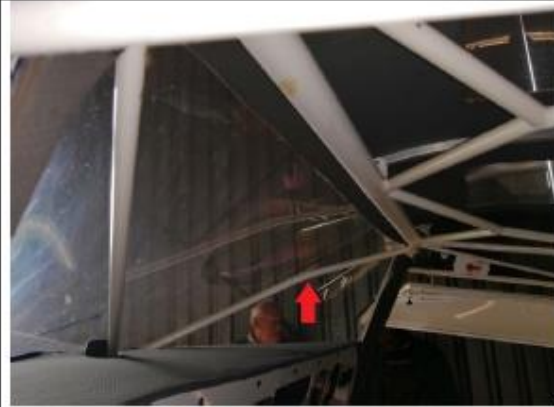
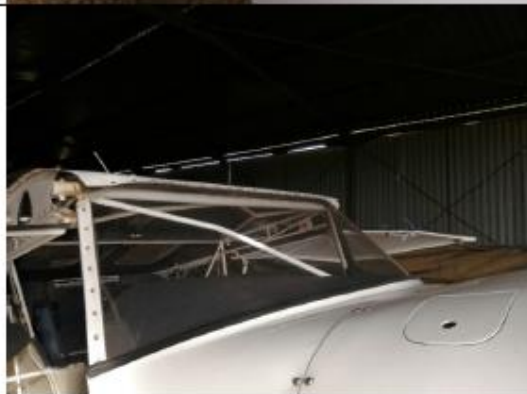
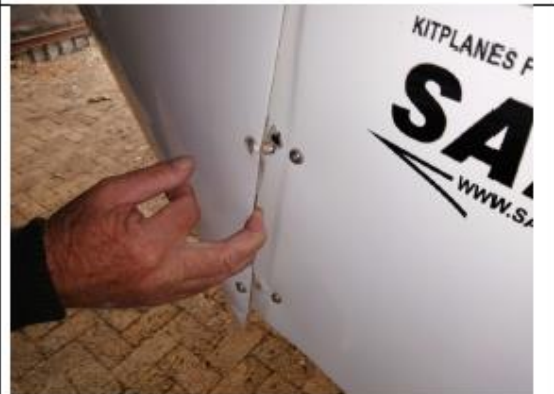
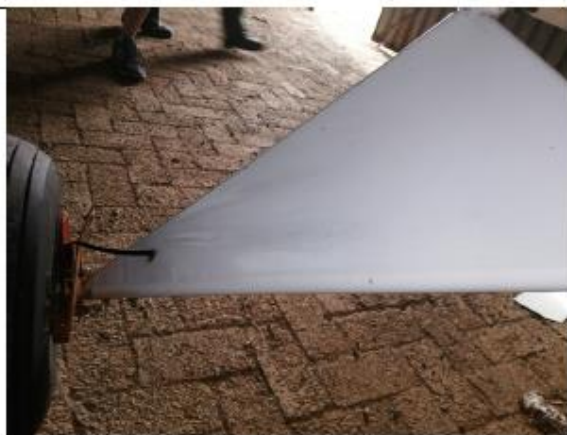
Damage report for the aircraft ZU-FSE

The following items were found to be damaged and will either require repair or replacement;

Item	Action
1. Spinner damaged	Replace with new spinner
2. Propeller (Woodcomp) damaged	Replace with new prop
3. Side Bungee truss slightly bent (both sides)	Repair damages
4. Left hand Wingtip damaged	Repair damages
5. Flaperon stall fences (left and right) bent	Replace
6. Bottom cowling and boot cowl, button head screw ripped out from bottom and boot cowl	Repair both bottom and boot cowls
7. Windshield cracked	Replace windshield
8. Windshield brace tube bent	Repair windshield brace tube
9. Left main landing gear bent	Replace left main landing gear
10. Left hand wheel spat damaged	Repair left wheel spat damages
11. Engine	Shock load on engine

- Other
 - No damage to the engine mount or firewall found.
 - The aircraft was generally in a very good condition.
 - The damage that occurred is typical for the type of aircraft when either encountering a severe ground loop or encountering a side load due to centrifugal forces. The damage seem to be consistent with the owners description of events.
 - The previous annual was done at 113.0 engine tach time and 124.9 prop and 1813.2 airframe.
 - The aircraft has flown 23 hours since it's last annual. The annual inspection was done on 15/09/2018. The total time on the engine is thus 136 hours
 - Propeller is 147.9.
 - Airframe total hours are 1836.2.
