Accident and Incident Investigations Division

AIRCRAFT SERIOUS INCIDENT REPORT AND EXECUTIVE SUMMARY

Reference:	CA18/3/2/1264	
Aircraft Registration	ZS-DFJ	Date of Incident	5 April 2019		Time of Incident	0546Z
Type of Aircraft	Dassault Aviation Falcon 900B		Type of Operation	Air Transport (Part 135)		
Pilot-in-command Licence Type	ATPL		Age	51	Licence Valid	Yes
Pilot-in-command Flying Experience	Total Flying Hours		5328		Hours on Type	1550
Last point of departure	Robert Gabriel Mugabe International Airport (FVRG), Zimbabwe					
Next point of intended landing	Victoria Falls International Airport (FVFA), Zimbabwe					
Location of the incident site with reference to easily defined geographical points (GPS readings if possible)						
50 nm South-East of FVFA (18° 33' 36" South, 026° 44' 00" East)						
Meteorological Information	Wind: 120°/8 kt, Temperature: 23°C, Dew point: 8°C, Visibility: CAVOK, QNH: 1023 hPa					
Number of people on-board	2 + 8	No. of people injured	0	No. of people killed	0	
Synopsis

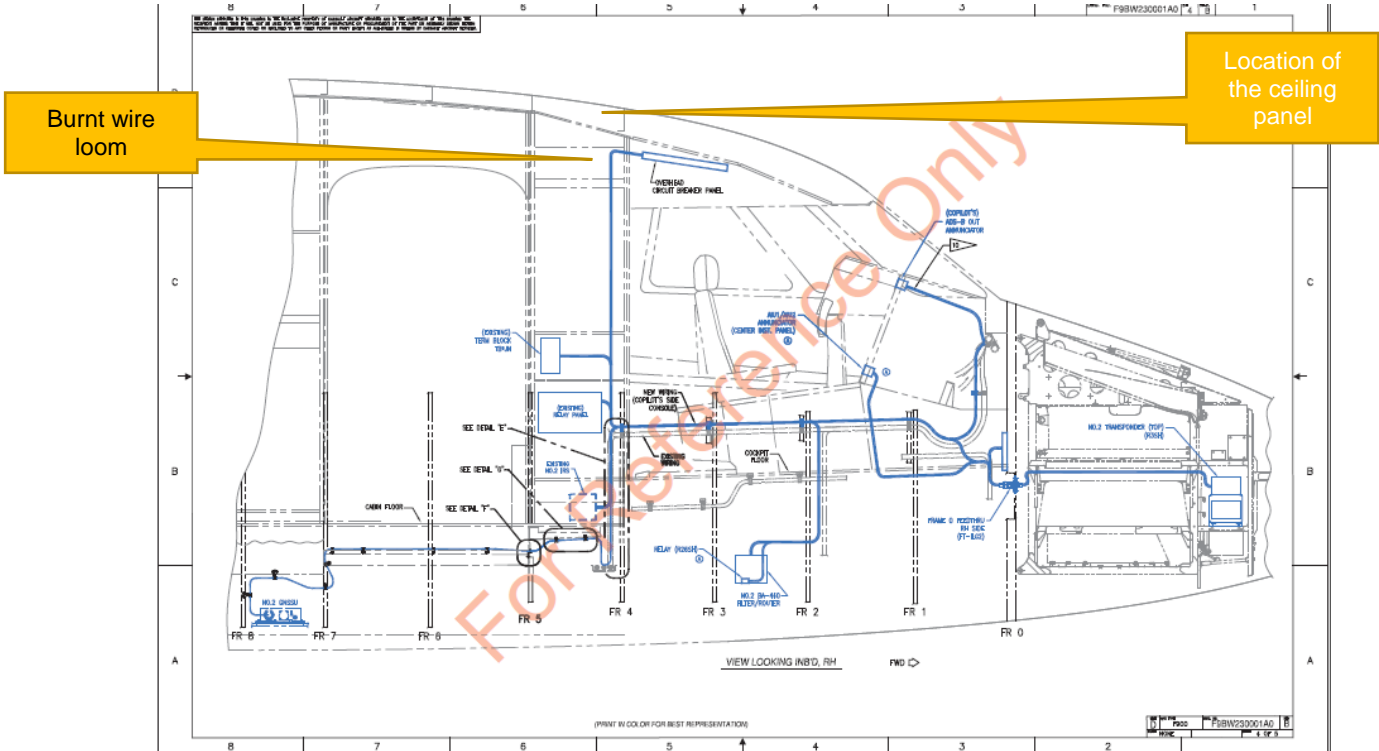
1.3.1 The aircraft sustained minor damage to an overhead panel located between frame 4 and 5 which showed signs of burning. The loom had run directly below this panel. The burn damage to the loom was limited to an area near a mounting clamp which had failed.

Figure 4: Location of the burnt ceiling panel and position of the burnt loom. (Source: Dassault Aviation)

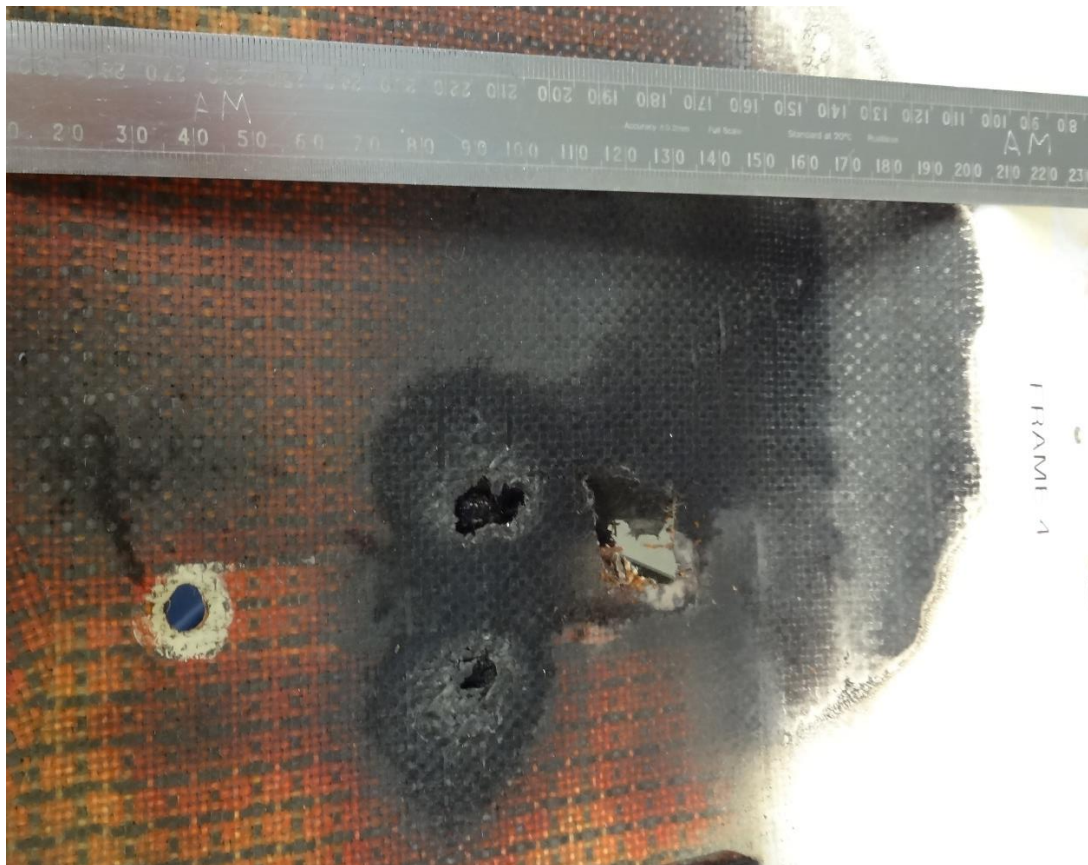
Figure 5: Burn damage sustained to the ceiling panel. (Source: Zenith Aviation)

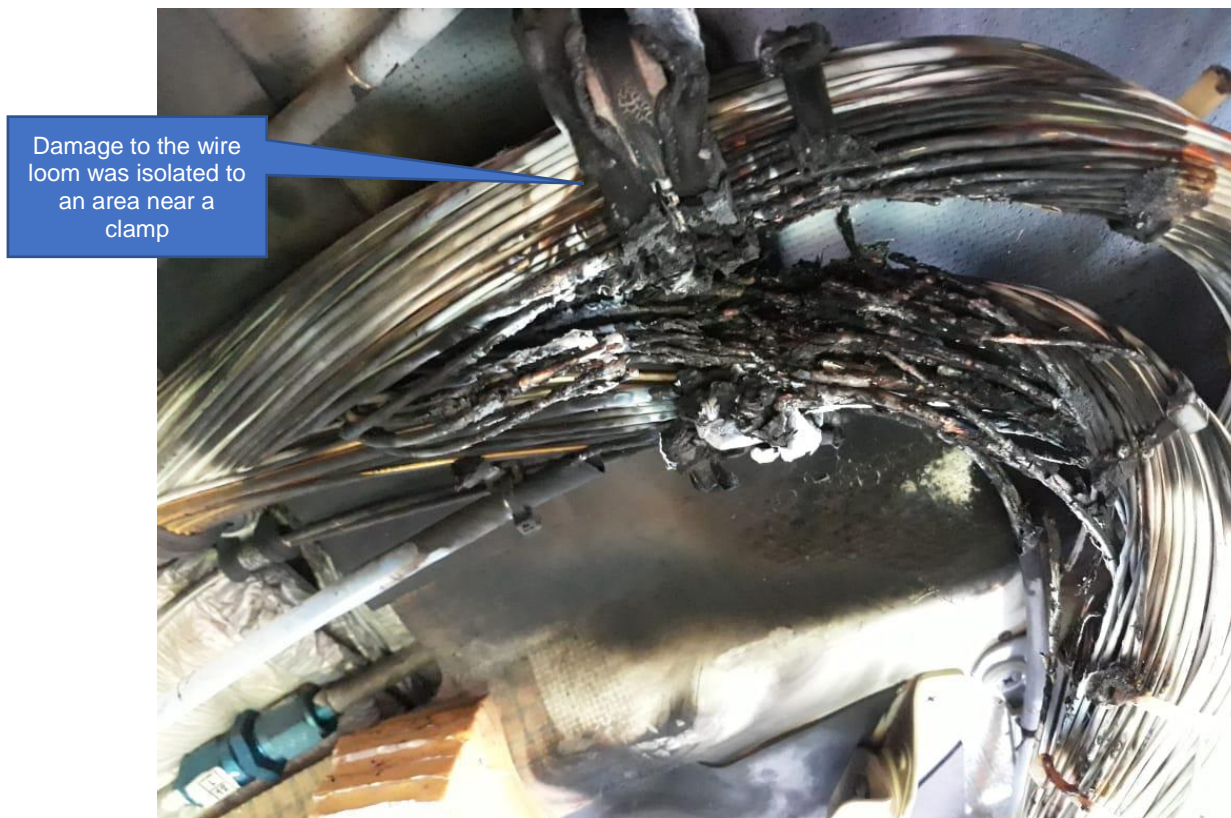
- 1.1.5 The aircraft sustained damage to a wire loom (various electrical conducting wires which are insulated and bound together), which had burnt in the ceiling of the flight deck, as well as burn damage to the ceiling panel above the wire loom. The duration from the first sighting of smoke to the time it began to dissipate was approximately 3 minutes.

Figure 6: Burn damage sustained to the wire loom (Source: Zenith Aviation)

- 1.14.1 There was no evidence of a pre- or post-impact fire, however, there was smoke in the flight deck area during the descent into FVFA. The cause of the smoke was due to a wire loom overheating and melting the insulation around it. Due to the excessive heat generated, one ceiling panel above the loom showed signs of excessive heat damage, and it was the source of the smoke which entered the flight deck.
- 1.14.2 The smoke entered the flight deck as the aircraft was passing through FL250 on the descent. After carrying out the required AFM steps, the smoke began dissipating as the aircraft passed FL190 before clearing.
- 1.14.3 The ARFF at FVFA had been placed on standby and escorted the aircraft to the apron. The smoke did not affect the evacuation process and the occupants disembarked normally.

- 3.3.1 During the modification which required cable be threaded on to the wiring loom secured by a clamp, it is likely that when the wire was threaded through the clamp, the wire insulation was inadvertently damaged due to the clamp not being opened, and the damaged wire started to arc on the clamp causing high temperature which resulted on the smoke in the flight deck, multiple system failure.

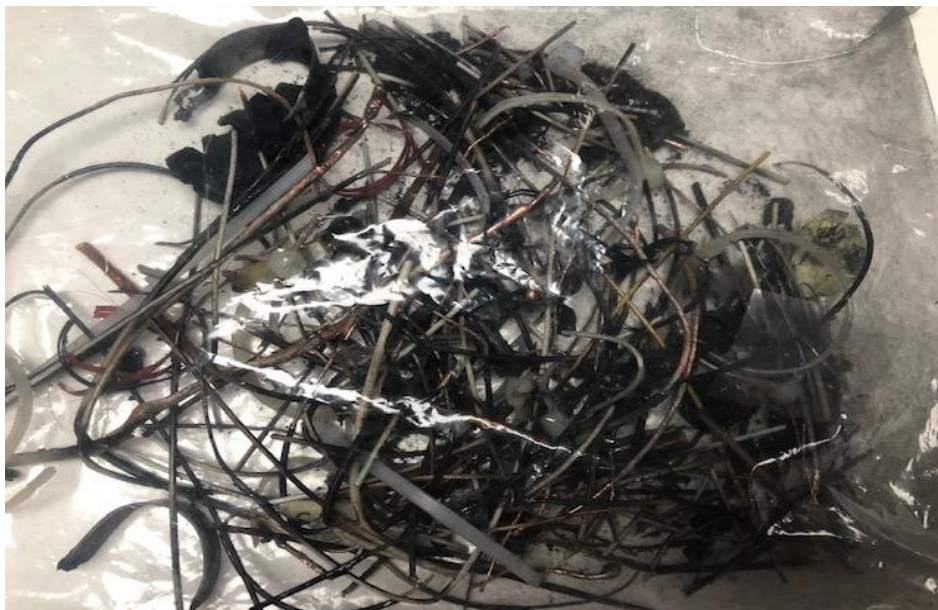
- 1.16.1 The remains of the wiring loom repair were sent to Dassault Aviation for analysis. Due to the condition of the remnants, Dassault Aviation were unable to carry out any testing to determine the integrity of the wires.

Figure 9: The wire off cuts sent to Dassault Aviation after the temporary repair was carried out. (Source: Dassault Aviation)

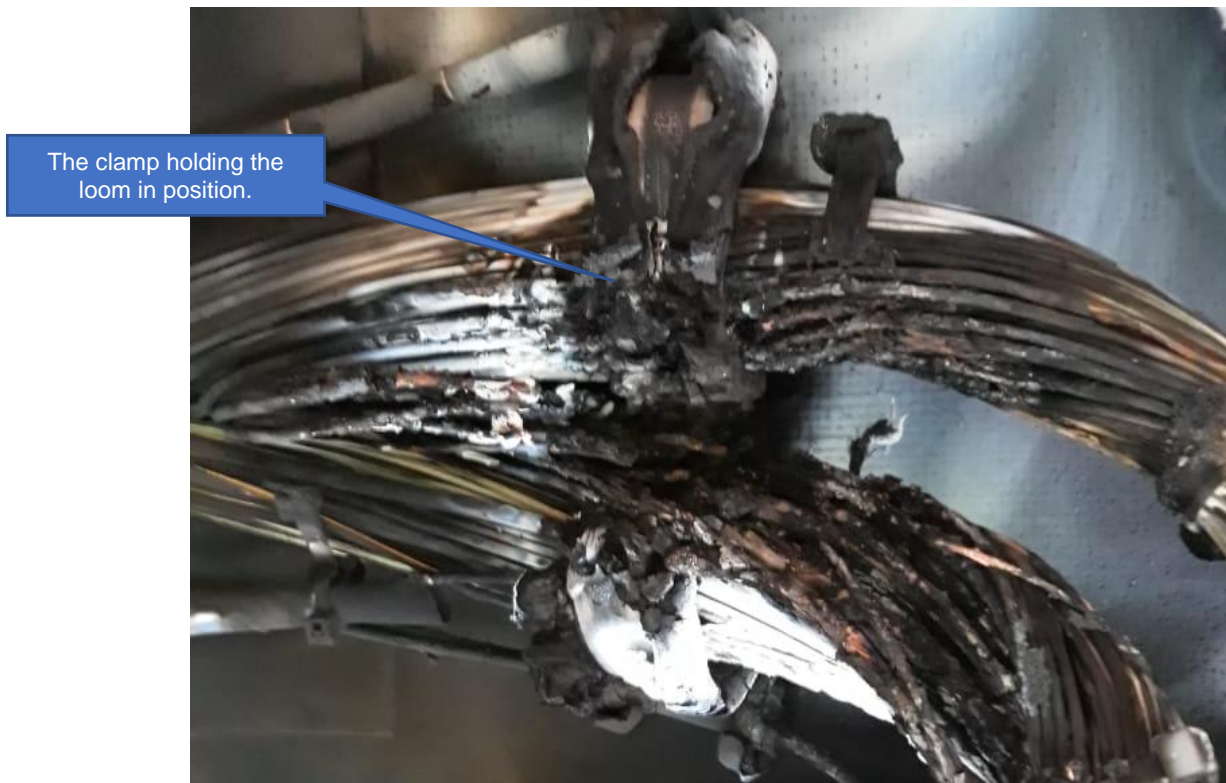
1.16.3 The clamp is made up of a steel loop covered with a silicone cushion.

Figure 10: The failed clamp (Source: Zenith Air)

- 2.10 On 30 August 2018, a modification was embodied to ensure the aircraft is ADS-B compliant. The modification required that a single wire be added to the wire loom. The wire was routed through the clamp (without the clamp being opened); and the wire was threaded through it (the clamp). The aircraft standard practices manual does not state that a clamp should be opened when adding an additional wire to a loom. The last maintenance conducted in this area of the burnt loom was during the last C check on 8 November 2018 which was a visual inspection.

- 3.2.10 The investigation revealed that there had been a modification which required that a cable be threaded on to the wiring loom which is secured by clamps to the airframe. During the threading of the cable, the securing clamp was not opened, and it is likely that when the wire was threaded through the clamp, the wire insulation was inadvertently damaged, and the open wire started to arc on the clamp. That in turn caused the increase in temperature which resulted in the smoke in the flight deck, as well as multiple systems failure.

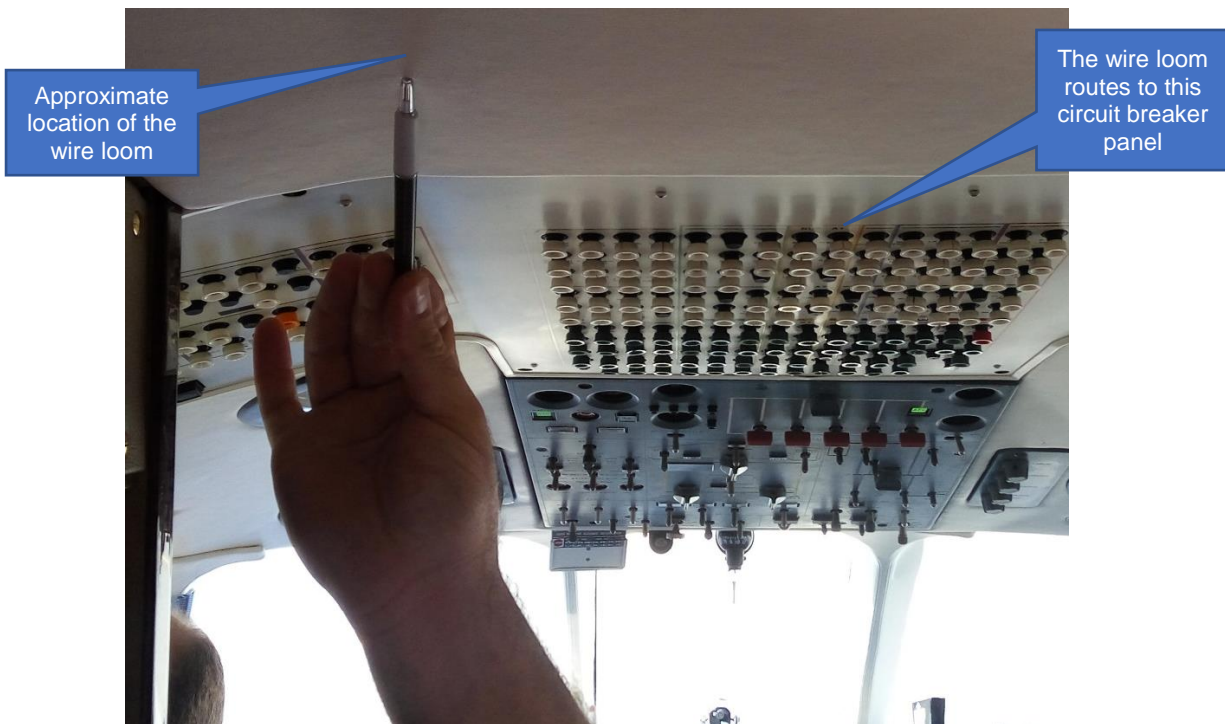
1.16.5 The wire loom routed above the ceiling to an overhead circuit breaker panel. As the wire loom started heating up, the circuit breakers began tripping, causing the circuits of each wire in the loom to be disconnected from its associated system. This is a protection feature to prevent excessive current conditions from damaging the aircraft and its systems. The tripping of the circuit breakers also led to multiple systems failure, such as the PIC's display going off-line.

Figure 11: Location of the wire loom and circuit breaker panel.

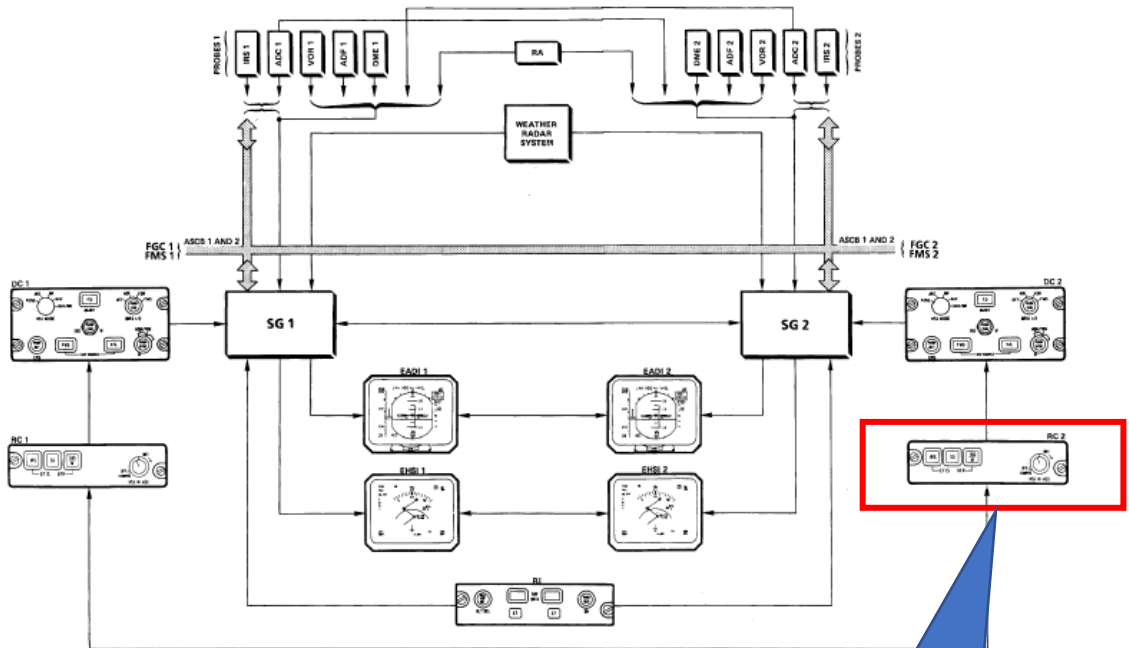
Right hand reversion controller panel was inoperative
