AIRCRAFT INCIDENT SHORT REPORT

CA18/3/2/1265: The aircraft failed to rotate due to overweight; the take-off was aborted but the aircraft could not stop and it overshot the runway before impacting a parameter fence.

Date and time : 20 May 2019; 1210Z
Aircraft registration : ZU-LSC
Aircraft manufacturer and model : Czech Aircraft Works, SPOL SRO
Last Point of departure : Brits Aerodrome (FABS)
Next point of intended landing : Brakpan Aerodrome (FABB)
Location of incident site with reference to easily defined geographical points (GPS readings if possible) : S25°31'56,4" E027°46'29,45" Brits Aerodrome (FABS)
Meteorological Information : Surface wind: 110° at 5 knots; Temperature: 25°C; Cloud cover: none
Type of operation : Private
Persons on board : 1 + 1
Injuries : 0
Damage to aircraft : Propeller, wings and landing gear

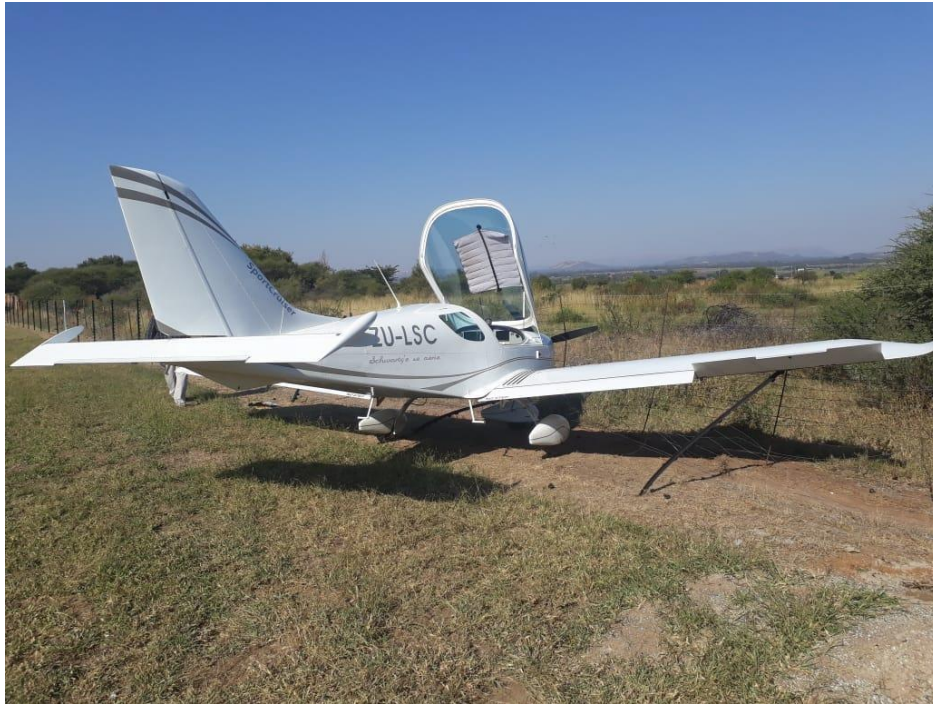
Figure1: The aircraft as it came to rest.

2.2 The pilot and the passenger sustained no injuries. The aircraft had minor damage to the propeller blades, spinner, right-hand wing and right-hand main wheel.

- 3.12 The aircraft sustained damage to the propeller blades, spinner, undercarriage and the wings.
- 3.13 After the incident, the pilot inspected the aircraft flight control surfaces and found no anomalies with the aircraft.

- 3.16 The investigation revealed that after the aircraft reaching the rotation speed of 65kts, the aircraft couldn't rotate due to its weight being in excess by 7.7lb above the maximum certified take-off weight of 1320lb. The take-off was aborted; however, the aircraft could not stop on the remaining runway and it overshot the runway and collided with the aerodrome perimeter fence.

- 4.1 During take-off, after reaching rotation speed at 65 kts, the aircraft couldn't rotate due to exceedance of maximum take-off weight by 7.7 lb, the pilot aborted the take-off however the aircraft overshot the runway and collided with the aerodrome perimeter fence

- 5.1 Late decision to abort the take-off run.
