| AIRCRAFT INCIDENT REPORT AND EXECUTIVE SUMMARY |

| | | | | Reference: | CA18/3/2/1270 | |
| Aircraft Registration | ZU-CVT | Date of Incident | 14 June 2019 | | Time of Incident | 1218Z |
| Type of Aircraft | UFM-10 Samba | | Type of Operation | | Private (Part 94) | |

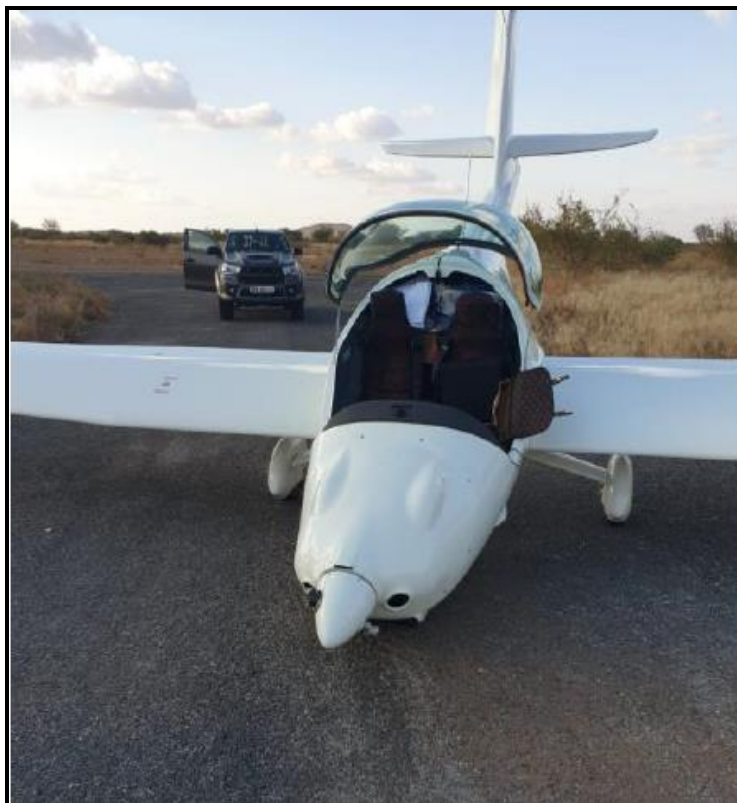
- 1.1.3 According to the video footage taken by the aircraft's owner, the aircraft was observed taxiing at a high speed towards the runway's exit. During the turn onto the taxiway, the nose landing gear broke off, causing the propeller to strike the runway surface at a high rotating speed. As a result, both propeller blades broke off.

Figure 2: The aircraft after the incident.

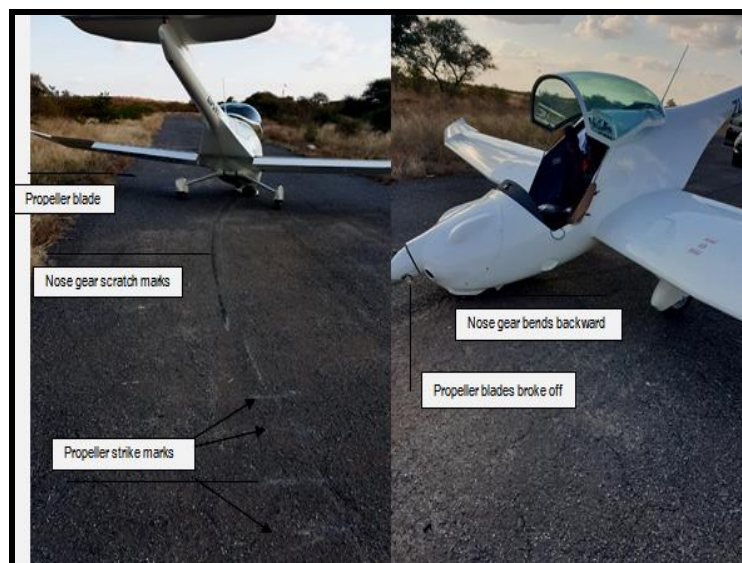
Figure 2: The aircraft after the incident.

1.12.1 The incident occurred on a taxiway after the pilot vacated the runway while the aircraft was still at a high forward speed. This was after the brake application system became unresponsive during landing to reduce forward speed so as to bring the aircraft to a desired taxiing speed for it to safely vacate the runway. According to the gathered information, the aircraft's nose landing gear broke off during a turn, causing the propeller to strike the taxiway at high rotational energy and braking off both propeller blades. The incident photos provided by the pilot revealed that the aircraft was leaning on its nose section's bottom part with the nose landing gear bent backward. The wreckage observation was as follows:

- The aircraft appeared to be leaning on its nose section.
- The aircraft propeller hub was missing the two propeller blades.
- The nose landing gear had broken backward with the aircraft's nose section laying on it.
- A trail of ground scars caused by the nose landing gear as it was dragged along were found.
- The four strike marks relating to the propeller strike during the incident sequence.

1.12.2 The wreckage distribution was localised and contained within a radius of approximately 5 metres. One of the propeller blades was found in front of the aircraft towards the left-hand side. The wreckage itself was mostly intact.

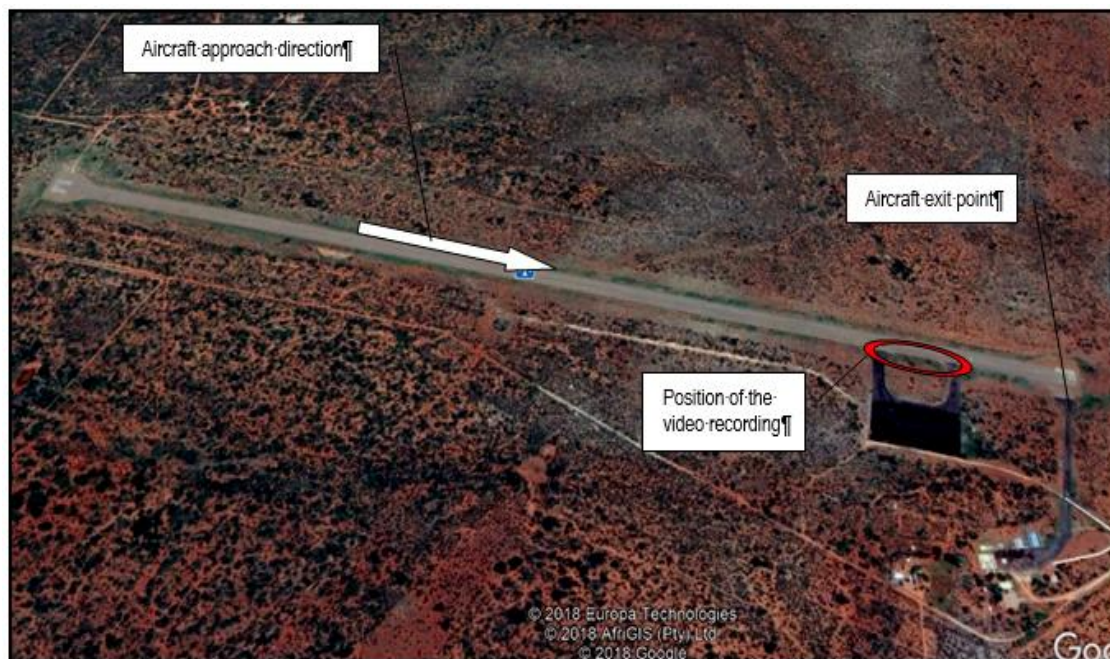
- 1.18.1 On the day of the incident, the owner of the aircraft recorded the aircraft during its approach for land. The video was recorded near the apron's entrance. On the video, the aircraft's touchdown was uneventful; however, by the time it (the aircraft) reached the point where the video was being taken, it was still moving at a high speed. This is where the recording stopped.

Figure 3: The position of the video recorder.
