Accident and Incident Investigations Division

AIRCRAFT INCIDENT REPORT AND EXECUTIVE SUMMARY

Reference:	CA18/3/2/1273		
Aircraft Registration	ZS-ZWE	Date of Incident	8 July 2019		Time of Accident	1112Z	
Type of Aircraft	Boeing 737-800NG		Type of Operation	Commercial (Part 121)			
Pilot-in-command Licence Type	Airline Transport Pilot Licence			Age	41	Licence Valid	Yes
First Officer Licence Type	Airline Transport Pilot Licence			Age	30	Licence Valid	Yes
Pilot-in-command Flying Experience	Total Flying Hours	10569	Hours on Type	6879			
First Officer Flying Experience	Total Flying Hours	3459	Hours on Type	1012.5			
Last Point of Departure	Cape Town International Aerodrome (FACT), Western Cape Province						
Next Point of Intended Landing	Lanseria International Aerodrome (FALA), Gauteng Province						
Location of the incident site with reference to easily defined geographical points (GPS readings if possible)							
In-flight south of Potchefstroom Aerodrome (FAPS) FAR75 at position 30nm from FALA

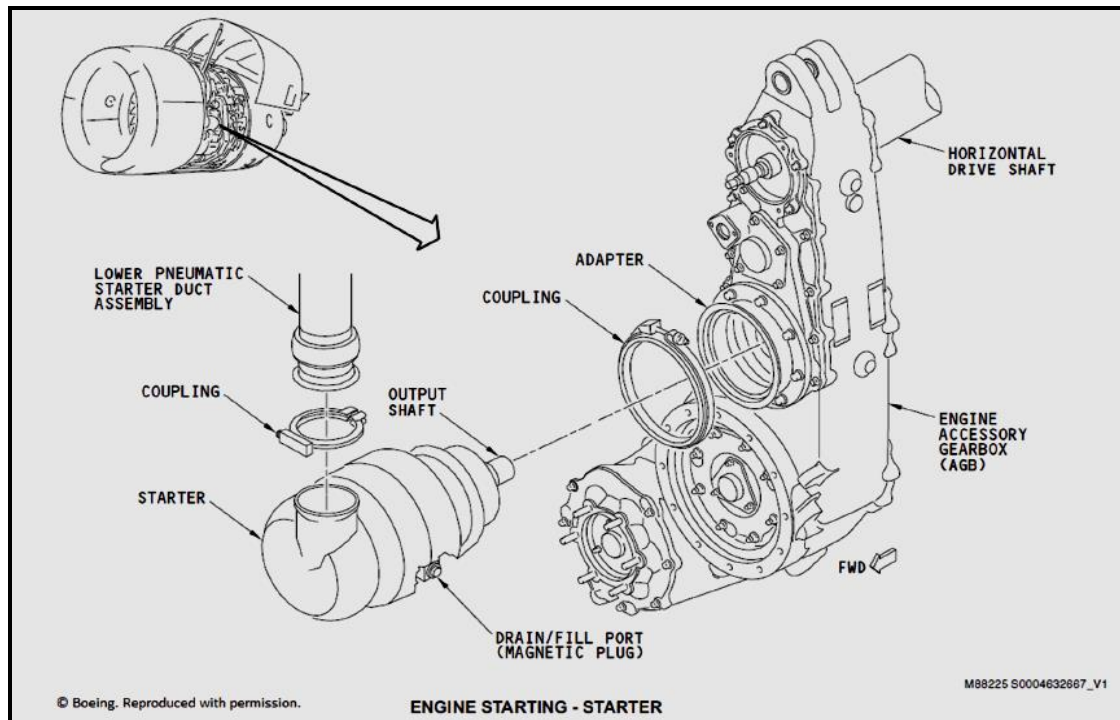
Figure 3: The aircraft engine starter attachment. (Extracted from GMM-1130041-02-A)

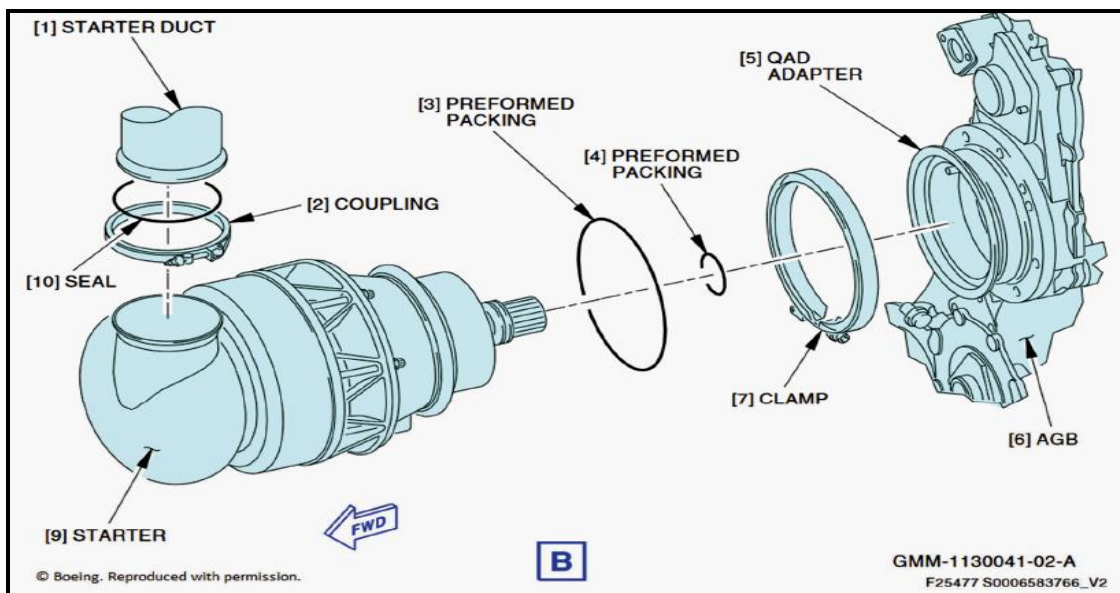
Figure 4: The starter installation diagram. (Extracted from GMM-1130041-02-A)

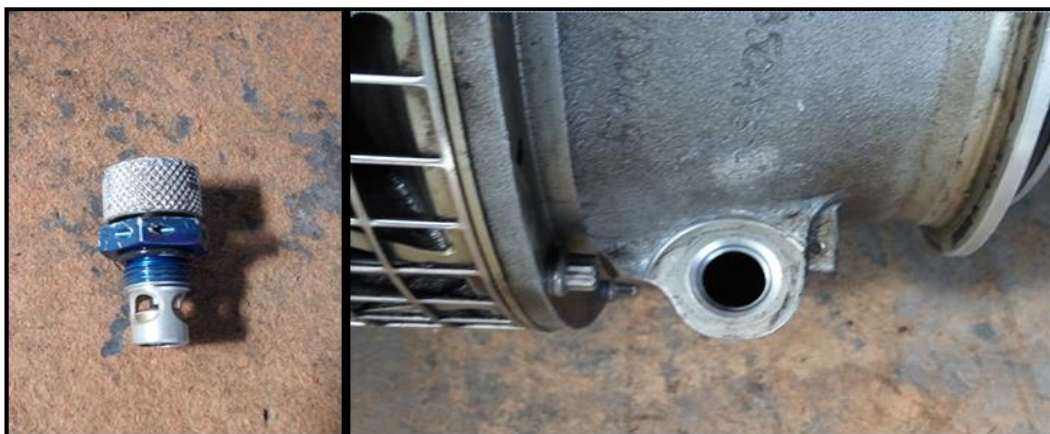
Figure 5: The drain/fill magnetic plug and the starter without locking wires.

- 1.16.1 According to the SAAT, during post-incident inspection, oil was found on the inside of the engine cowlings. Also, the starter drain/fill magnetic plug housing was found to have separated, and inside the cowlings and also without a wire lock.
- 1.16.2 A review of the maintenance procedure on how to remove and to install a serviceable starter was carried out.

- 2.2.10 Post-incident inspection revealed oil in the engine number 1 bay with the starter oil drain/fill magnetic plug separated from its attachment and located inside the engine bay on the bottom cowling. The separation of the starter oil drain/fill plug was determined to be the cause of the oil leaking from the engine number 1.
