AIRCRAFT SERIOUS INCIDENT SHORT REPORT

CA18/3/2/1275: Separation of the left main wheel assembly on rotation.

Date and time	: 2 August 2019, 1515Z
Aircraft registration	: ZU-FIU
Aircraft manufacturer and model	: Bantam B22J
Last point of departure	: Zandspruit Aero Estate, Limpopo Province
Next point of intended landing	: Zandspruit Aero Estate, Limpopo Province
Location of incident site with reference to easily defined geographical points (GPS readings if possible)	: 24°22'19.20" S 030°55'36.05" E, on Runway 35 at Zandspruit Aero Estate
Meteorological information	: Wind: 330°/04 kt, Temperature 24°C, Dew point: 11°C, QNH: 1021 hPa, CAVOK
Type of operation	: Private (Part 94)
Persons on-board	: 1 + 0
Injuries	: None
Damage to aircraft	: Minor

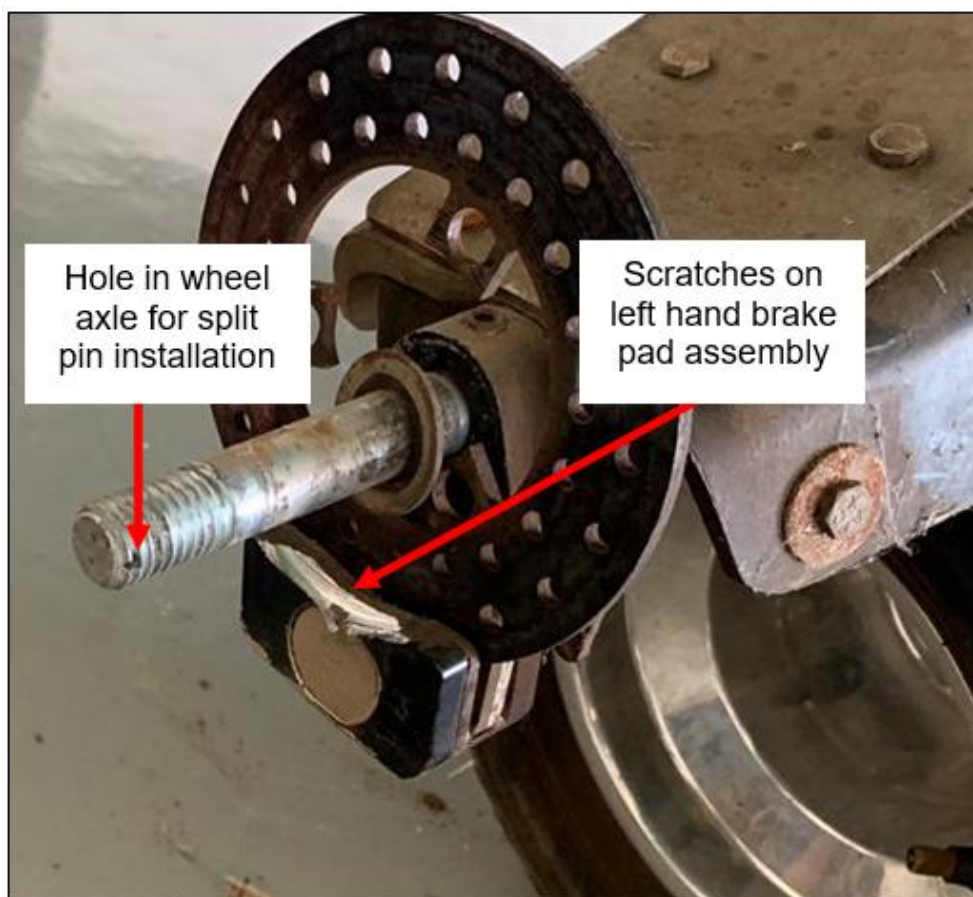
- 2.3. The damage to the aircraft was limited to the area where the wheel scratched the upper side of the left-hand outer brake calliper assembly (see Figure 1). The pilot did not sustain any injuries.

Figure 1: Minor damage to the upper area of the brake calliper assembly. (Source: Leading-Edge Maintenance)

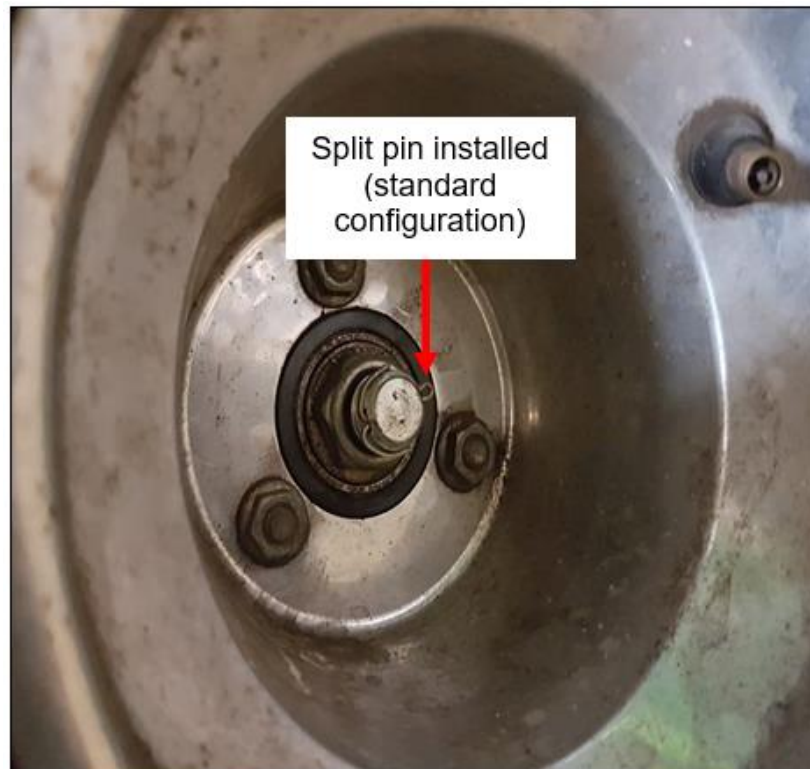
- 2.7. The owner drilled a hole on the landing gear axle for extra safety to enable the fitment of a split pin following the installation of a nylock nut which is not caselated (see Figure 2).

Figure 2: Image of the Bantam B22J wheel secured by a split pin after the serious incident.
(Source: Leading-Edge Maintenance)

- 3.6. The aircraft does not come from the factory with holes on the axle nut for the fitment of a split pin as it uses self-locking nuts. The owner had drilled holes on both left and right landing gear axles as an extra safety feature which would allow the fitment of a split pin. The interview with the pilot revealed that there was no split pin fitted on the right-hand axle, thus, indicating that the left-hand side also did not have a split pin fitted.

- 3.12. The investigation revealed that the left main gear axle nut which secures the main wheel assembly separated during rotation, followed by the separation of the main wheel assembly. It is likely that the axle nut separated due to its locking mechanism being worn out of limits and the omission to install split pins which would have secured the axle nut in place.

6.1. Safety message: NTCA maintenance organisation to comply with best practise maintenance in the absence of any maintenance procedure established by the manufacturer.
