AIRCRAFT INCIDENT REPORT AND EXECUTIVE SUMMARY

Reference	CA18/3/2/1278	
Aircraft registration	ZS-JRM	Date of incident	20 August 2019		Time of incident	1825Z
Type of aircraft	Boeing 737-400		Type of operation		Air Transport Operation (Part 121)	
Pilot-in-command licence type	Airline Transport	Age	31	Licence valid	Yes	
Pilot-in-command flying experience	Total flying hours	5 703.2		Hours on type	3 535.7	
Last point of departure	Cape Town International Aerodrome (FACT), Western Cape					
Next point of intended landing	King Shaka International Aerodrome (FALE), Kwa-Zulu Natal					
Location of the incident site with reference to easily defined geographical points (GPS readings if possible)						
En route from FACT to FALE abeam Montagu (GPS position: South 33°46'30.20" East 020°06'56.82")						
Meteorological information	Surface wind: 220°/12kts; temperature: 14°C; dew point: 12°C: CAVOK					
Number of people on-board	2 + 4 + 134	No. of people injured	0	No. of people killed	0

Reference number : CA18/3/2/1278
Name of the Owner : Safair Operations (Pty) Ltd
Name of the Operator : FlySafair
Manufacturer : Boeing Aircraft Company
Model : 737-400
Nationality : South African
Registration mar

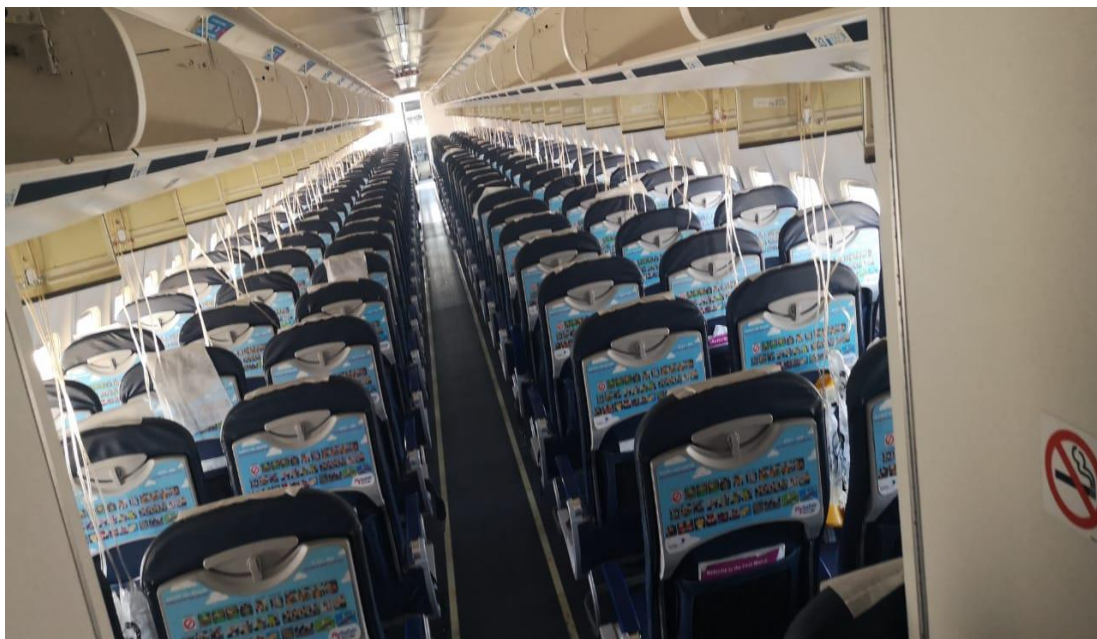
1.15.1 The incident was considered survivable as no damage was caused to the cockpit or cabin structure of the aircraft. Oxygen masks deployed automatically from the service panels in the cabin, and the cockpit crew donned their respective oxygen masks manually. Figure 5 depicts the cabin (actual aircraft) following the incident.

Figure 5: Deployed oxygen masks in the cabin. (Photograph courtesy of the Operator)

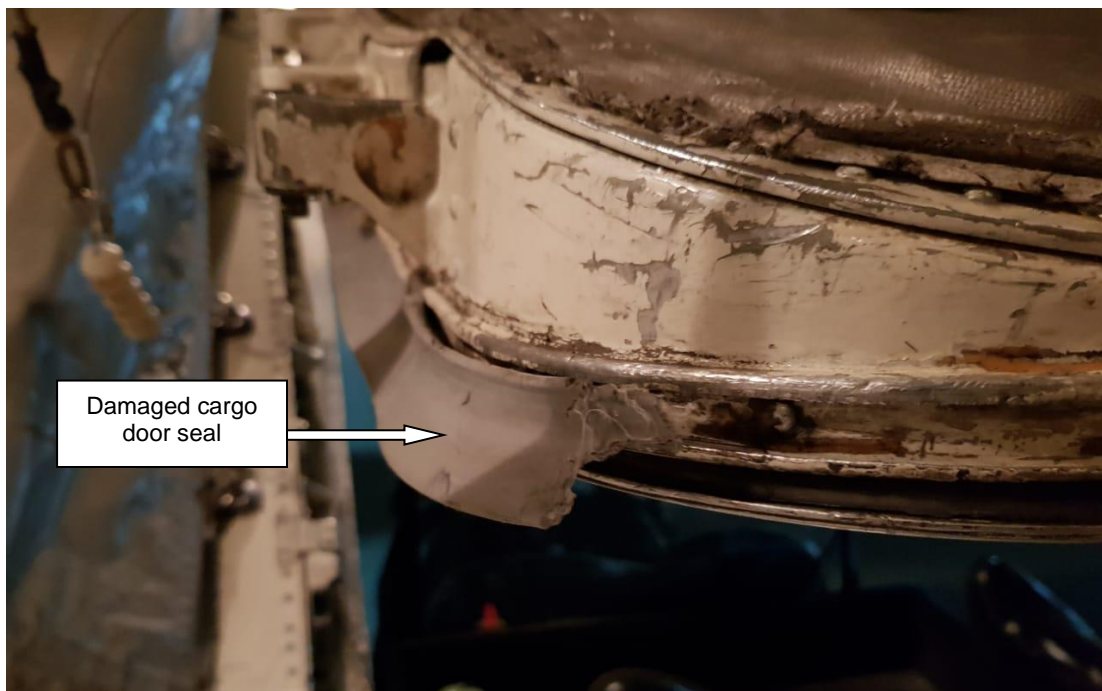
Figure 8: A section of the aft cargo door pressure seal (with the door in the open position).

Approximately 84 centimetres (cm) of the cargo door pressure seal (entire bottom section – with door in the closed position) had separated during an inspection of the aft cargo door as a section of the seal was found protruding from the door while in the closed position. The ceiling in the cargo hold also displayed evidence of collapse as a result of the air that escaped from the pressurised fuselage when the seal finally failed and the pressure exited (was sucked out) the door structure.

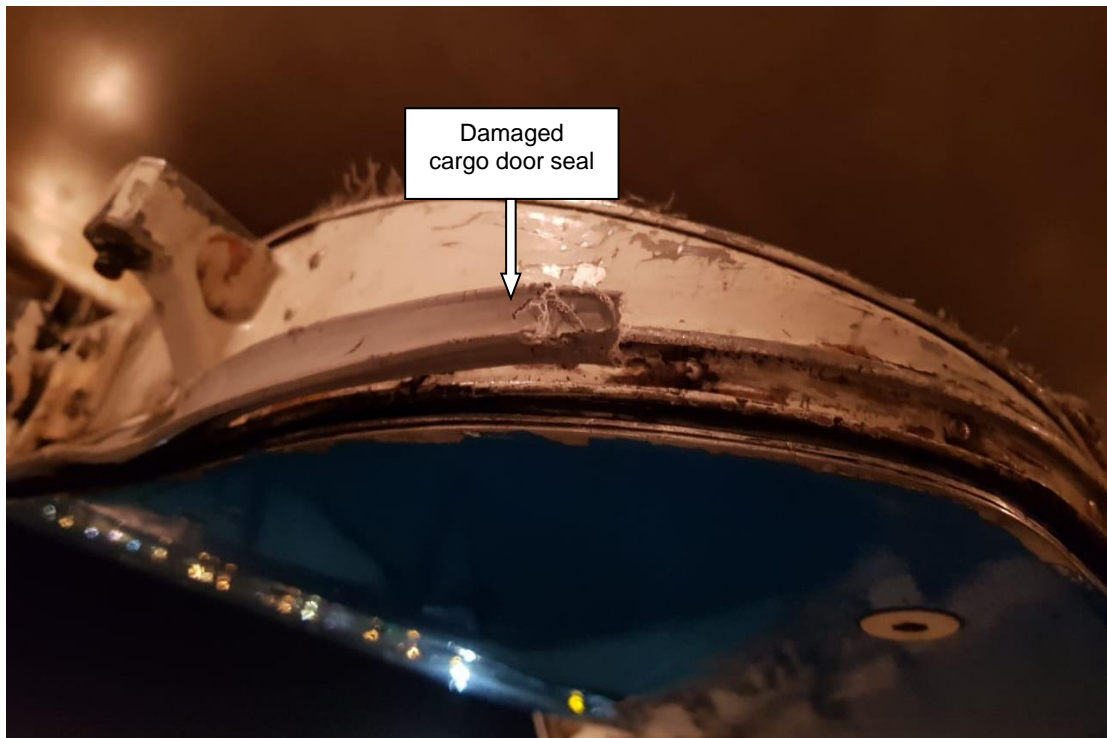
Figure 9: A section of the damaged aft cargo door pressure seal.

3.2.1 The rapid decompression was caused by the failure of the aft cargo door pressure seal. The failure of the pressure seal was most likely attributed to manhandling of the door during cargo/baggage handling, which is conducted manually (by hand) before and after each flight.

- (i) Fleet wide inspection carried out on all forward and aft cargo door pressure seals.
- (ii) Implementation of a daily and weekly inspection of cargo door pressure seals.
- (iii) All cargo nets, clips and anchor points to be inspected for condition and to ensure the nets provide the necessary protection (prevent baggage within the area where the cargo needs to open and close).
- (iv) The cargo door seal will be replaced on every aircraft C-Check inspection.

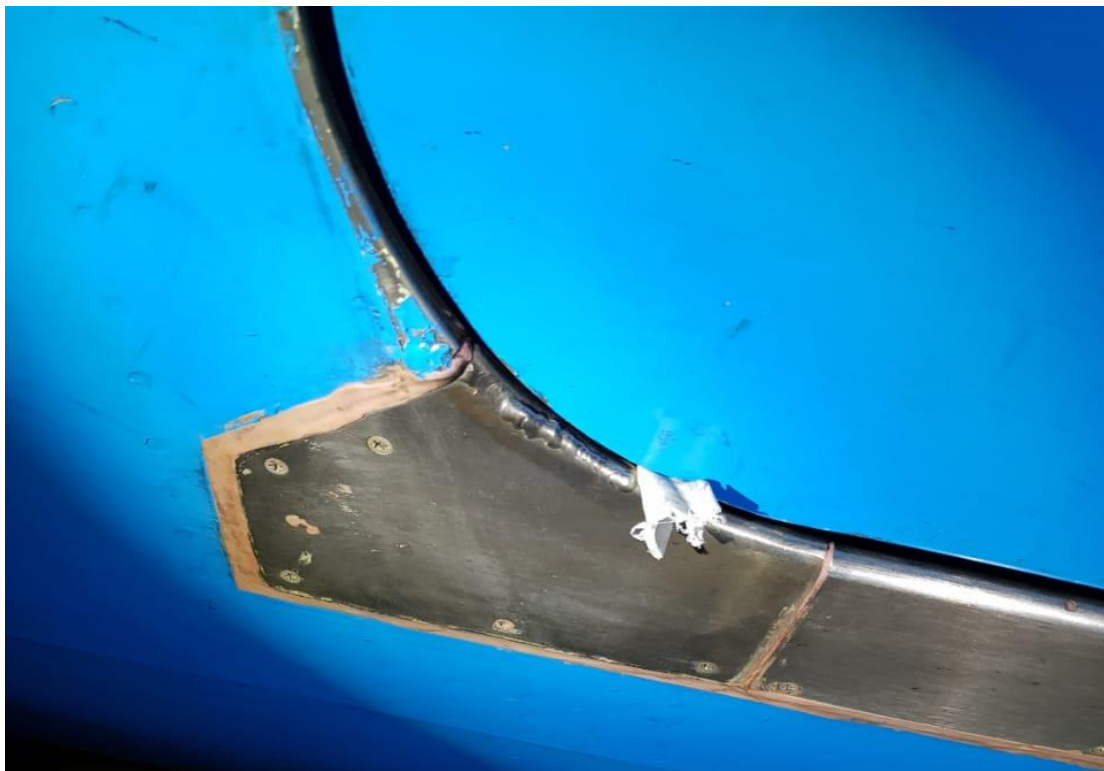
Figure 10: A section of the aft cargo door pressure seal protruding from the closed cargo door.

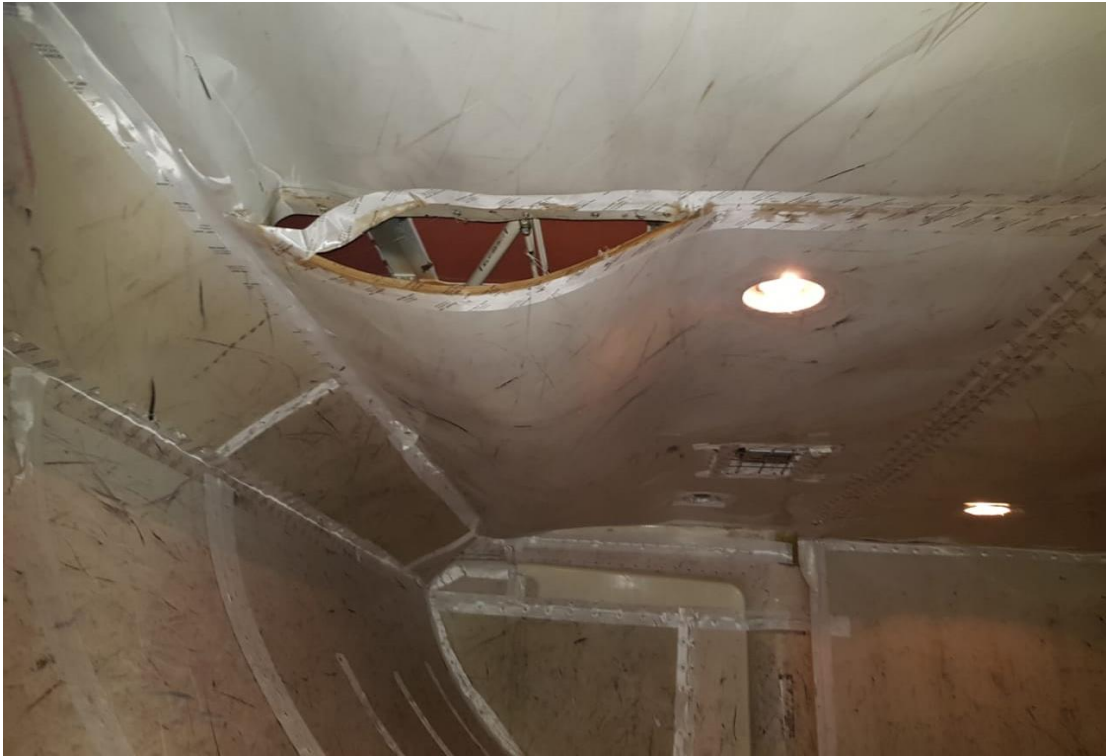
1.3.1 The aircraft sustained minor damage to the aft cargo door seal, as well as a partially collapsed sealing in the cargo hold, which had to be replaced.

Figure 11: The interior of the aft cargo hold area with a partially collapsed ceiling.

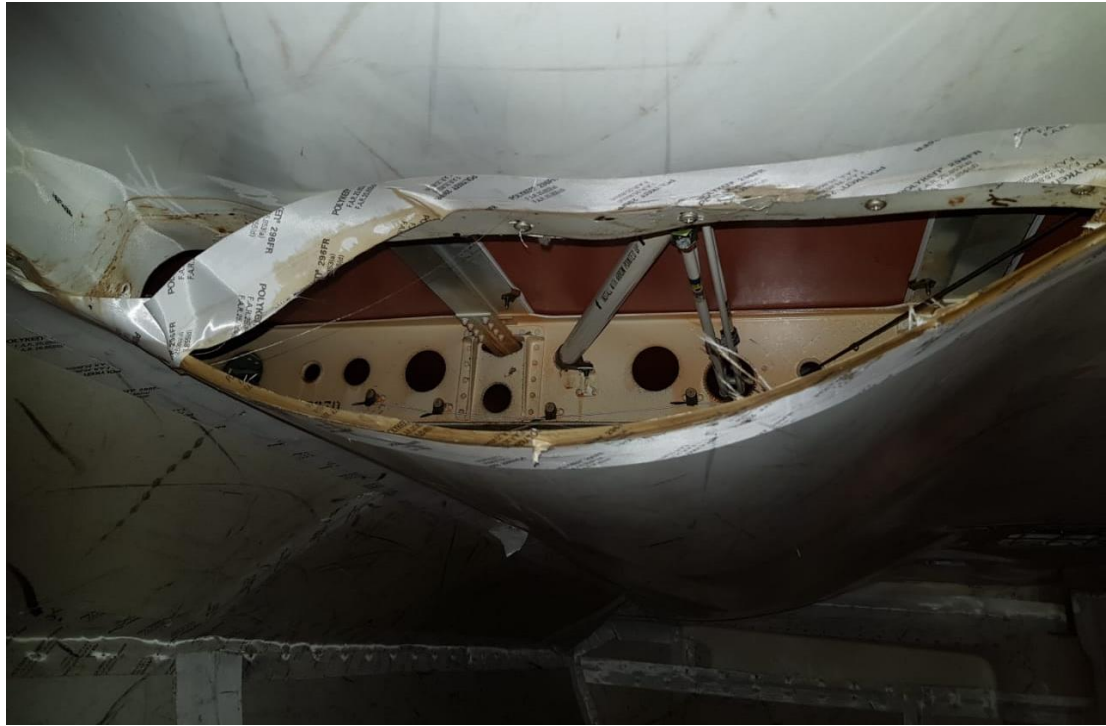
Figure 12: View of the partially collapsed ceiling in the cargo hold.

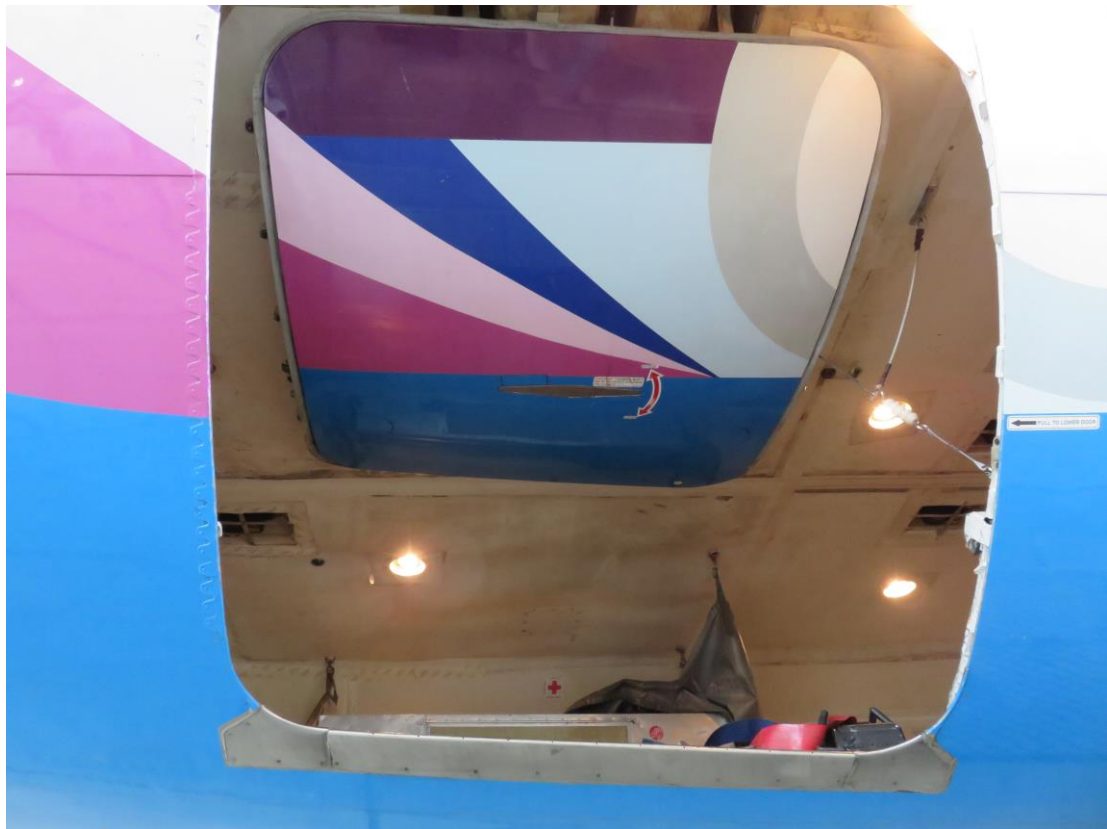
Figure 14: The aft cargo door in the open position. The photograph was taken from outside the aircraft.

The forward and aft cargo doors of the Boeing 737 series aircraft open inward as illustrated in Figures 14 and 15. The cargo loaded in these cargo holds are mostly luggage/baggage from travelling passengers. The loading process is conducted manually where people from a baggage handling company (external service provider) physically load the baggage in the cargo hold and unload it after every flight. During the loading and unloading process, the cargo door and, especially, the cargo door pressure seal could get damaged. The pressure seal is an on-condition item that needs to be replaced when any damage is noted which could lead or cause a leakage of pressurised air during flight.

With the cargo door in the open position, the cargo door pressure seal can only be inspected when a person physically climbs into the cargo hold and inspect the door as well as the pressure seal. It is not possible to conduct a detailed inspection of the cargo door pressure seal from the outside (with the door in the closed position).

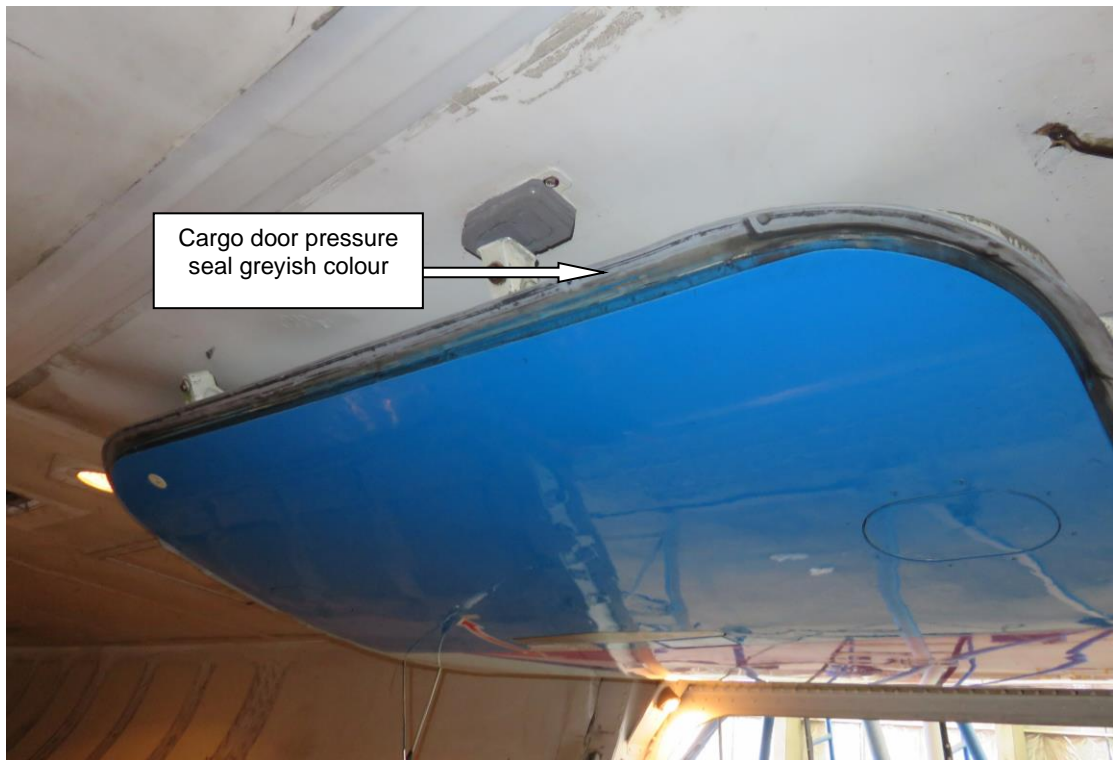
Cargo door pressure seal greyish colour

Figure 15: The aft cargo door in the open position. The photograph was taken from inside the cargo hold.

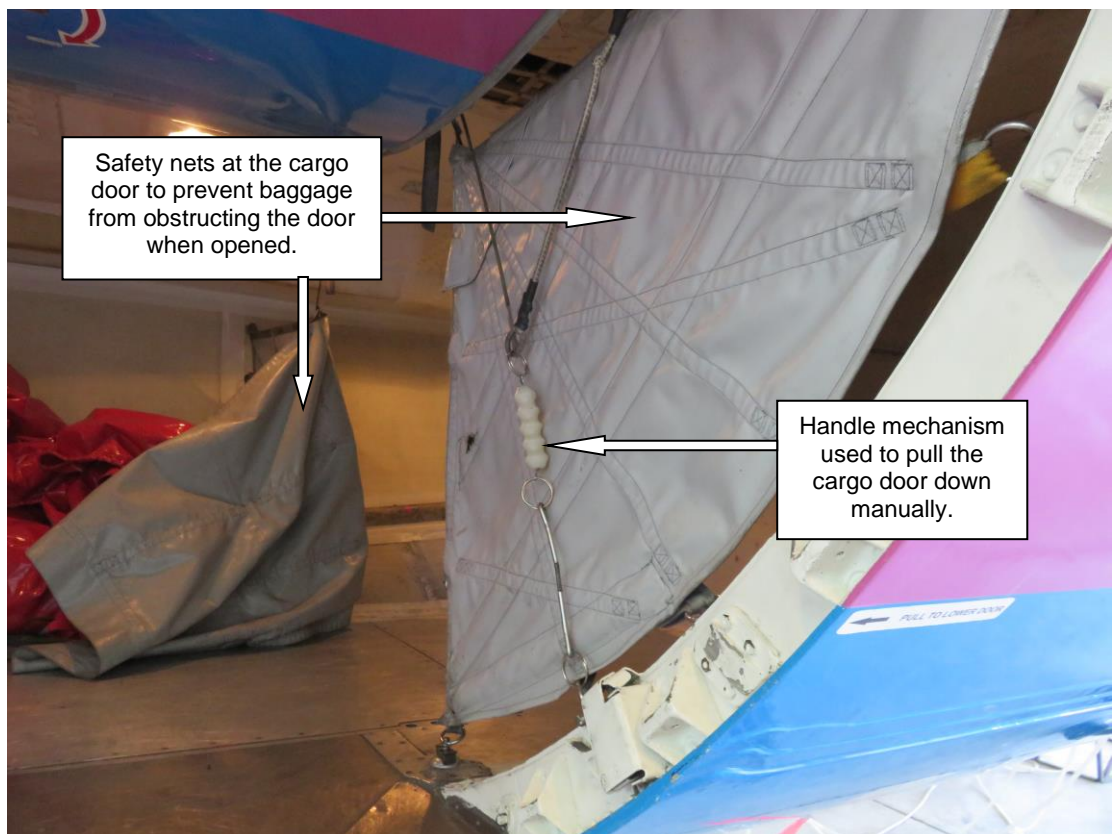
Safety nets at the cargo door to prevent baggage from obstructing the door when opened.

Handle mechanism used to pull the cargo door down manually.

Figure 16: The handle mechanism used to pull the door down into the closed position.

Both the forward and aft cargo doors close manually on this aircraft type. For this purpose, Boeing has provided a door-closing mechanism on the right side of the door (when standing outside looking into the cargo hold as illustrated on Figure 16), whereby an individual has to physically pull the door down via the handle mechanism provided. It was noted by the investigator during an inspection of the aircraft that to get hold of the handle, a person needs to be relatively tall. A short person will require a stand to elevate him/her from the ground or might have to jump and grab the handle and will then have to apply substantial force to pull the door down. Even for the investigator, who is 1.88m tall (6ft 2 inches) the handle mechanism was just in reach standing on the ground outside the aircraft.

- (i) The cargo door has a specially designed handle on the right side with the door in the open position that should be used to pull the door down into the closed position. Personnel that close the cargo doors need to make use of this handle. Personnel should NOT pull the door down by hand from the inside as this could damage the door pressure seal. (It was noted during an inspection on the aircraft that it might be difficult for 'shorter' people to get a grip of the handle to pull it down unless the person is slightly elevated from the ground).

- (ii) The cargo nets used inside the cargo hold need to be correctly fitted and secured by the baggage handlers before the cargo door is closed. This is essential to ensure the cargo door pressure seal, especially the bottom part, does not get damaged by baggage that may move during flight. With the door opening inwards, the immediate area behind the door needs to be free of obstruction to prevent damage to the door pressure seal.
