AIRCRAFT INCIDENT REPORT AND EXECUTIVE SUMMARY

Reference:		CA18/3/2/1281		
Aircraft Registration	ZS-SJD	Date of Incident	2 September 2019		Time of Incident	0625Z
Type of Aircraft	Boeing 737-800		Type of Operation		Air Transport Operation (Part 121)	
Pilot-in-command Licence Type	Airline Transport Pilot Licence	Age	43		Licence Valid	Yes
Pilot-in-command Flying Experience	Total Flying Hours	12 345.2		Hours on Type	3 696.4	
Last Point of Departure	O.R. Tambo International Aerodrome (FAOR), Gauteng Province					
Next Point of Intended Landing	Cape Town International Aerodrome (FACT), Gauteng Province					
Location of the incident site with reference to easily defined geographical points (GPS readings if possible)						
At waypoint UTEBA on GPS co-ordinates: 26° 57' 08.34" South 027° 02' 10.63" East at flight level (FL) 360.						
Meteorological Information	Wind direction and speed: 280° at 6kts; Visibility: 9999m; Temperature: 13°C; Dew point: 4°C; QNH: 1029hpa.

SRP Date	1 December 2020		Publication Date	3 December 2020

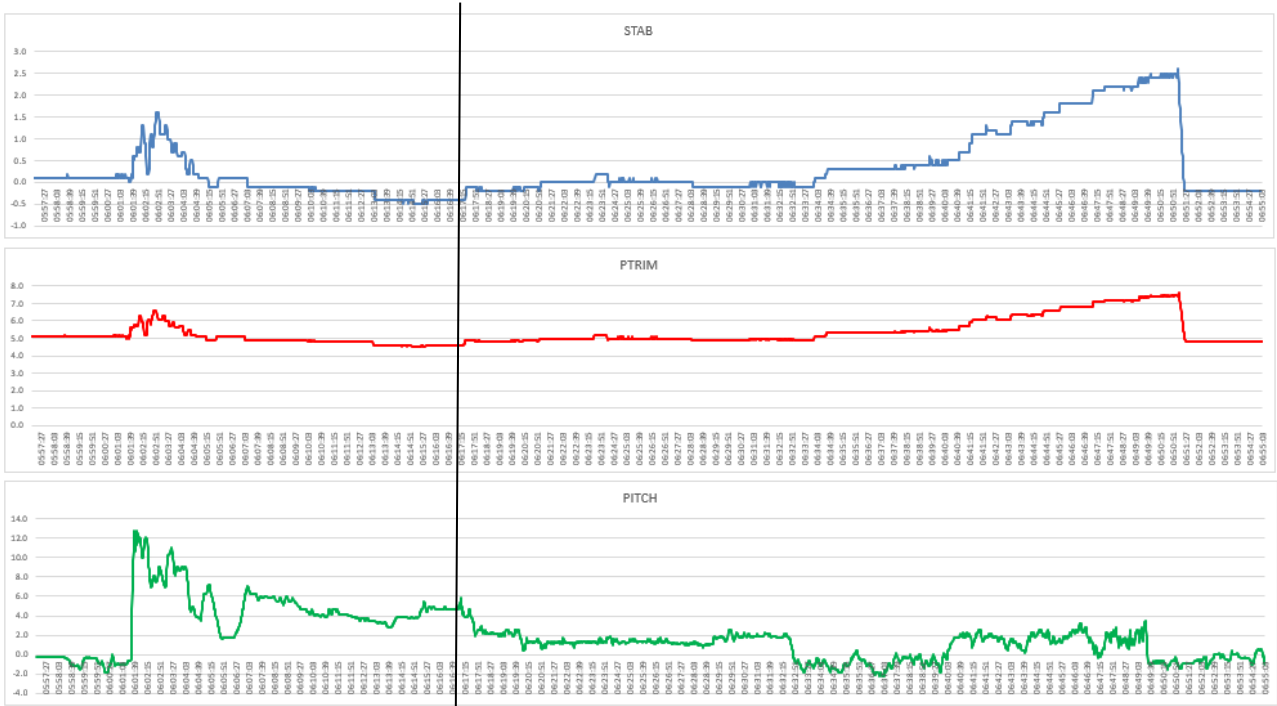
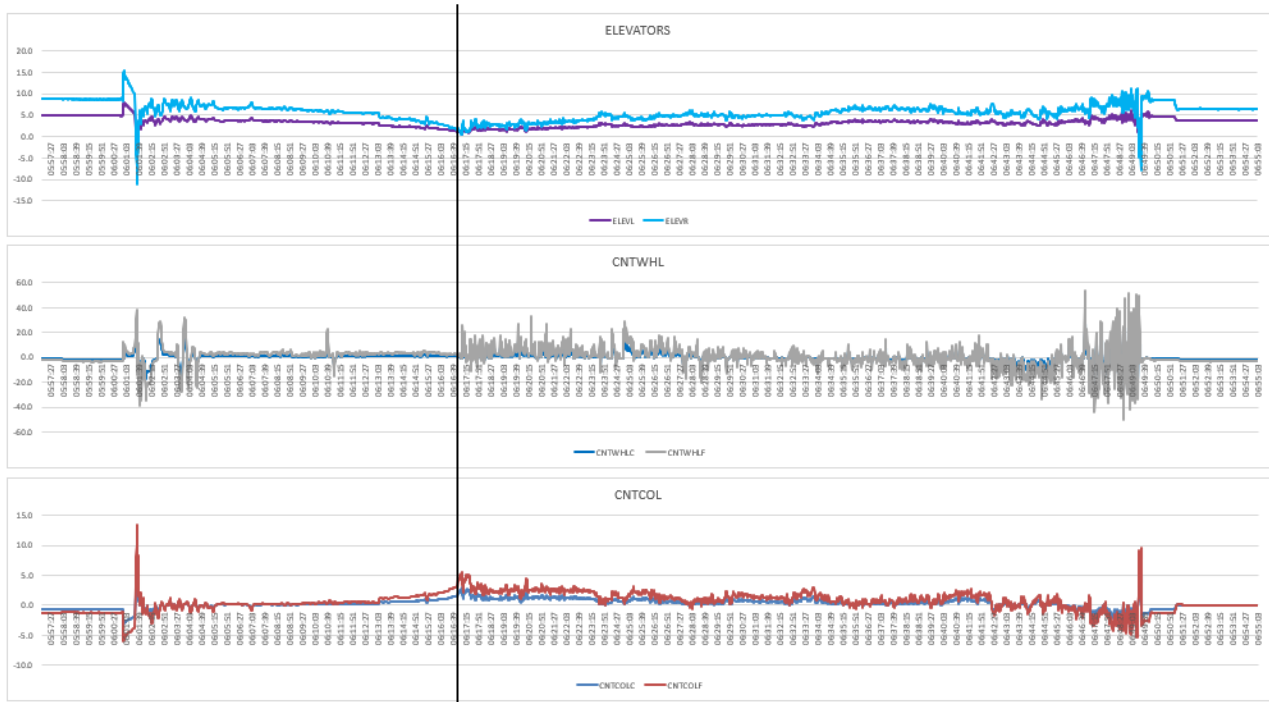
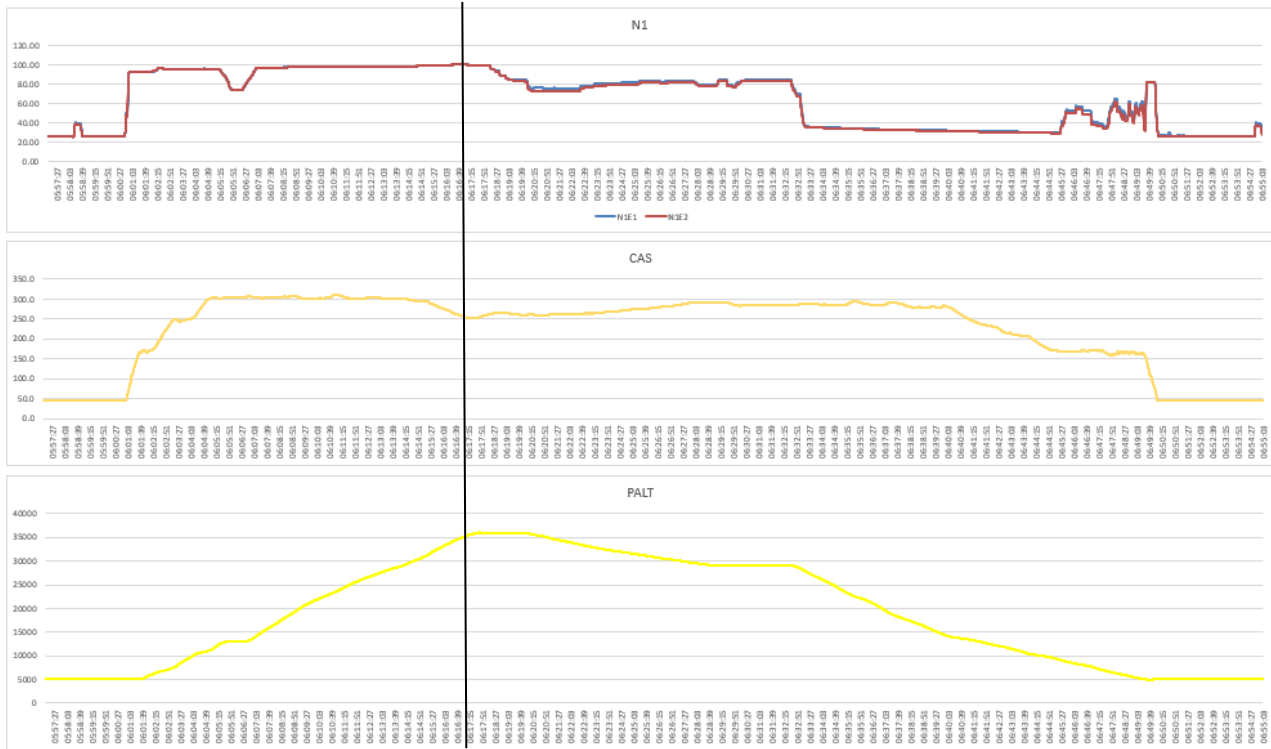
Figure 5: The downloaded QAR data of the incident flight. The (vertical) line shows where the event took place.

1.11.2 The QAR data depicted in Figure 5 indicates that at top of climb (TOC) after levelling off at FL360 at 06:16:55, the horizontal stabiliser out of trim occurred as indicated by the manual reversions on the graph of control wheel and control column.

1.11.4 *On ground prior to aircraft lining up on runway, difference between left and right elevator position values were observed between 0.9 and 1.1 deg on ground, after leaving the runway, there are recorded differences in the left and right elevator position values between 0.9 and 1.3 deg. During the flight the difference between the elevators became less due to loading compliance, except for the expected transient due to switching elevator tabs to/from the balance position. This observation suggests there is not an issue with the elevator system.*
