AIRCRAFT INCIDENT REPORT AND EXECUTIVE SUMMARY

Reference:	CA18/3/2/1282	
Aircraft Registration	ZS-JRM	Date of Incident	16 September 2019		Time of Incident	0743Z
Type of Aircraft	Boeing 737-400		Type of Operation	Commercial (Part 121)		
Pilot-in-command Licence Type	Airline Transport Pilot Licence		Age	50	Licence Valid	Yes
Pilot-in-command Flying Experience	Total Flying Hours	17 673		Hours on Type	709:05	
First Officer Licence Type	Airline Transport Pilot Licence		Age	38	Licence Valid	Yes
First Officer Flying Experience	Total Flying Hours	7 266.02		Hours on Type	137.05	
Last Point of Departure	O.R. Tambo International Aerodrome (FAOR)					
Next Point of Intended Landing	Cape Town International Aerodrome (FACT)					
Location of the incident site with reference to easily defined geographical points (GPS readings if possible)						
FAOR Runway 03L, at GPS co-ordinates S26°07'32.72" E28°16'00.42"						
Meteorological Information	Wind: Variable/4kt; Visibility: 10km, Temperature: 24°C and Dew point: 4°C

Reference Number : CA18/3/2/1282
Name of Owner/Operator : Safair Operations (Pty) Ltd
Manufacturer : Boeing Aircraft Company
Model : 737-400
Nationality : South African
Registration Mar

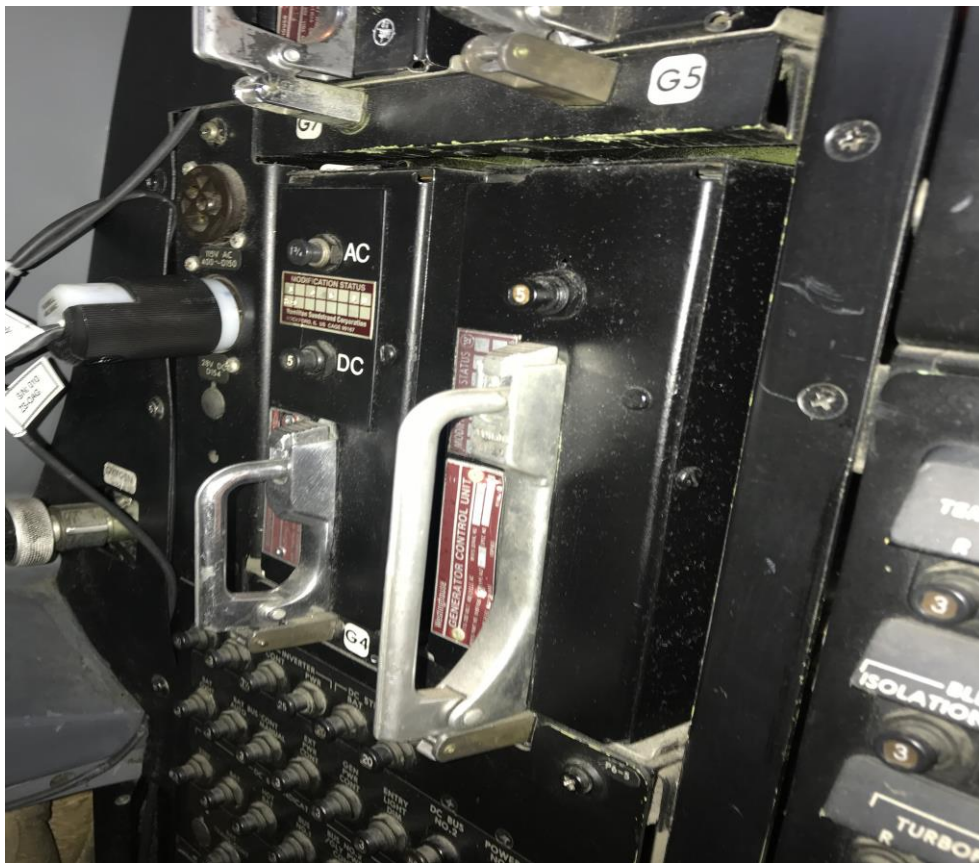
Figure 1: Generator Control Unit. (Picture courtesy of Safair)

1.1.5 The aircraft was initially assigned to land on Runway 03R, which was later changed to Runway 03L. Emergency services were not dispatched as the crew felt that the aircraft was flying normally. The landing was uneventful until the landing roll phase when the captain's flight instruments and communications 1 (COMM 1) failed, an indication that the captain's instruments were powered by standby electrical system. After shutdown, it was discovered that the lever latch of the Generator Control Unit (GCU) of the No. 1 engine had broken and the unit had moved out of its position.

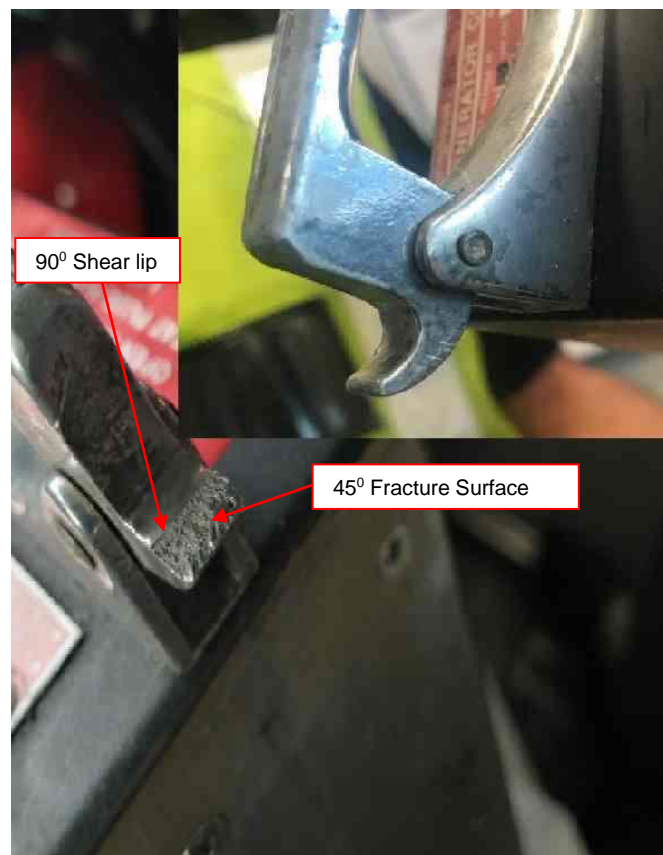
1.16.2 When the GCU of the No 1 engine was inspected, it was discovered that the lever latch tip was broken. The tip enables it to lock securely into the tray (Figure 4).

Figure 4: The main picture shows the broken hook; the inset shows a complete hook.

1.16.3 A fatigue crack normally grows in so-called mode I, with a flat fracture surface perpendicular to the loading direction. Sometimes the crack front becomes slanted, at about 45° with the loading direction (Figure 4).

- 2.2.5 The lever latch of the GCU of the No. 1 engine had developed a fatigue crack on its hook which was perpendicular to the loading direction, resulting in a shear lip before its final failure (see Figure 4). The shear lip caused the unit to move out of its rack, resulting in electrical system 1 disconnection and multiple system failures controlled by the unit.

- 3.2.10 The hook that would have prevented the GCU of the No.1 engine from moving out of its rack had failed due to fatigue crack (see Figure 4).
- 3.2.11 The GCU of the No. 1 engine was fitted to the aircraft on 21 February 2019, seven months prior to this incident; moreover, it accumulated 167 hours since its fitment to the aircraft. There was no record of defect to the number 1 electrical system.

multiple system failures because of the broken lever latch of the GCU of the No.1 engine due to fatigue.

4.2 The Director of Civil Aviation (DCA) to review the possibility of introducing a maintenance requirement for a non-destructive testing on the lever latch mechanism of the GCU whenever the GCU is removed for bench test.

4.3 Safety Action: The operator inspected all GCU latch mechanisms in its fleet and all were found to be serviceable with no signs of cracks.
