AIRCRAFT INCIDENT SHORT REPORT

CA18/3/2/1287: During touch-and-go, the nose landing gear wheel assembly and fork separated from the landing gear strut.

Date and time	: 17 October 2019 at 1145Z
Location	: On Runway 07 at Lanseria Aerodrome (FALA)
Aircraft registration	: ZS-SJY
Aircraft manufacturer and model	: Diamond Aircraft Industries, DA 20-C1
Last point of departure	: Lanseria Aerodrome (FALA)
Next point of intended landing	: Lanseria Aerodrome (FALA)
Location of incident site with reference to easily defined geographical points (GPS readings if possible)	: S25°56'15.99" E27°55'35.02" Elevation 4521 feet
Meteorological information	: Wind: Variable at 5 knots, Temperature: 31°C, Dew point 8°C, Visibility: CAVOK
Type of operation	: Training (Part 141)
Persons on-board	: 1+1
Injuries	: None
Damage to aircraft	: Substantial

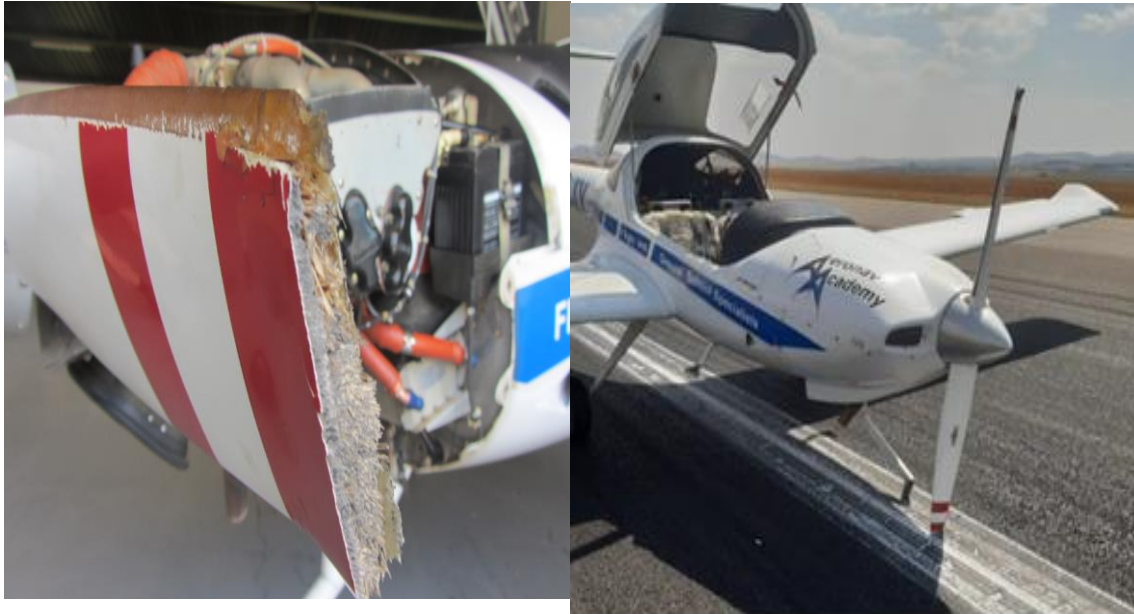
- 2.2. The instructor reported that the student pilot completed four take-offs and four circuits, with three successful touch-and-go landings. The instructor and the student pilot did not notice any signs of defects, nose wheel shimmy or other abnormalities during the first three touch-and-go landings. However, during the fourth circuit touch-and-go, the instructor noticed that after they had touched down, there was a slight jolt on the main wheels as the aircraft's nose lowered. The nose dropped lower than normal, and at that point, the instructor took control of the aircraft. The instructor then applied full back pressure on the control column and closed the mixture control. As the aircraft slowed down, the nose lowered followed by a loud grinding sound that could be heard in the cockpit. The instructor stated that the propeller scraped the runway's surface just before the aircraft came to a full stop on the centreline of Runway 07.

Figures 1 and 2: The damaged propeller (left) and the aircraft as it came to rest (right).

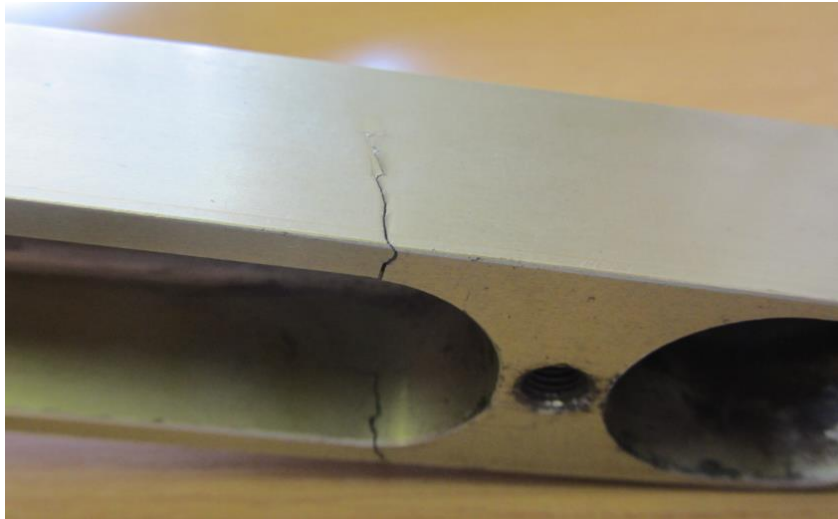
assembly was changed because of cracks that were found on the nose gear fork (see Figure 3). The nose landing gear fork with part number 20-3220-08-00 was removed and replaced with a new nose landing gear fork with part number 20-3220-08-00_1 which was in accordance with Diamond Service Information Letter No. SIL20C1-005 (Appendix A) and Service Bulletin DAC1-32-03 (Appendix B). According to the aircraft maintenance manual (AMM), the nose landing gear fork should be inspected every 100 hours. This led to the installation of an improved nose landing gear fork assembly with part number 20-3220-08-00_1.

Figure 3: Cracks found on the changed nose landing gear fork assembly.

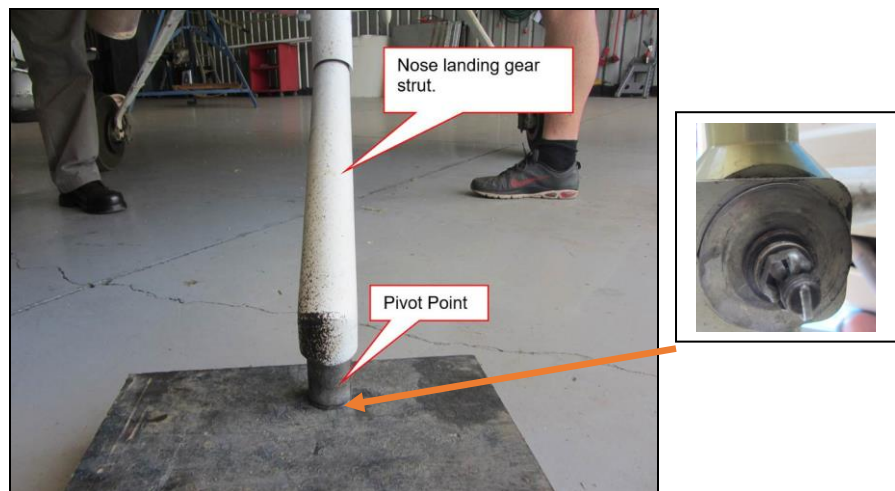
2.4.6 The aircraft had accrued 2.2 hours and accomplished five successful landings after its last MPI (before the nose landing gear fork and wheel assembly separated from the nose landing gear strut at the pivot point). The nose landing gear fork and wheel assembly separated from the landing gear strut during the fourth touch-and-go on an asphalt runway.

Figure 4: The nose landing gear strut and pivot point.

2.4.11 The damaged landing gear strut was sent to the TSB laboratory for a detailed inspection. The inspection revealed that there was no information that could be analysed on the landing gear strut because the lower end of the strut was damaged when it came into contact with the runway's surface during the touch-and-go exercise.

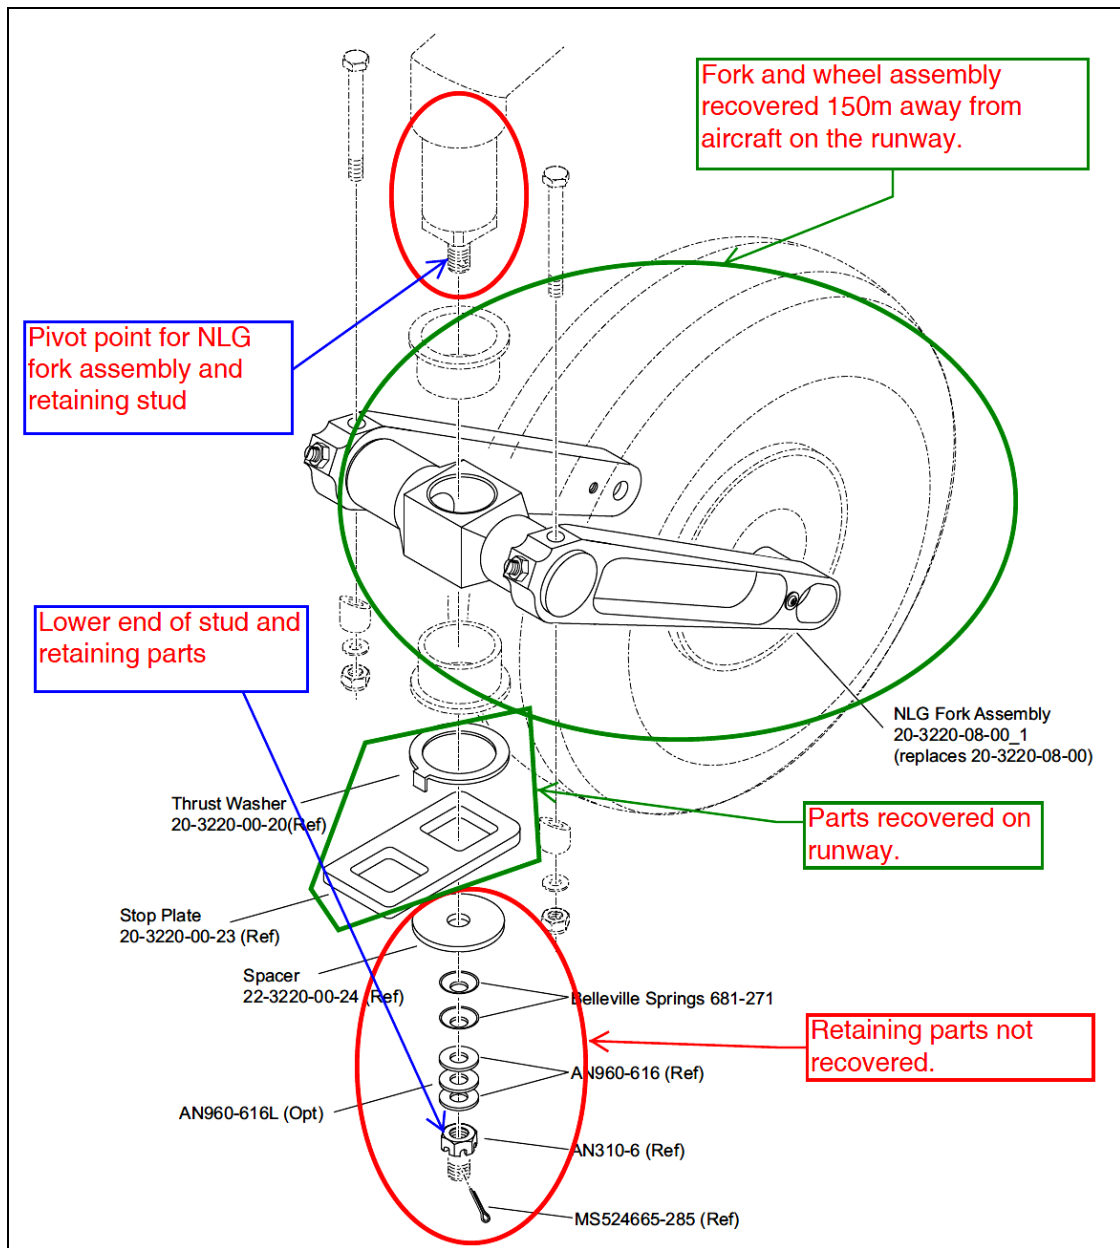
2.4.3 The last step of the AMM requires the installation of the cotter pin to secure the castellated nut in position. During the interview with the aircraft maintenance organisation (AMO), they had indicated that all installation steps were followed and that the nut was secured using a cotter pin. The material list that was supplied by the AMO to the investigator indicated that part number MS24665-360 cotter pin was used to secure the nut. According to the Service Bulletin for installation of the improved nose landing gear fork assembly, the part number required to be used is MS524665-285 cotter pin. The AMO did not install the required (cotter pin) part number as stipulated by the manufacturer in the AMM.

Figure 5: Diagram of the nose landing gear fork assembly. (Source: Diamond SB DAC1-32-03)

2.4.13 The investigation revealed that it was likely that during the replacement of the cracked nose landing gear fork, the engineer fitted the incorrect cotter pin when reassembling and refitting the new nose landing gear fork to the nose gear strut.

- 7.1 In the interest of safety, it is recommended that the AMO uses recommended approved parts as required by the manufacturer during the performance of aircraft maintenance.

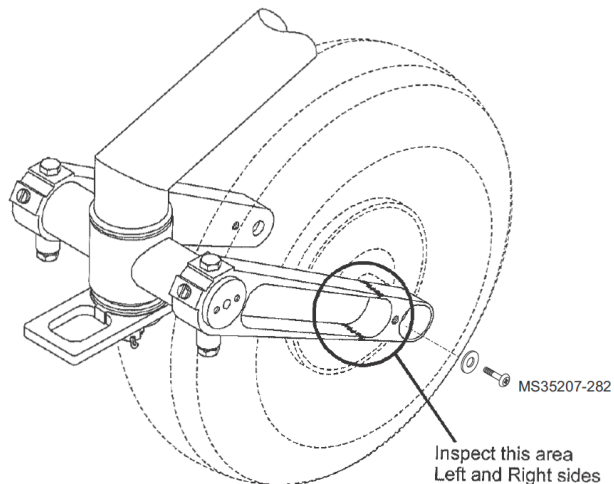
Cracks have been found on some NLG Fork assembly, P/N 20-3220-08-00 during routine inspections. Cracking usually occurs on higher time aircraft but could occur sooner with rough field operations or hard landings. Figure 1 shows where the cracking has normally occurred. Also, the machine screw, pan head, P/N MS35207-282 (see Figure 1) should be installed with Loctite 242 when the wheel fairings are not used to avoid any potential cracking that may occur at that location.

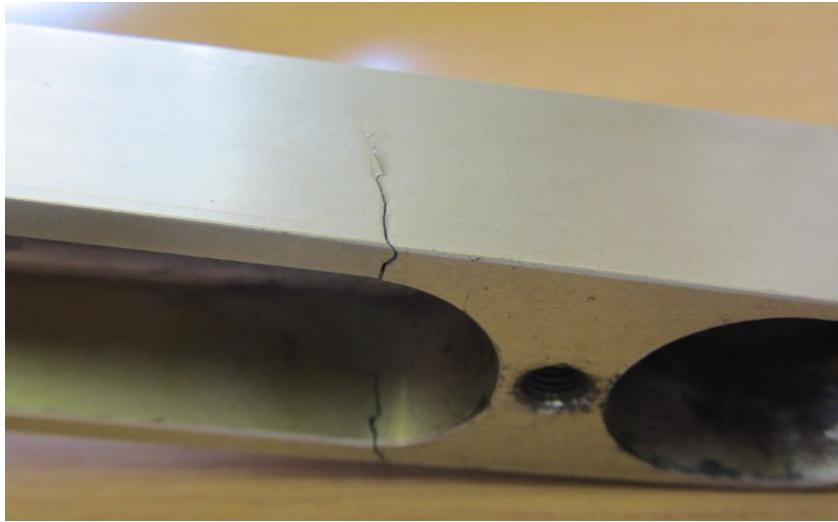
Figure 6: Cracks found on the fork assembly.
