**AIRCRAFT INCIDENT REPORT AND EXECUTIVE SUMMARY**

Reference:	CA18/3/2/1288	
<b>Aircraft Registration</b>	ZS-OBD	<b>Date of Incident</b>	16 October 2019		<b>Time of Incident</b>	1402Z	
<b>Type of Aircraft</b>	Cessna 172P		<b>Type of Operation</b>	Training (Part 141)			
<b>Pilot-in-command Licence Type</b>	Commercial Pilot Licence		<b>Age</b>	36	<b>Licence Valid</b>	Yes	
<b>Pilot-in-command Flying Experience</b>	Total Flying Hours		1780.9		Hours on Type	71.4	
<b>Last Point of Departure</b>	Rand Aerodrome (FAGM): Gauteng Province						
<b>Next Point of Intended Landing</b>	Rand Aerodrome (FAGM): Gauteng Province						
<b>Location of the incident site with reference to easily defined geographical points (GPS readings if possible)</b>							
A farm in Kalbasfontein, Randfontein, approximately 24nm south-west of FAGM at the following GPS co-ordinates: 26°38'26.73"S 027°47'12.38"E at an elevation of 4881 feet							
<b>Meteorological Information</b>	Wind: Light & variable, Temperature: 32°C, Visibility: CAVOK

SRP Date	13 October 2020		Publication Date	16 October 2020

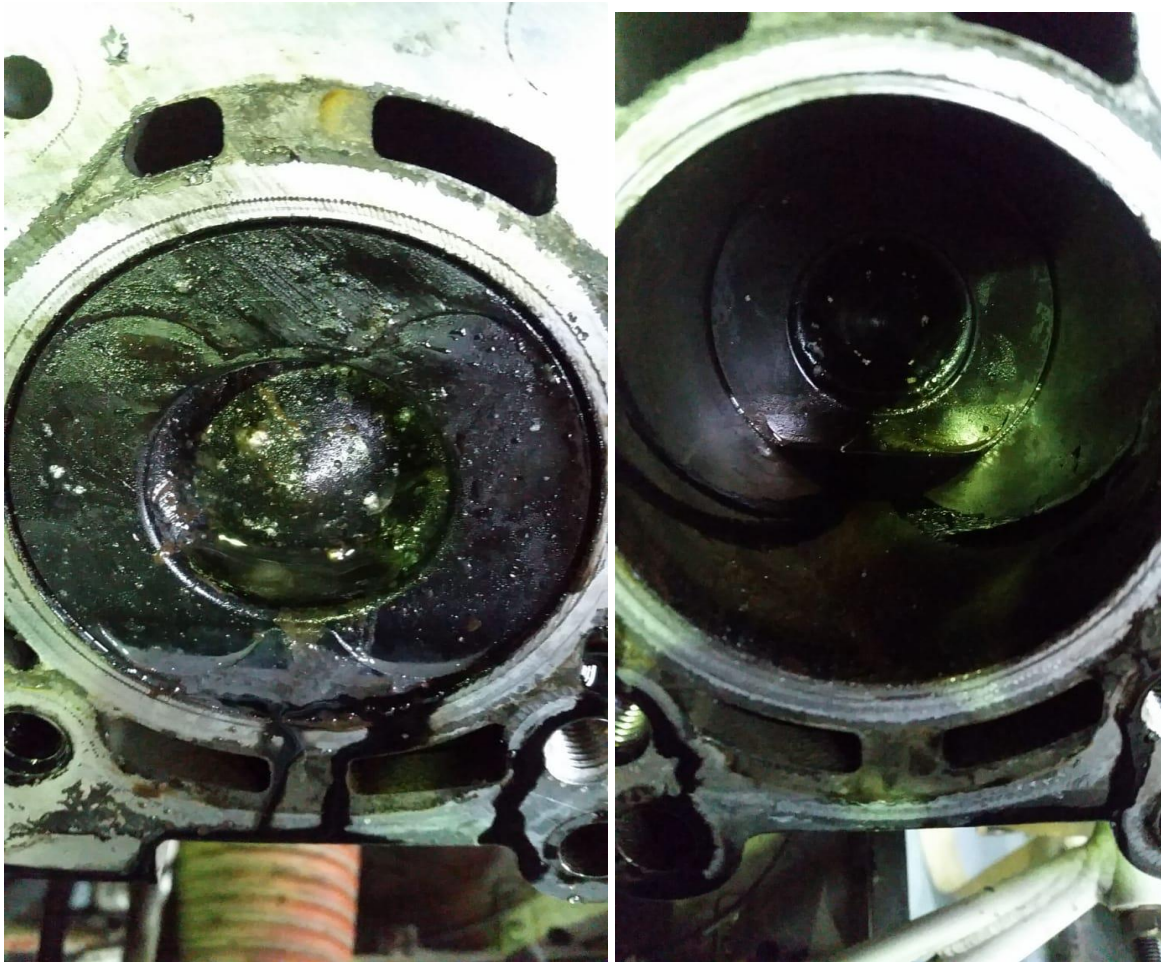
- The AMO stated that the aircraft was brought for its annual 100-hour inspection with snags reported by the pilot. A major snag was of the difficulty of the engine to start daily. A FADEC download was done and sent to the factory for analysis. The AMO was informed by the factory to conduct a glow plug test and confirm that all four glow plugs were working. The glow plugs were removed and tested; and were found satisfactory.
- It was also noted that when the propeller was turned over by hand, a mixture of water and oil was pumped out of the open holes in the cylinder head (see Figures 2 and 3). The water issue was also reported to the engine factory and it was confirmed that this was the cause for the engine's difficulty to start as well as overheating that was reported by the instructor.

**Figures 2 and 3:** Water in the cylinder head.

- Work order was raised to replace the cylinder head and the AMO stated that the replacement was carried out in accordance with (IAW) RM-02-02 Chapter 73-30.03. Replacement of the cylinder head requires the timing chain to be disconnected and re-connected, which the AMO stated was carried out in accordance with RM-02-02 Chapter 72-30.02. (See timing chain installation procedure, pages 1, 2, 7, 8, 13, 14, 15, 16 17 and 18 attached as Appendix C).
- The AMO did not follow the instructions as indicated in Appendix C and as indicated by the engine investigation report following the incident, which indicated the following amongst others:
  - Synchronisation of the camshaft drive gears was wrong.
  - Timing chain fitted incorrectly
  - Chain tensioner fully in end position.

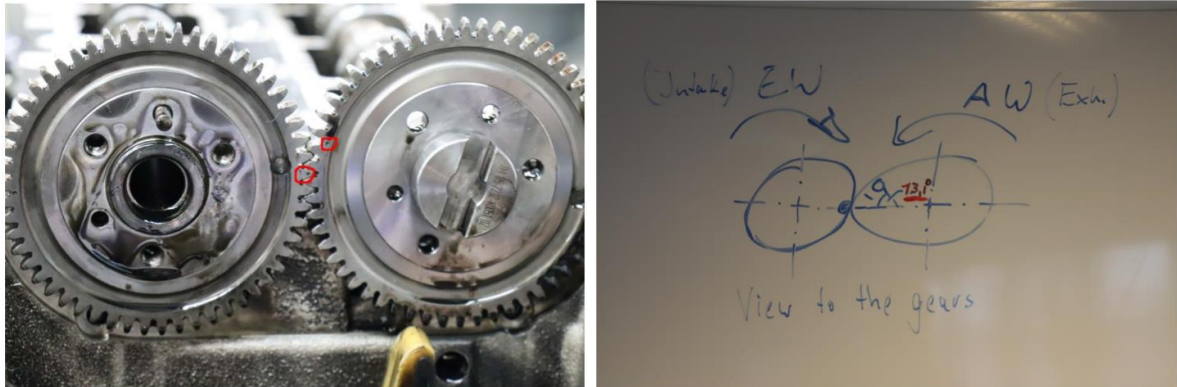
Germany for the engine strip. The engine strip was overseen by an Accredited Representative from the Federal Bureau of Aircraft Accidents Investigation. Synchronisation of the camshaft was found to be fitted incorrectly with gears moved two-teeth clockwise (see Figures 4 & 5) and the timing chain was found broken. The report concluded that the cause of the engine failure was due to a crack on the timing chain which led to its failure as well as caused damage to the valve timing system. (See engine strip report attached as Appendix B)

**Figures 4 & 5:** Picture and a diagram for synchronisation of the camshaft drive gears which had shifted two-teeth clockwise (~13°).

- 3.2.8 Following the engine strip, the synchronisation of the camshaft drive gears and the timing chain were found to have been fitted incorrectly, thus, the AMO failed to follow the requirements of the manufacturer in the maintenance of the engine.

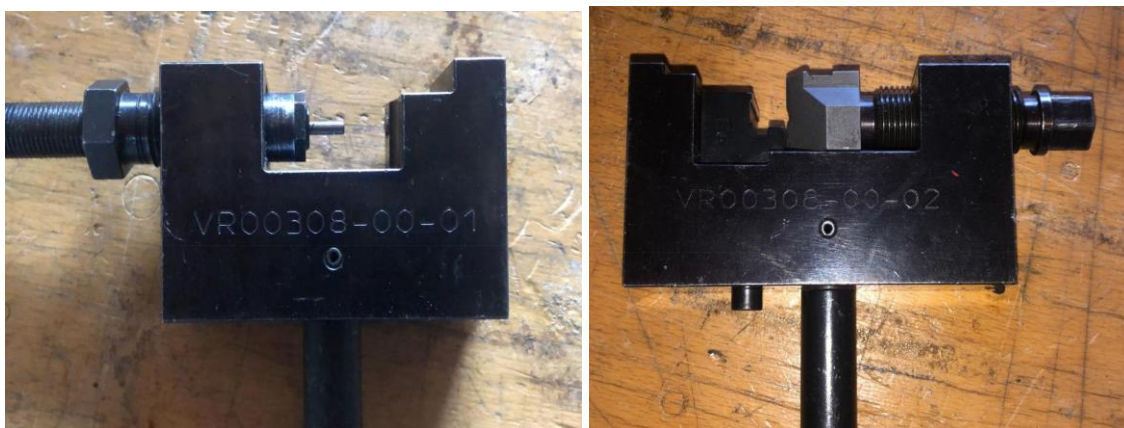
- It is possible to disconnect the timing chain using a special tool. But if the timing chain has been disconnected, it would not be possible to reconnect the same timing chain again. In that case, one would need to install a new timing chain. The new timing chain comes open with a special new pin which is closed by being pressed using a special tool. According to the AMO, a new pin was used to re-connect the timing chain, and part number VR 00308-00-01 and VR 00308-00-02 tools were used for the removal and assembly. (See Figures 6, 7, 8 and 9)

**Figures 6 & 7:** Special tools used by the AMO for the removal and installation of the timing chain.

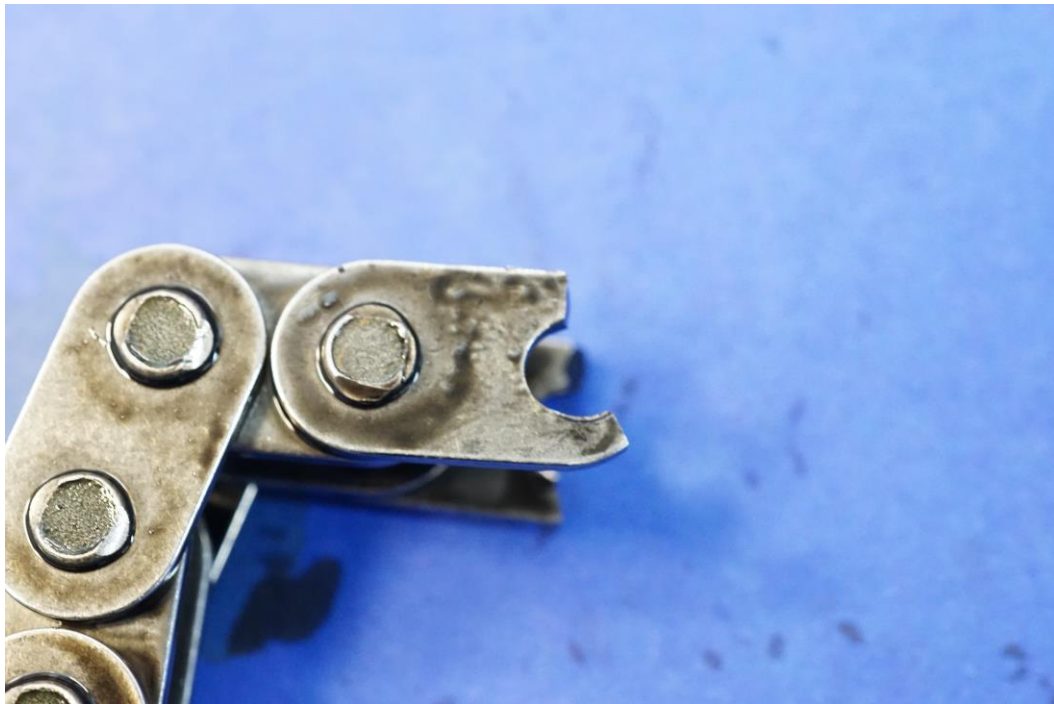
- The affected timing chain was measured by the manufacturer's engineers. The elongation actual value was calculated to be 0.124%, which was a normal value for this engine run time. If the elongation was higher than 0.5%, the timing chain might have snapped.
- The chain showed a broken side plate at the connecting bolt (pin area). (See Figures 10 and 11). The surface of the bottom connecting bolt showed a damaged surface.

**Figure 10:** A broken plate.

- 3.2.9 The chain showed a broken side plate in the connecting bolt and the surface of the connecting bolt was also damaged.
- 3.2.10 The investigation revealed that the engine stoppage was caused by the timing chain that failed, probably due to over tension of the timing chain tensioner, resulting in the valve timing being out of synchronisation and the valves rubbing against the pistons. The contributing factors include the incorrectly fitted timing chain and the incorrect alignment of the camshaft gears.

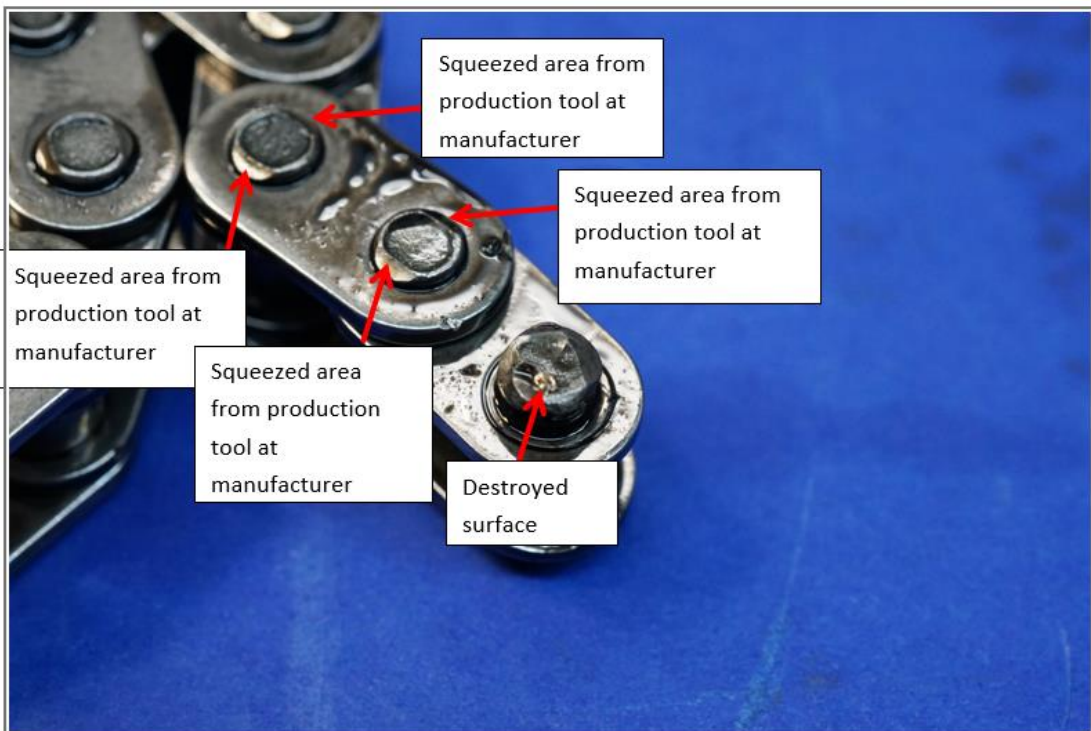
**Figure 11:** Bolts squeezed by the manufacturer and a damaged bolt/pin.

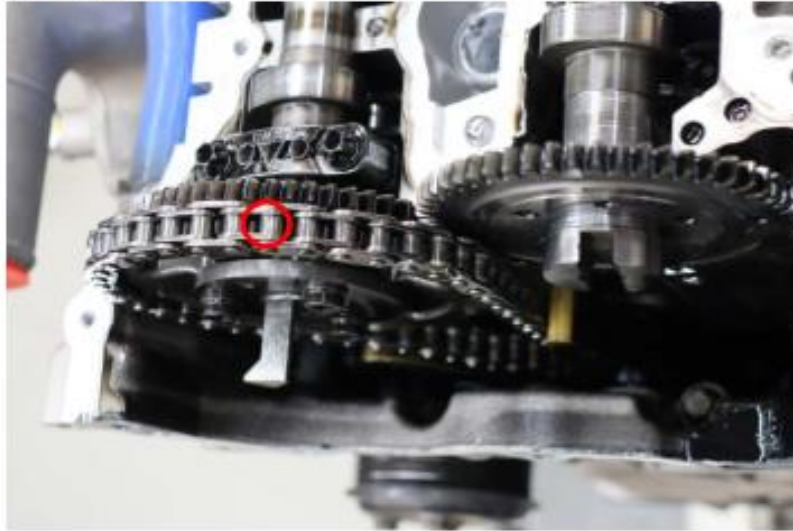
- Timing chain was found in the wrong position – holes were on the inner side
- Chain tensioner: fully in end position
- breakaway torque [Nm] Cylinder Head

Figure 1: Assembly of the time chain - holes in the bushings not visible

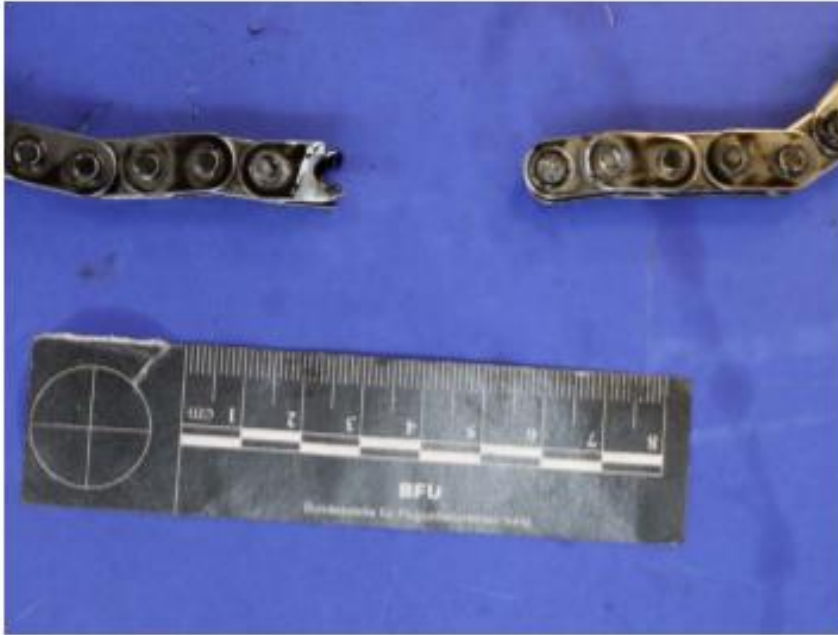
The engine failure was caused by the crack of the timing chain. The crack of the timing chain caused the distortion of the engine timing and subsequent contact of the valves and the piston. It is not possible to determine the cause of the crack at that stage of investigation.

Figure 3: Fracture of the time chain

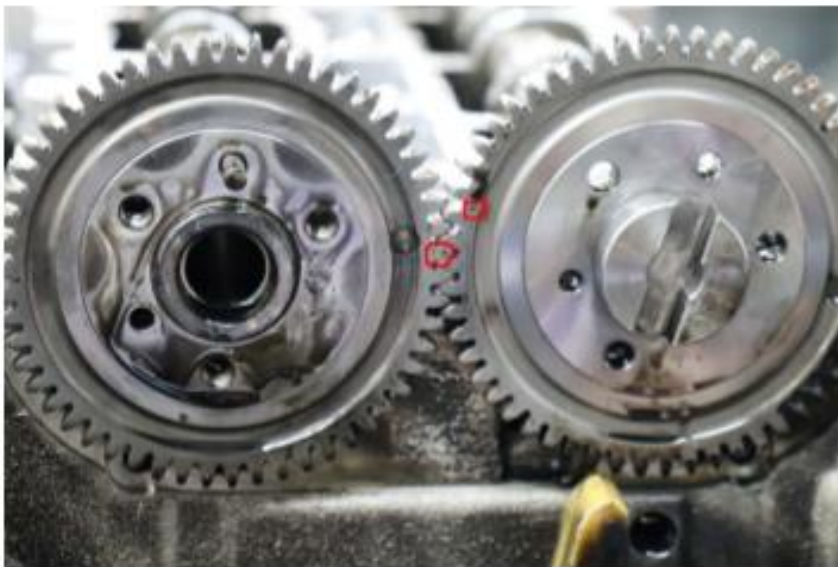
Figure 4: Synchronization of the cam shaft drive gears; shift 2 gears clockwise (~13°)
