AIRCRAFT SERIOUS INCIDENT REPORT AND EXECUTIVE SUMMARY

Reference:		CA18/3/2/1291	
Aircraft Registration	ZS-CAR	Date of Incident	8 November 2019	Time of Incident	0720Z
Type of Aircraft	Cessna 550	Type of Operation	Flight Calibration (Part 135)		
Pilot-in-command Licence Type	Airline Transport Pilot Licence	Age	48	Licence Valid	Yes
Pilot-in-command Flying Experience	Total Flying Hours	5200	Hours on Type	1300	
Co-Pilot Licence Type	CPL	Age	33	Licence Valid	Yes
Co-Pilot Flying Experience	Total Flying Hours	1046.4	Hours on Type	250.5	
Last Point of Departure	Lanseria International Airport (FALA), Gauteng Province				
Next Point of Intended Landing	Polokwane International Airport (FAPP), Limpopo Province				
Location of the serious incident site with reference to easily defined geographical points (GPS readings if possible)					
On Runway 07 at FALA at the following GPS co-ordinates: S23°50'43.2" E029° 27'30.7" with an elevation of 4521ft AGL					
Meteorological Information	Wind: 260°/ 3kt; Visibility: >10km; Cloud: Nil, QNH 1022

SRP Date	13 October 2020	Publication Date	21 October 2020

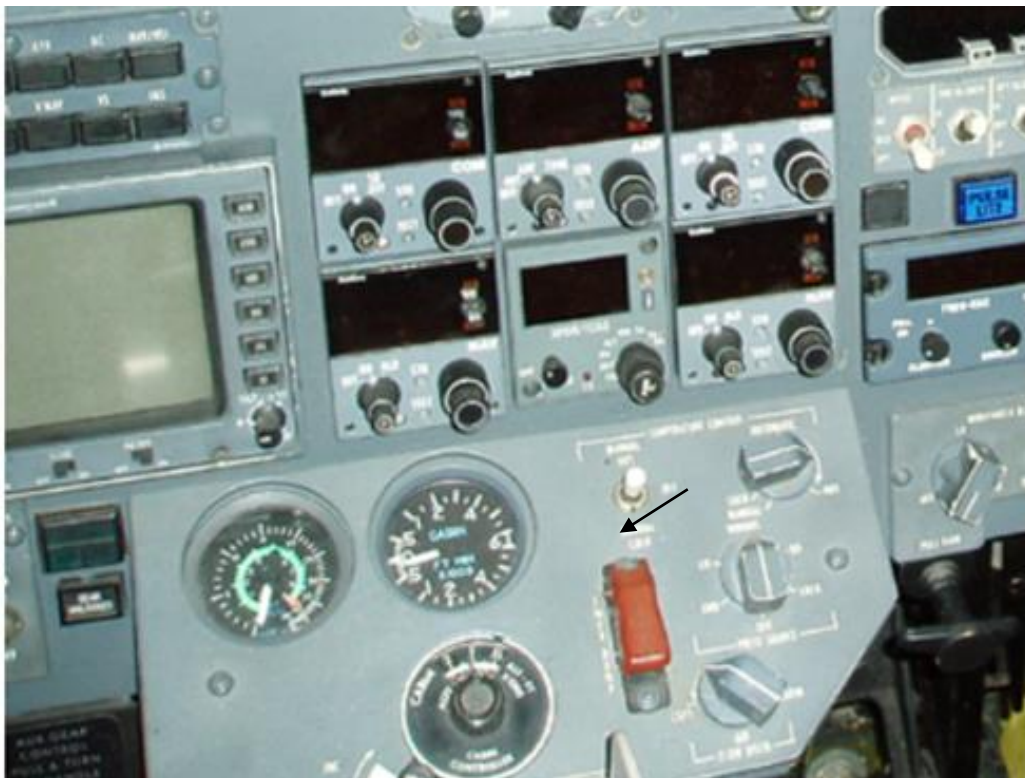
Figure 1: The arrow points at the pressure select knob. (Source <http://www.scanav.com>)

3.2.11 It was also found that the AME misdiagnosed the reported serious incident of an oil smell and smoke in the cockpit/cabin as a result of a reliance on what the crew was informing him and also that he was not following the manufacturer's prescribed maintenance practises by continually attempting to simulate the serious incident whilst the environmental/pressurisation system control knob was on "ground" mode rather than being on "normal" mode.

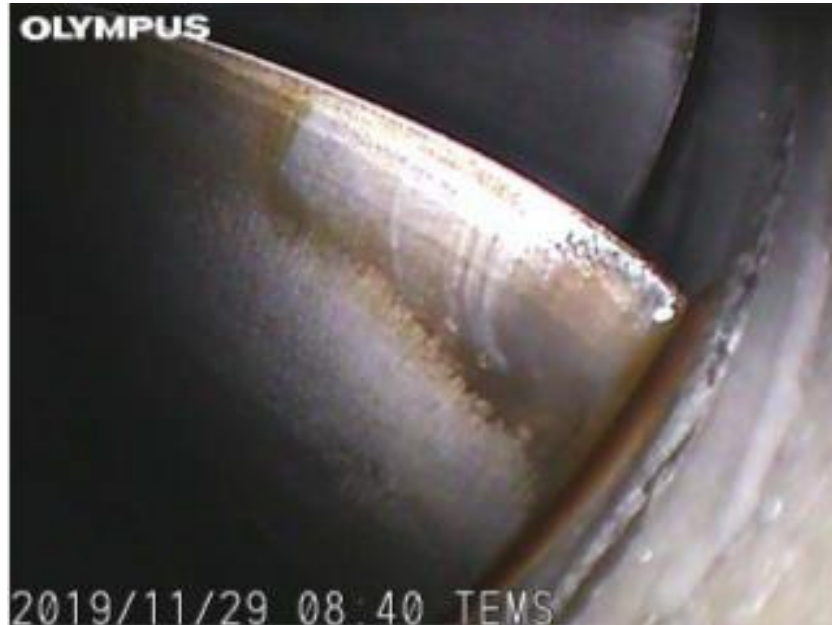
1.6.6 The AMO conducted another borescope inspection on 29 November 2019 to inspect the internal components of the number 1 engine, with job card number T2143, by Turbine Engine Management Services (Pty) Ltd. The borescope inspection, once again, revealed that there was a leak around the HP impeller flutes and diffuser entry points and there was presence of oil in the HPC impeller. (See Figures 2 and 3)

Figure 2: The high-pressure compressor (HPC) / impeller blade with oil on it.

2.2.14 The investigation revealed that during the take-off roll, the crew experienced an oil smell and smoke in the cockpit as a result of the number 3 bearing labyrinth seal failure of number 1 engine. This caused the oil to leak into the HPC and the oil mixed with compressed and heated air, resulting in the oil smell and smoke in the cockpit.

1.6.7 Following the second borescope inspection results, the maintenance organisation and the operator took a decision to remove the defective number 1 engine from the aircraft ZS-CAR and the defective engine was shipped to the manufacturer to establish the cause of the oil leak and the presence of oil in the HPC impeller.

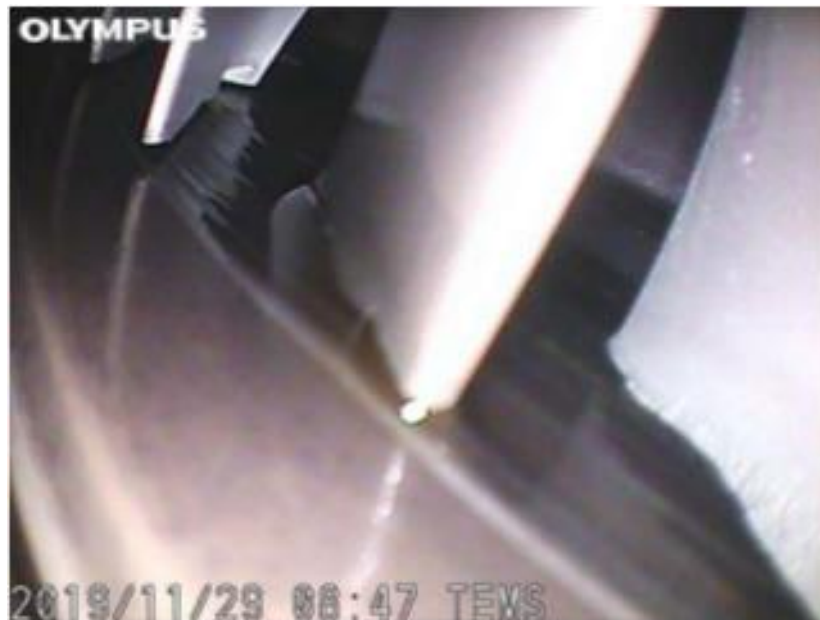
Figure 3: The HPC / impeller blade with evidence of oil on it.

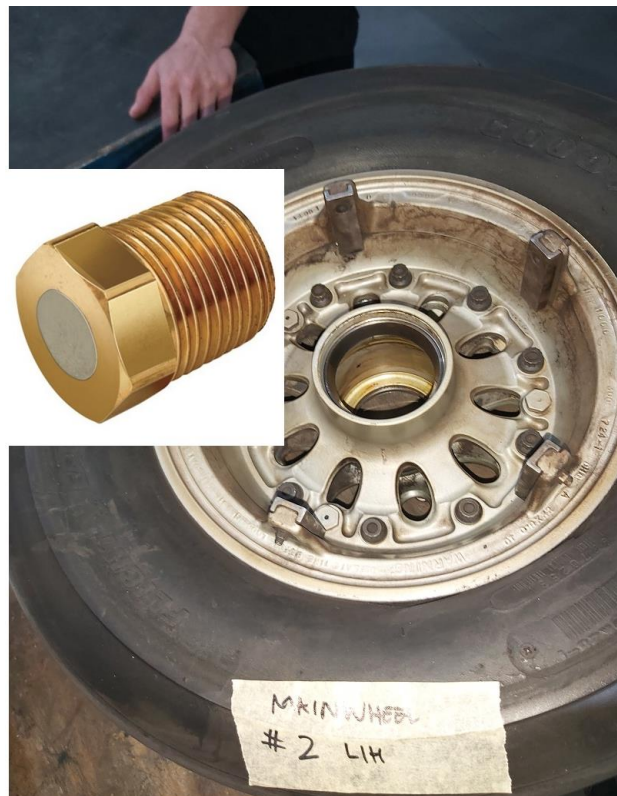
1.12.1 The crew aborted take-off on 8 November 2019 on Runway 07 at FALA due to smoke and oil smell in the cockpit. The crew taxied the aircraft to the hangar. On inspection of the aircraft, it was found that the right main landing gear tyre had deflated and, shortly after, the left main landing gear tyre also deflated due to the melting of fuse plugs, which is normal when the wheel assembly was subjected to excessive heat during braking.

Figure 5: Fuse plug on aircraft tyre.

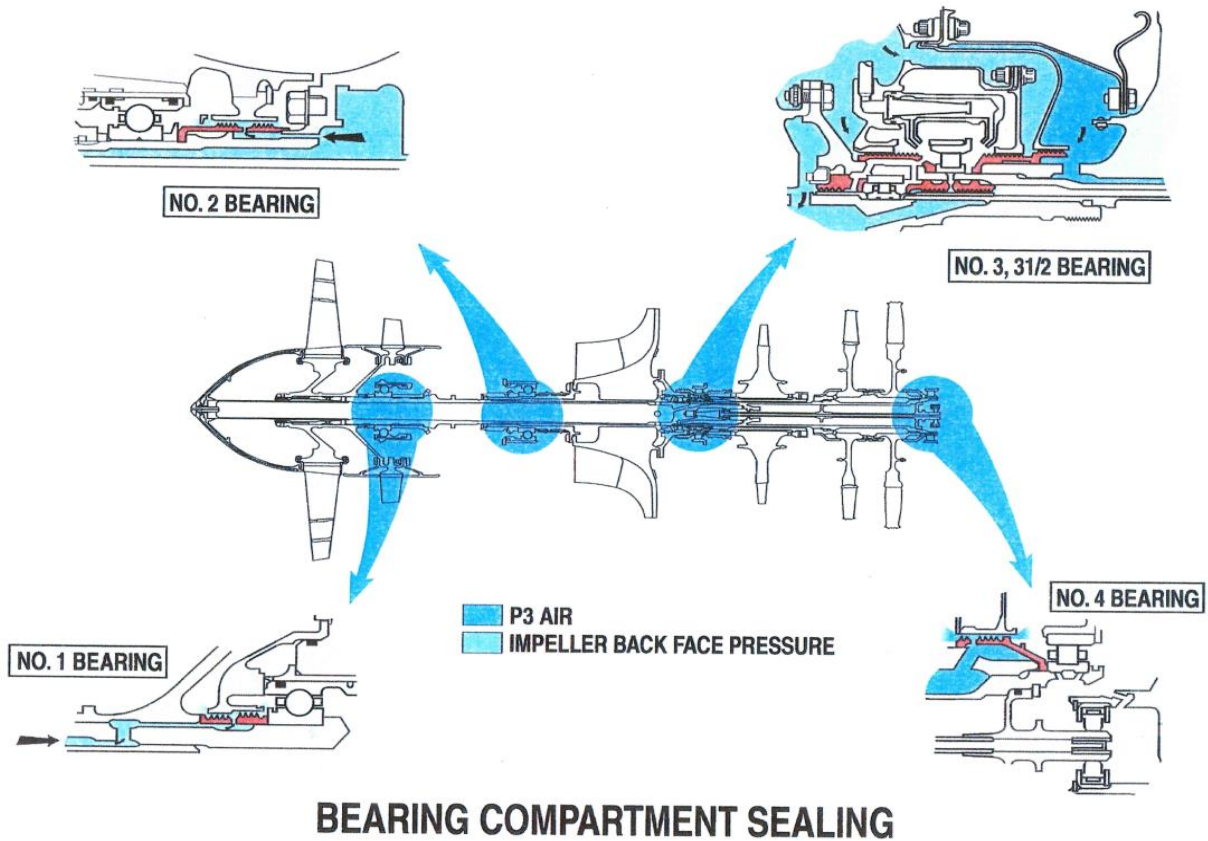
Figure 8. Bearing compartment sealing showing source of leak on bearing number 3. (Source: JT5D-1/1A/1B/4/4B/4D engine training manual)

3.2.16 The investigation revealed that during the take-off roll, the crew experienced an oil smell and smoke in the cockpit as a result of the number 3 bearing labyrinth seal failure of engine number 1. This caused the oil to leak into the high-pressure compressor and the oil mixed with compressed and heated air, resulting in the oil smell and smoke in the cockpit.
