AIRCRAFT INCIDENT SHORT REPORT

CA18/3/2/1292: Uncontained engine failure during flight as a result of separation of the No. 4 connecting rod big end bearing cap.

Date and time : 29 November 2019 at 1246Z
Location : En route to Port Elizabeth Aerodrome (FAPE)
Aircraft registration : ZS-EZK
Aircraft manufacturer and model : Cessna 206C
Last point of departure : Port Elizabeth Aerodrome (FAPE)
Next point of intended landing : Port Elizabeth Aerodrome (FAPE)
Location of incident site with reference to easily defined geographical points (GPS readings if possible) : S33°59'24.0" E026°36'.37.0" at an elevation of 226 ft AMSL
Meteorological information : Temperature: 24°C, Visibility: 10km CAVOK
Type of operation : Aerial Work (Part 137)
Persons on-board : 1 + 1
Injuries : None
Damage to aircraft : Damage limited to engine

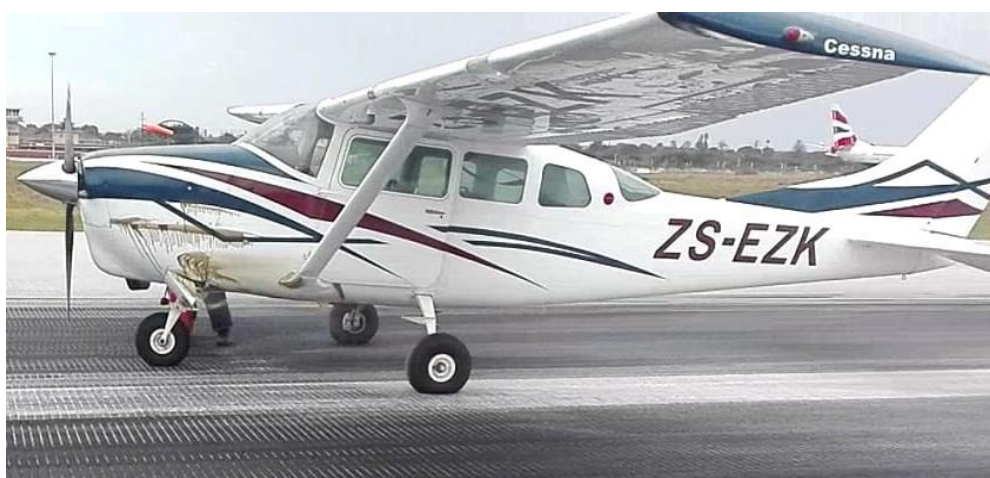
- 2.4 The engine continued to run, and the pilot reduced the power to avoid further damage. The pilot broadcasted a MAYDAY call to the ATC informing them of the situation and requested to proceed straight for Runway 26. The aircraft was cleared to land, and the Aircraft Rescue and Firefighting (ARFF) service was alerted by the ATC. About 3 minutes later, another loud bang was heard from the engine. Oil leaked to the cowlings, followed by loss of engine power which was indicated by a drop in manifold pressure. The pilot reported that he managed to keep control of the aircraft and used the available engine power to perform a safe landing on Runway 26. No injuries were reported, and the aircraft damage was limited to the engine. The aircraft was operated under the provisions of Part 137 of the South African Civil Aviation Regulations of 2011 as amended.

Figure 2: The aircraft post-incident. (Source: Operator)

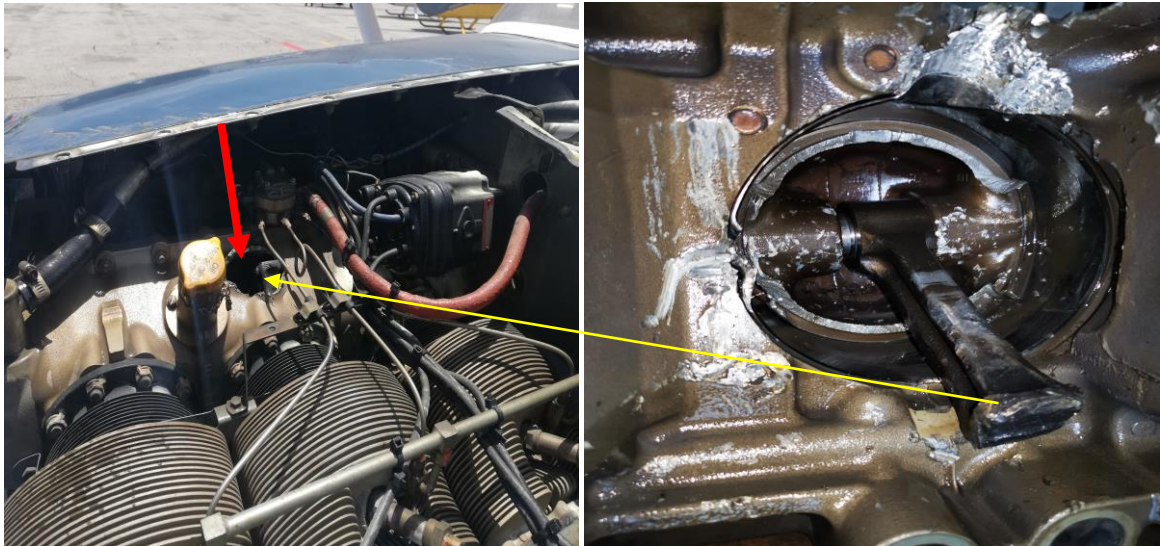
3.2 The engine was installed on the aircraft at zero hours (new) on 20 July 2017 at 18993.95 recorded tachometer hours. The aircraft had accumulated a total of 19735.04 tachometer hours at the time of the incident and the engine had accumulated 741.09 hours. The engine time between overhaul (TBO) is 1600 hours or 12 years, whichever occurs first. The engine was examined after the incident and a hole was noted on the top left side of the crankcase; it was apparent that it was caused by the No. 4 connecting rod. Oil was forced out of the crankcase and had escaped through the gaps of the engine cowlings and had spread onto the windscreen. Licensed engineers from the supporting aircraft maintenance organisation (AMO) at FAPE were ordered to remove the engine, which was later transported to an independent engine overhaul facility at Springs Aerodrome (FASI) for a teardown examination. The teardown examination revealed that the No. 4 connecting rod and piston had disconnected from the crankshaft journal. The connecting rod shaft was found fractured. Cylinders No.1, 2, 3, 5 and 6 were not compromised.

3.4 The overall condition of the overhauled engine oil sump showed no defects and there was a small amount of oil remaining, which is consistent with Standard Aerospace Equipment (SAE) 100 Grade mineral oil. Some metallic debris, which was found in the oil sump, was examined and it was discovered that it originated from the connecting rod shaft and the aluminium crankcase.

Figures 6/7: A hole on the crankcase top left area (left) and the No.4 piston showing a fractured connecting rod shaft (right).

3.6 The connecting rod bolts, bearings and nuts were not found during the teardown inspection. Engineers who removed the engine at FAPE indicated that nothing originating from the connecting rod was found in the engine compartment. Most of the debris appeared to have been ejected through the hole on the crankcase. The engine oil filter element was examined, and it showed evidence of significant deposits of a material with copper and

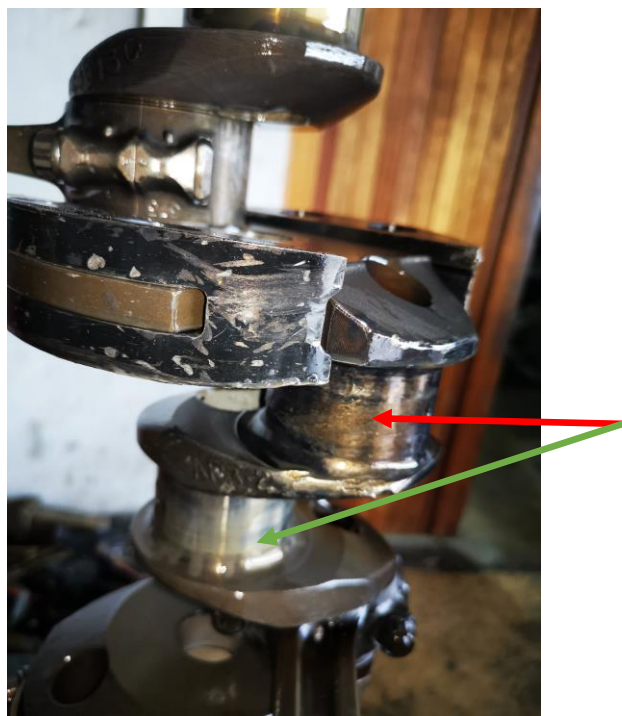
3.5 Evidence of heat discolouration was noted on the No.4 connecting rod journal area (see Figure 7). Oil to the connecting rod bearings is supplied via drilled holes on the crankshaft journal. The holes were inspected and were found to be free from obstruction. This suggested that there was no restriction of oil supply to the crankshaft and that oil starvation was limited to the No.4 connecting rod journal area.

Figures 8: Heat discolouration noted on the connecting rod No. 4 crankshaft journal area.

- 3.8 The oil sump is equipped with an oil level dipstick or gauge notched and stamped with numerals representing quarts. According to the Continental Engine Operation and Installation Manual (page 12-00-03), the engine requires a minimum of 6 quarts of useable oil in the sump, including the one in the oil filter so it can function properly in all flight attitudes and atmospheric conditions in which the aircraft is expected to operate. The engine oil consumption, in accordance with (IAW) Lycoming's Service Instruction No - 1427C dated 29 December 2010, was calculated to be 0.9 quarts per hour ($0,006 \times 285\text{BHP} \times 4 \div 7.4 = 0.92$ quarts per hour), meaning that an uplift of 1 quart of oil was required for every 6 hours of operation. Between 17 and 22 November 2019, a total of 31.51 hours was flown in six sorties with no oil upliftment recorded. The incident happened during the last flight at 741.09 total engine hours, at which point the No.4 connecting rod detached from the crankshaft journal. The 31.51 hours flown after the 50-hour oil change showed that the engine had consumed about 5.25 quarts of oil from the initial 9 quarts that was uplifted on 13 November 2019. Heat discolouration was noted on the camshaft of the No.4 journal area.

- 3.9 This was an indication that the engine was operated with less than the minimum required quantity (below 6 quarts) of oil in the sump, which contributed to inadequate oil film or lubrication that caused excessive heat concentration on the No.4 connecting rod big end journal area. This suggested that the pilot did not confirm the oil level using the dipstick prior to the incident flight. The absence of adequate oil film between the bearing and the

journal created metal-to-metal contact, thus, causing the metal to expand, either compressing the aluminium of the connecting rod bearing cap or stretching the steel bolts, causing them to lose their pre-load, at which point they started backing out. The engine continued to run with the loose bearing cap until the bolts became completely loose as the connecting rod was stretched and compressed at every stroke.

- 5.1 The No.4 connecting rod had failed due to excessive heat that was concentrated on the No. 4 camshaft journal area as a result of oil starvation.
