AIRCRAFT SERIOUS INCIDENT SHORT REPORT

CA18/3/2/1294: The propeller separated from the crank shaft flange in-flight and the pilot executed a forced landing on a farm.

Aircraft registration : ZU-CUN

Aircraft manufacturer and model : Zenith Air, Zodiac CH-601 XL

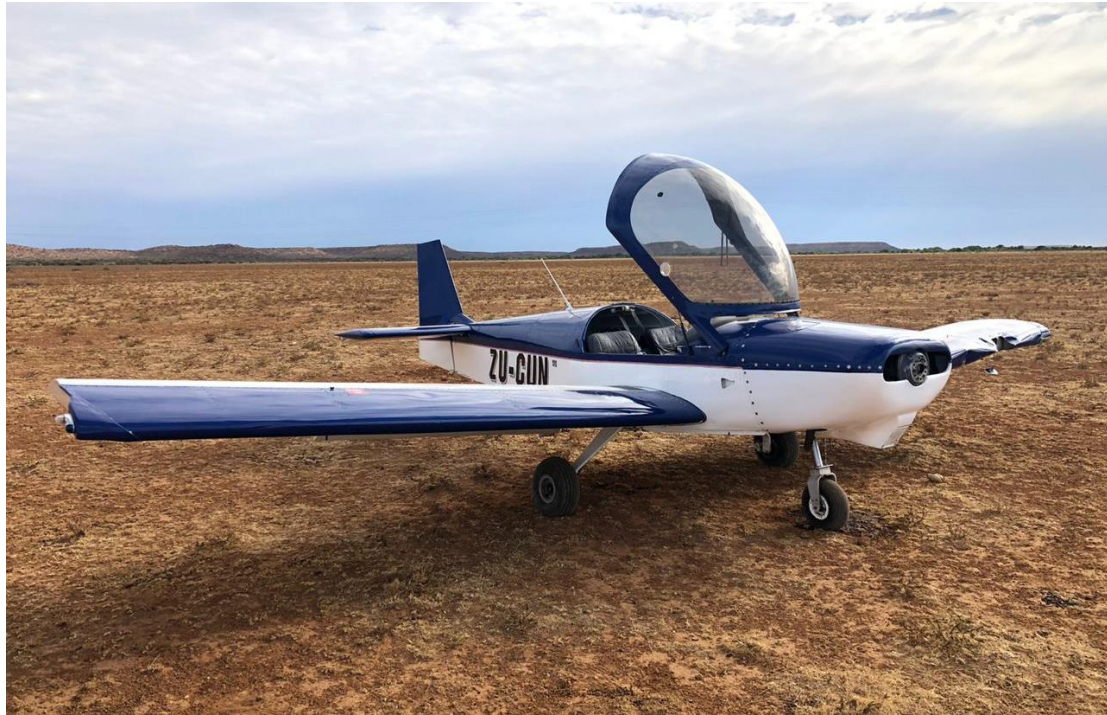
Figure 1: The aircraft at the incident site. (Photograph was taken on-site by the pilot)

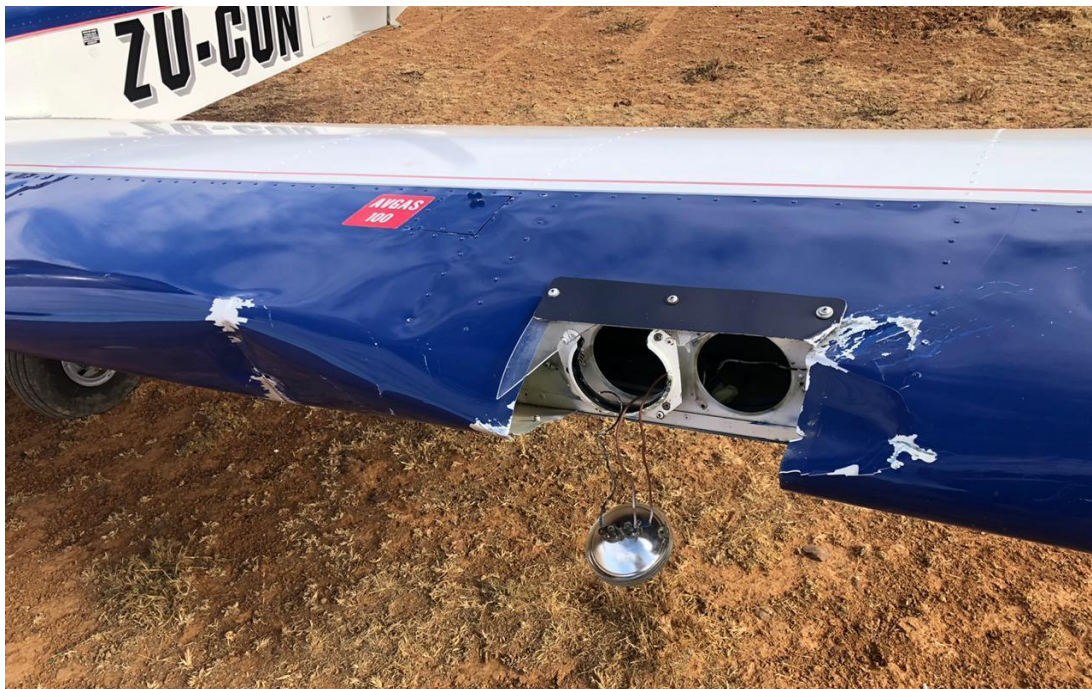
- 2.1.3 He then declared an emergency by broadcasting a Mayday three times on the Johannesburg radar west frequency, stating that he was going to execute a forced landing in an open field near Spitskop Dam. After the aircraft was brought to a stop, he again broadcast on the same frequency that he was safe on the ground. His message was relayed to the Johannesburg radar by the crew of another aircraft — ZS-SST, a Cessna T206H — which was flying in the Kimberley area at the time. The pilot was not injured during the forced landing, but the aircraft sustained minor damage when the left wing impacted a perimeter fence post (see Figure 2).

Figure 2: Damage to the left wing caused by impact with a fence post. (Photograph was taken on-site by the pilot)

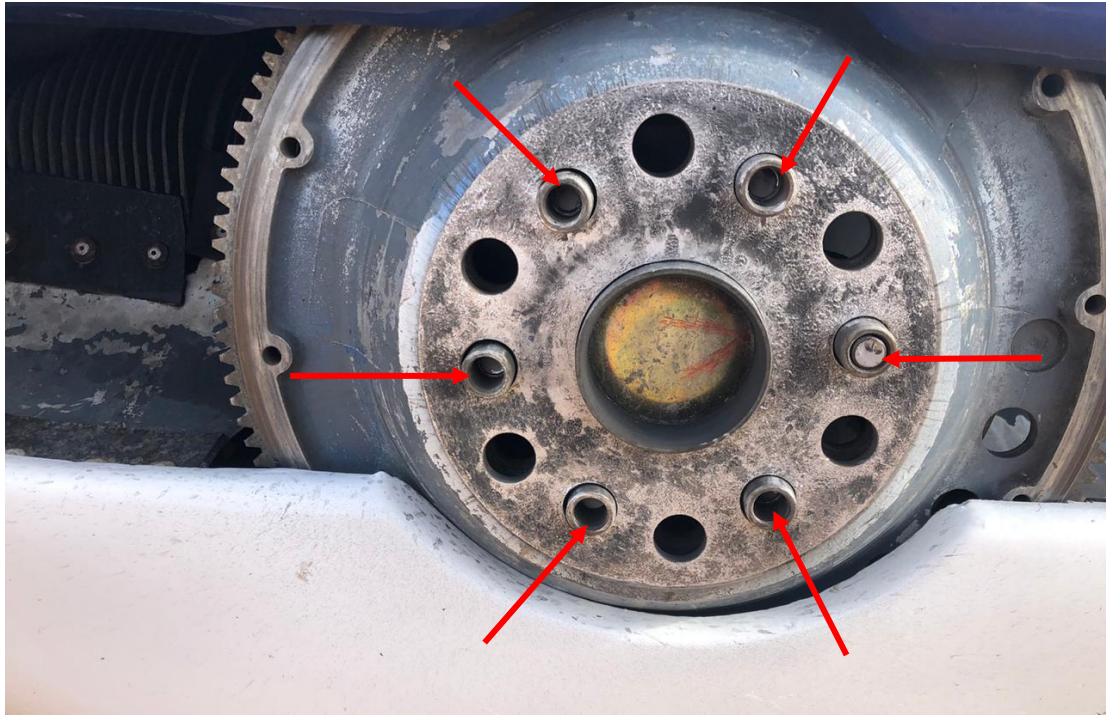
2.1.9 The six drive bushes as well as the flywheel/ring gear depicted in Figure 3 were taken to a laboratory for microscopy and microanalysis examination, which concluded the following:

- (i) *“Considering the noted elongation damages at all 6 flywheel holes, it can be derived that **under-torque** of the attachment bolts allowed for movement of the drive bushes in the rotational plane while under an applied load (engine).*

- (ii) *The extent of the elongation damages at the locating drive bush location again suggest **under-torque** as the primary contributing factor while the damages at the remaining 5 positions suggest a combination of **under-torque and bush/flywheel hole dimensional variations**. The reason for the latter discrepancy could not be ascertained by this investigation.*

- (iii) *Contributing to the above is the use of a singular locating drive bush thus allowing for radial movement of the remaining 5 bushes within the rotational plane under load.*

- (iv) *The resultant detrimental influence on propeller vibration due to the loosened attachment bolt and drive bush movement undoubtedly enhanced the fatigue fracture initiation and progression rate.”*

Figure 3: The six drive bushes protruding through the flywheel/ring gear. (Photograph was taken on-site by the pilot)

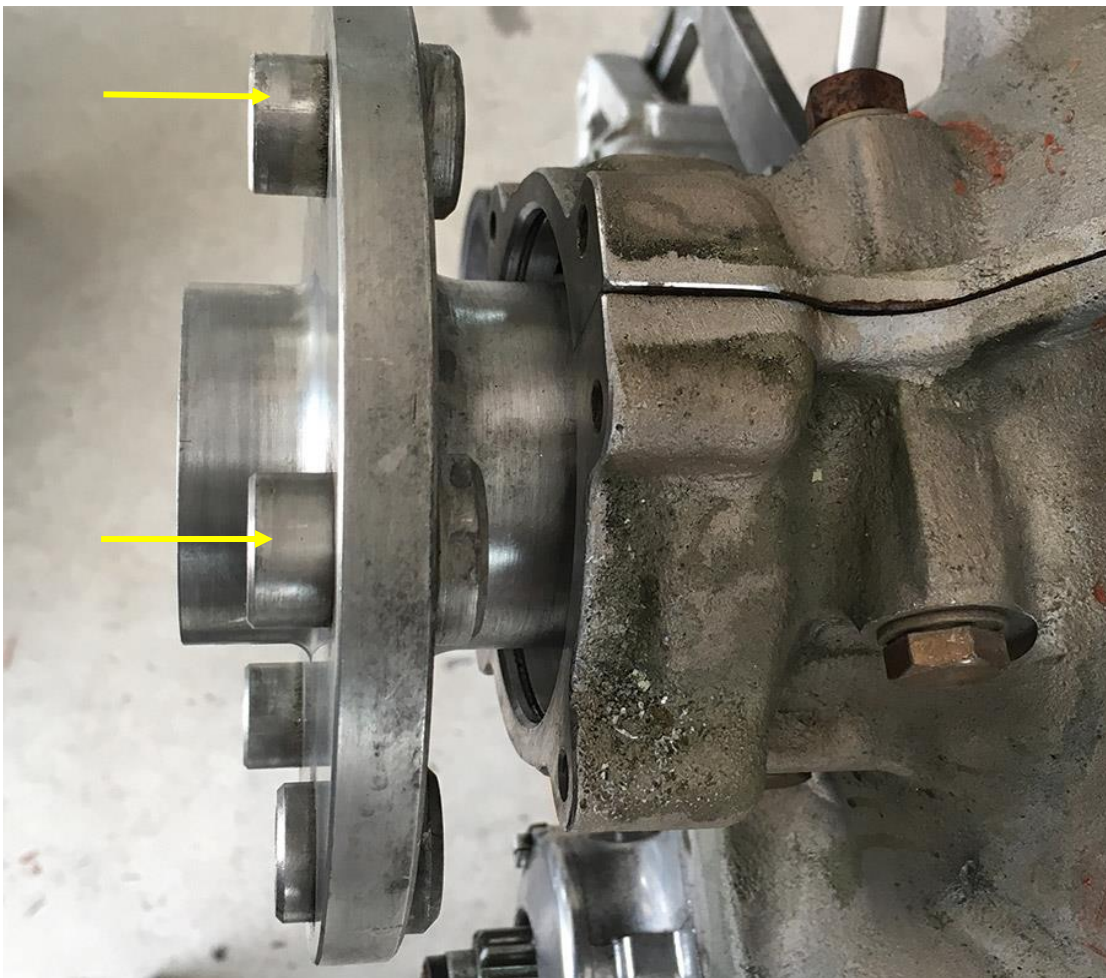
Figure 4: A view of the crankshaft flange with some of the drive bushes indicated by yellow arrows.

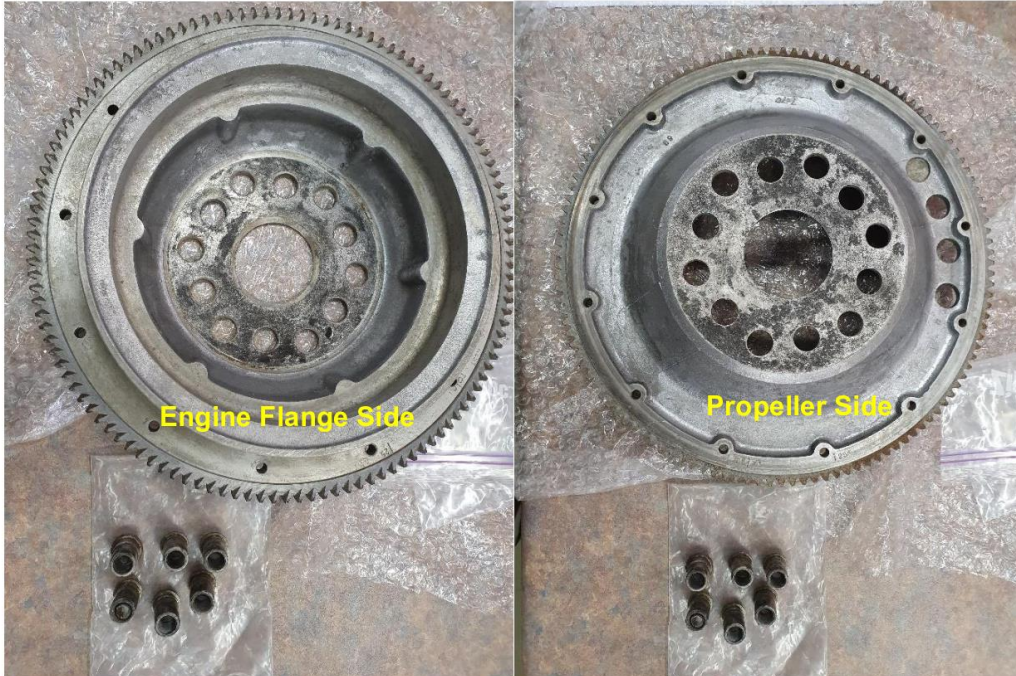
The visual inspection revealed 6x fractured propeller attachment bolts with failures initiated within the threaded sections (Photo's 2, 3 and 4) in proximity of the flywheel/starter ring assembly (Diagram 1).

Photo 3: Flywheel/Starter Ring assembly, as received (digital)

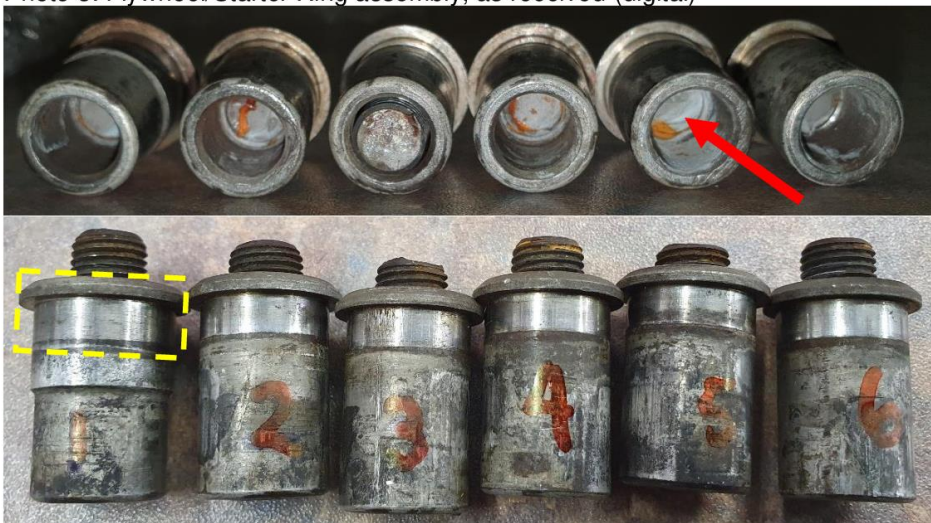
Notwithstanding corrosion damages inflicted post-failure, selected bolt fracture surfaces revealed indications towards a **fatigue failure mode** (Photo's 4 and 7).

Indications of extensive mechanical wear were noted on all 6 bushes at the drive bush/flywheel hole interfaces (Photo 4, yellow square).

Photo 4: DriveBushes, surface conditions and geometries (digital)

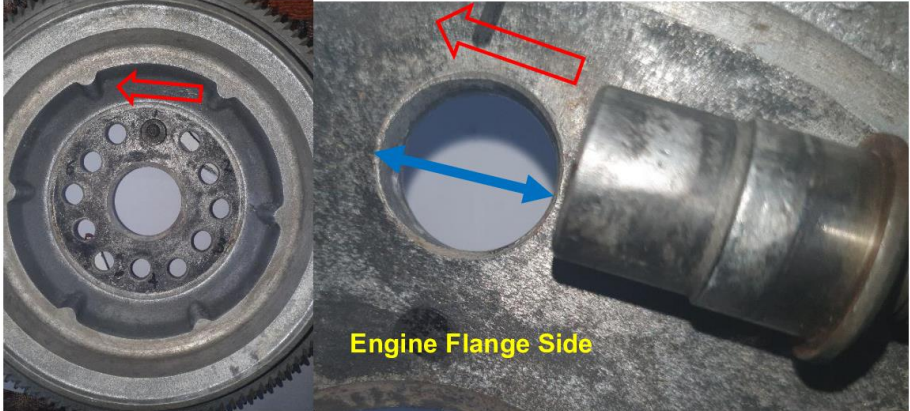
Inspection of the No 1 locating drive bush revealed extensive elongation damages to the flywheel hole (Photo 5, blue arrow) with corresponding damages to the remaining 5 positions.

The noted plastic deformation on the propeller side of the No 1 locating bush flywheel hole (Photo 6, red arrow) suggest an applied operational load in the direction as indicated (Photo 5, red arrows).

Photo 5: Locating Bush position; Flywheel hole elongation damages (digital)

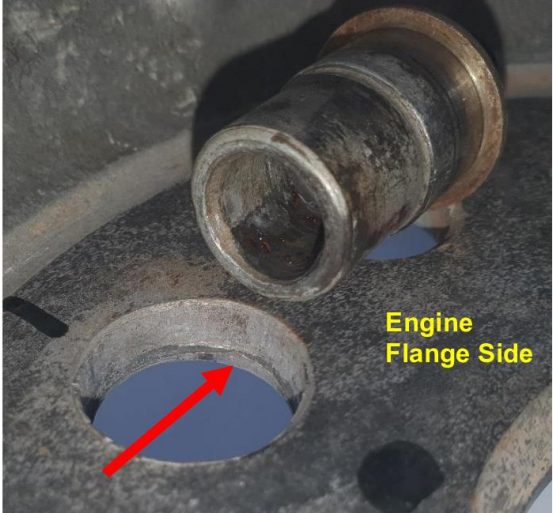
Photo 6: Locating Bush position showing mechanical smearing/lip (Stereo)

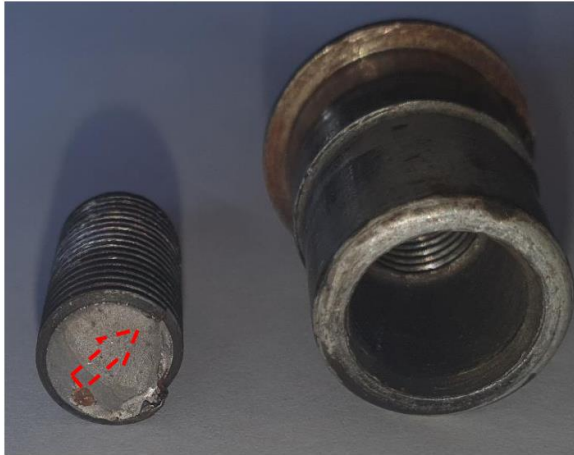
The locating drive bush bolt fracture surface revealed indications of a **fatigue mode of failure** initiating at the thread root area and progressing as indicated (Photo 7, red dashed arrow). A dimensional inspection revealed a **2.5%** clearance between the flywheel hole and the locating drive bush (Table 1). This clearance can be attributed to the extensive elongation damages noted at this position.

Photo 7: Locating Bush and Bolt Fracture surface (digital)

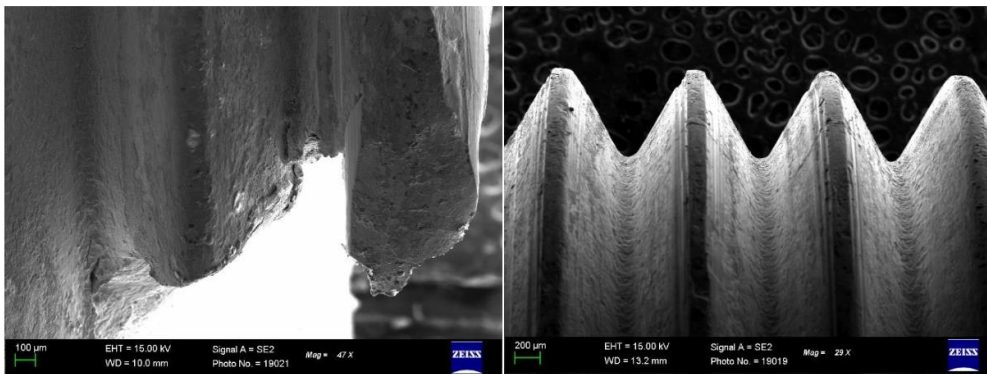
The threaded sections revealed no clear indications of over-torque induced damages (Fractograph 1).

Fractograph 1: Threaded section conditions (29-47X, 15kV, SE, FEGSEM)

However, the condition of the various threaded sections does not suggest over-torque during fitment to be a possible contributing cause i.e. lack of secondary fracture initiation/s, plastic deformation of the thread/s, thread surface damage/s.

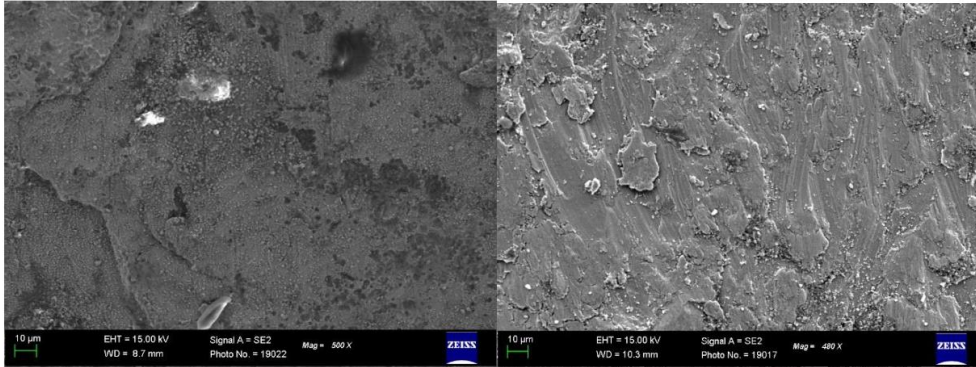
The drive bush/flywheel hole contact surface revealed extensive mechanical smearing damages (Fractograph 2).

Fractograph 2: Drive Bush contact surfaces showing mechanical- and corrosion damages (480-500X, 15kV, SE, FEGSEM)

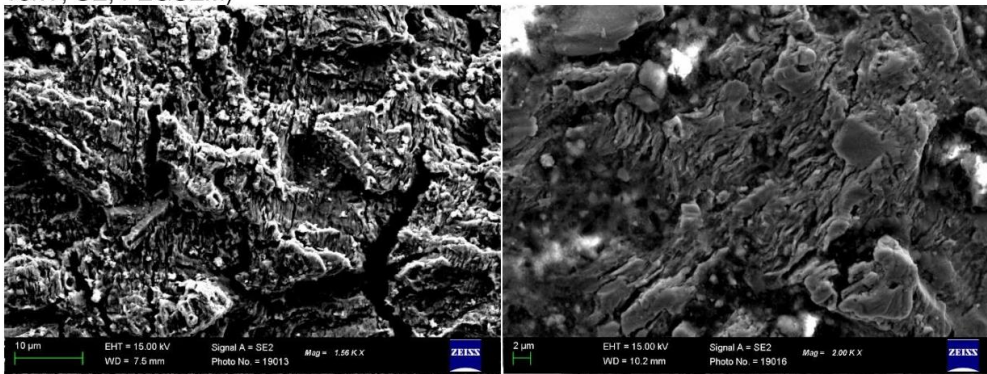
The SEM analysis of the bolt fracture surfaces revealed **fatigue** fracture initiations thus confirming the **failure mode** (Fractograph 3).

Fractograph 3: Bolt fracture surfaces showing fatigue striations (1560-2000X, 15kV, SE, FEGSEM)
