AIRCRAFT SERIOUS INCIDENT REPORT AND EXECUTIVE SUMMARY

Reference:		CA18/3/2/1297	
Aircraft Registration	ZS-ZWT	Date of Serious Incident	16 December 2019	Time of Serious Incident	0536Z
Type of Aircraft	Boeing 737-800	Type of Operation	Air Transport Operation (Part 121)		
Pilot-in-Command Licence Type	Airline Transport Pilot Licence	Age	60	Licence Valid	Yes
Pilot-in-command Flying Experience	Total Flying Hours	16232.3	Hours on Type	11071.5	
Last Point of Departure	O.R. Tambo International Aerodrome (FAOR), Gauteng Province				
Next Point of Intended Landing	King Shaka International Aerodrome (FALE), Kwa-Zulu Natal Province				
Location of the serious incident site with reference to easily defined geographical points (GPS readings if possible)					
At or near the STV VOR in Standerton at the following GPS position (26°41'40.58" S 28°51'59.70" E					
Meteorological Information	Wind: Variable at 5kts, Temperature: 16°C, Dew Point: .4°C, Visibility: 9999m, QNH: 1023hPa

DESCRIPTION OF SERIOUS INCIDENT

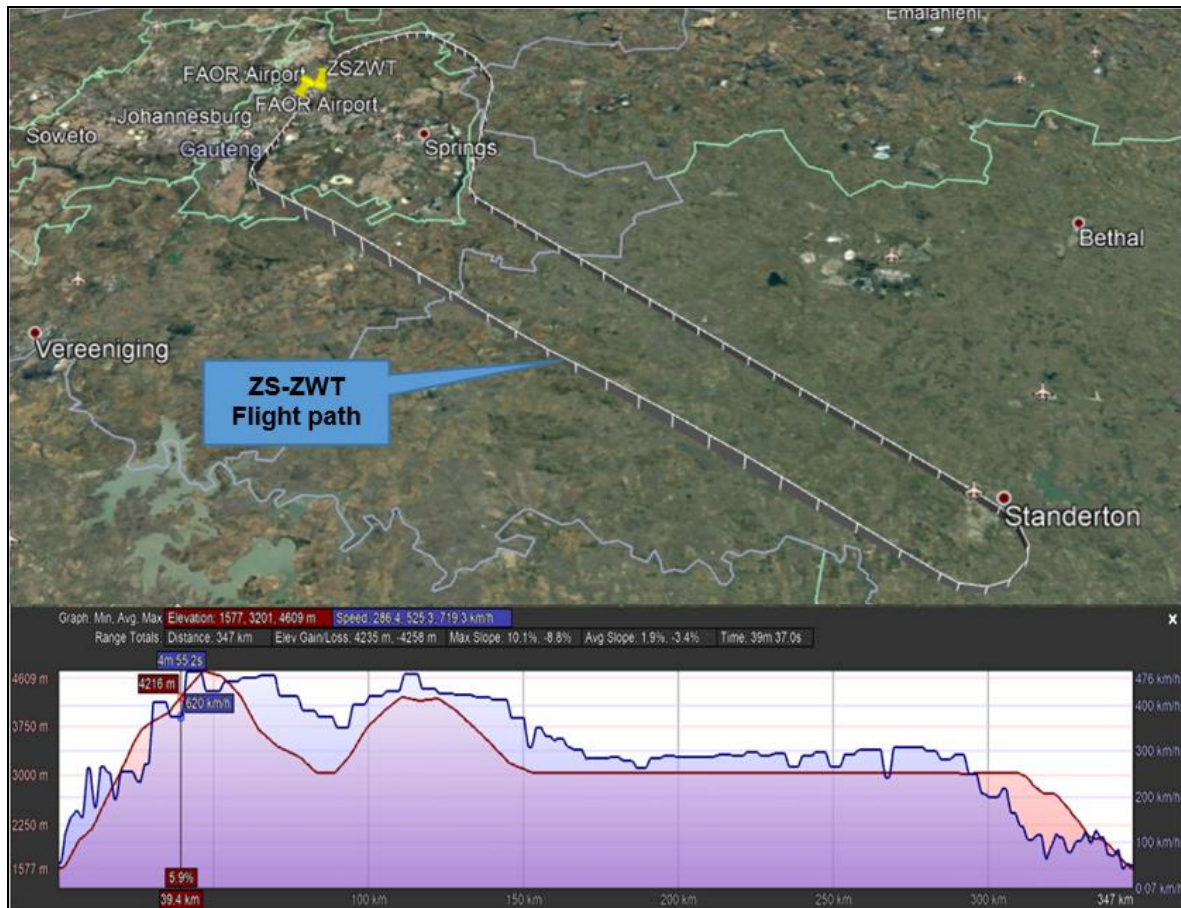
Figure 1: The flight path and elevation profile of ZS-ZWT from Flight Aware. (superimposed on Google Earth)

- 2.4.2. It is likely that the flight crew's actions temporarily resolved the cabin altitude fault as the aircraft began to climb again, shown by the second peak on the flight path and elevation profile diagram. The profile shows the aircraft reaching FL130. It is most likely that the cabin altitude fault warning came on again. It is highly probable that the flight crew executed the AUTO FAIL checklist procedures and were not able to restore the aircraft's standard cabin pressure when the emergency was declared by broadcasting a PAN-PAN-PAN, followed by the second emergency descent to FL100. The crew requested clearance from ATC to allow them to execute an air-turn back to FAOR.
