AIRCRAFT SERIOUS INCIDENT REPORT AND EXECUTIVE SUMMARY

Reference:		CA18/3/2/1298	
Aircraft Registration	ZS-MIN	Date of Incident	4 December 2019		Time of Incident	1035Z
Type of Aircraft	Beechcraft King Air B200		Type of Operation		Commercial (Part 135)	
Pilot-in-command Licence Type	Airline Transport Pilot Licence	Age	48		Licence Valid	Yes
Pilot-in-command Flying Experience	Total Flying Hours	9 140		Hours on Type	2 388	
Last Point of Departure	Virginia Aerodrome (FAVG): Kwa-Zulu Natal Province					
Next Point of Intended Landing	Hoedspruit Aerodrome (FAHT): Limpopo Province					
Location of the incident site with reference to easily defined geographical points (GPS readings if possible)						
En-route from FAVG to FAHT at flight level (FL) 250, at position R025 DME50nm from King Shaka International Aerodrome (FALE)						
Meteorological Information	Wind: Westerly at 70kts; Temperature: -15°C, Visibility: 9999m, Cloud: Overcast and Layered at FL250

Reference Number : CA18/3/2/1298
Name of Owner : Mkhombe Investments (PTY) LTD
Name of Operator : KZN Aviation (PTY) LTD
Manufacturer : Beechcraft Aircraft Corporation
Model : B200
Nationality : South African
Registration Marks : ZS-MIN
P

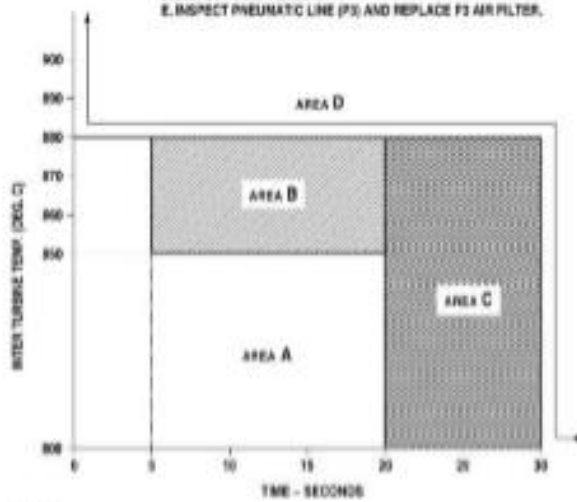
**Figure 501 Overtemperature Limits - All Conditions Except Starting
(sheet 3 of 3)**

- 2.1.6 According to the over-temperature limit in *Figure 501* in the engine report attached as Appendix B, if an engine had an ITT which is beyond allowable temperature between 0 and 30 seconds which is in the “D” area of the graph, the operator should remove the engine and ship it to the approved overhaul facility for HSI. According to the engine maintenance manual part number 3021442, most significant blade tip damages increases ITT, and even if the ITT is below maximum and CT blades damage is beyond the limit shown in *Figure 608* of Appendix B, it is recommended that the operator conducts an HSI. Post serious incident, the right-side engine was subjected to a borescope inspection and it was noted that there were open cracks on the CT blade tips. It is possible that the CT blades were already cracked, and ingestion of ice particles contributed in the ITT which had increased beyond limits.

- AREA A NO ACTION REQUIRED
- AREA B 1. DETERMINE AND CORRECT CAUSE OF OVERTEMPERATURE (REF. CHAP. 73-83-00, INSPECTION, UNSCHEDULED INSPECTION)
2. RECORD IN ENGINE LOG BOOK.
- AREA C DO HOT SECTION INSPECTION.
- AREA D 1. RETURN ENGINE TO AN APPROVED OVERHAUL FACILITY.
2. FOR OPERATORS UTILIZING THE MODULAR PROGRAM:
 - A. DO HOT SECTION INSPECTION.
 - B. RETURN POWER SECTION TO OVERHAUL FACILITY.
 - C. RETURN FUEL CONTROL UNIT TO OVERHAUL FACILITY.
 - D. INSPECT COMPRESSOR.
 - E. INSPECT PNEUMATIC LINE (PS) AND REPLACE P3 AIR FILTER.

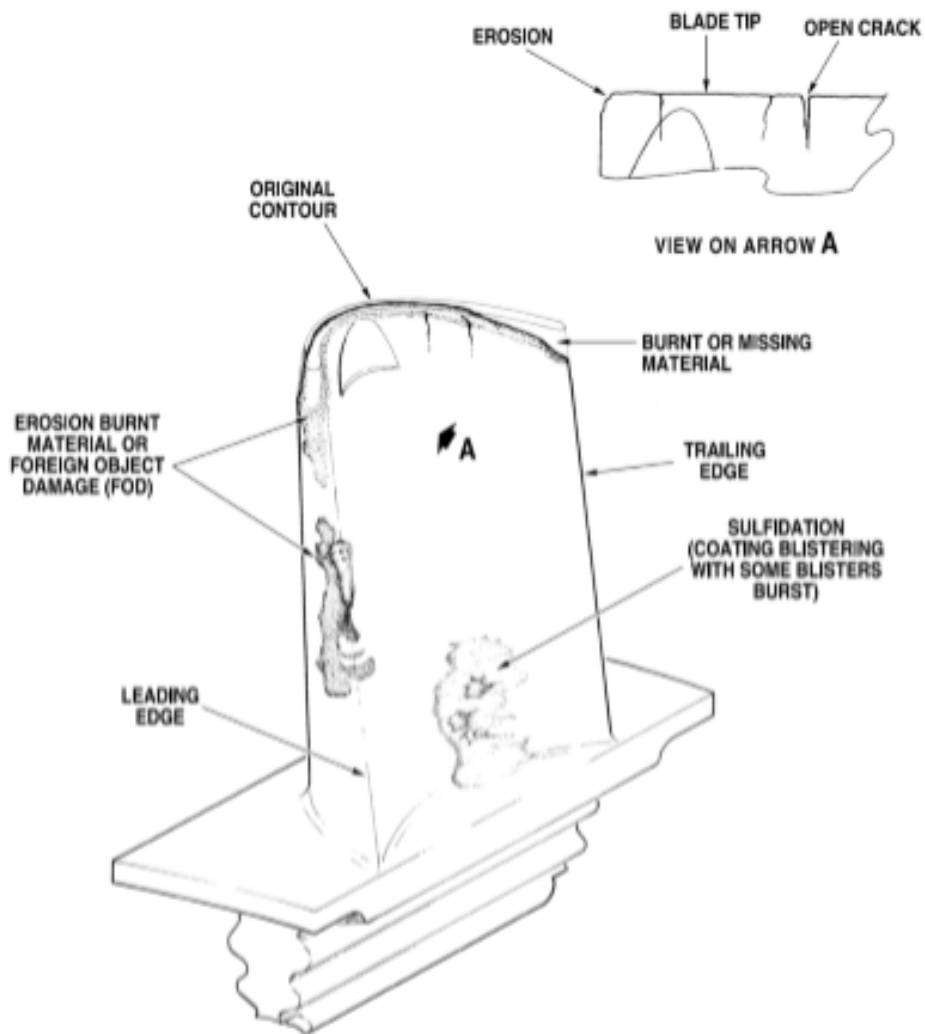
Figure 608 CT Blade Damage - Unacceptable

Hot Section – No Major heat erosion or cracks noted on CTVR and SED. Shrouds intact with no major rub observed between CT Blades and Shrouds. Low carbon content in CC liner with no visible cracks noted. No FOD or heat erosion noted on PT Blades. Open cracks noted on the CT Blade tips.

Hot section repair (Light Overhaul as per PWC Maintenance requirements for Overtemp condition) is required at this time due to the condition of the CT Blade tips. Crew reported engine Stall at cruise. The throttle was retarded to reduce the stall condition. The crew then noticed a climb in ITT, they noticed 950 deg C for 5 seconds. The Prop was feathered, and engine shut down at this time.

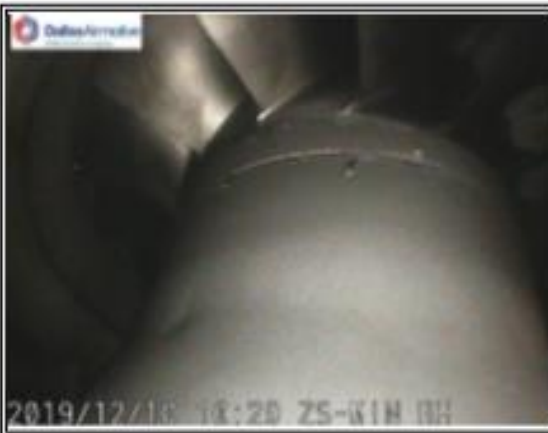
Inlet Case

Cold Section – No Oil leakage noted. Minor Paint Flaking from Inlet. No FOD noted on Compressor Blades.

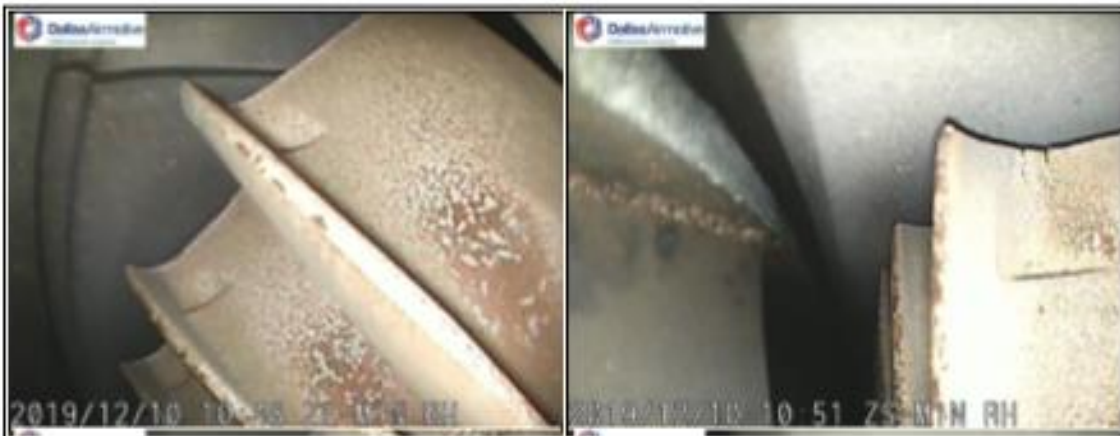
CT Blades

- 3.4.1 Non-adherence to standard operating procedures.
- 3.4.2 It is possible that the CT blades were already cracked, and ingestion of ice particles contributed in the ITT which had increased beyond limits.
