AIRCRAFT SERIOUS INCIDENT REPORT AND EXECUTIVE SUMMARY

Reference:	CA18/3/2/1299	
Aircraft Registration	ZS-DMI	Date of Incident	10 December 2019		Time of Incident	0448Z
Type of Aircraft	Boeing 737-400		Type of Operation		Air Transport Operation (Part 121)	
Pilot-in-command Licence Type	Airline Transport Pilot Licence		Age	46	Licence Valid	Yes
Pilot-in-command Flying Experience	Total Flying Hours		15 791.0		Hours on Type	381.0
Last Point of Departure	O.R. Tambo International Aerodrome (FAOR), Gauteng Province					
Next Point of Intended Landing	Port Elizabeth Aerodrome (FAPE), Eastern Cape Province					
Location of the incident site with reference to easily defined geographical points (GPS readings if possible)						
En route from FAOR to FAPE, Heilbron area (GPS position: 27°10'28.44" South 028°09'04.89" East)						
Meteorological Information	Surface wind: 050°/9kts, temperature: 13°C, dew point: 13°C, overcast and rain					
Number of People On-board	6 + 166	No. of People Injured	0	No. of People Killed	0

Synopsis	<p>On Tuesday morning 10 December 2019 at approximately 0436Z, a Boeing 737-400 aircraft with registration ZS-DMI departed O.R. Tambo International Aerodrome (FAOR) using

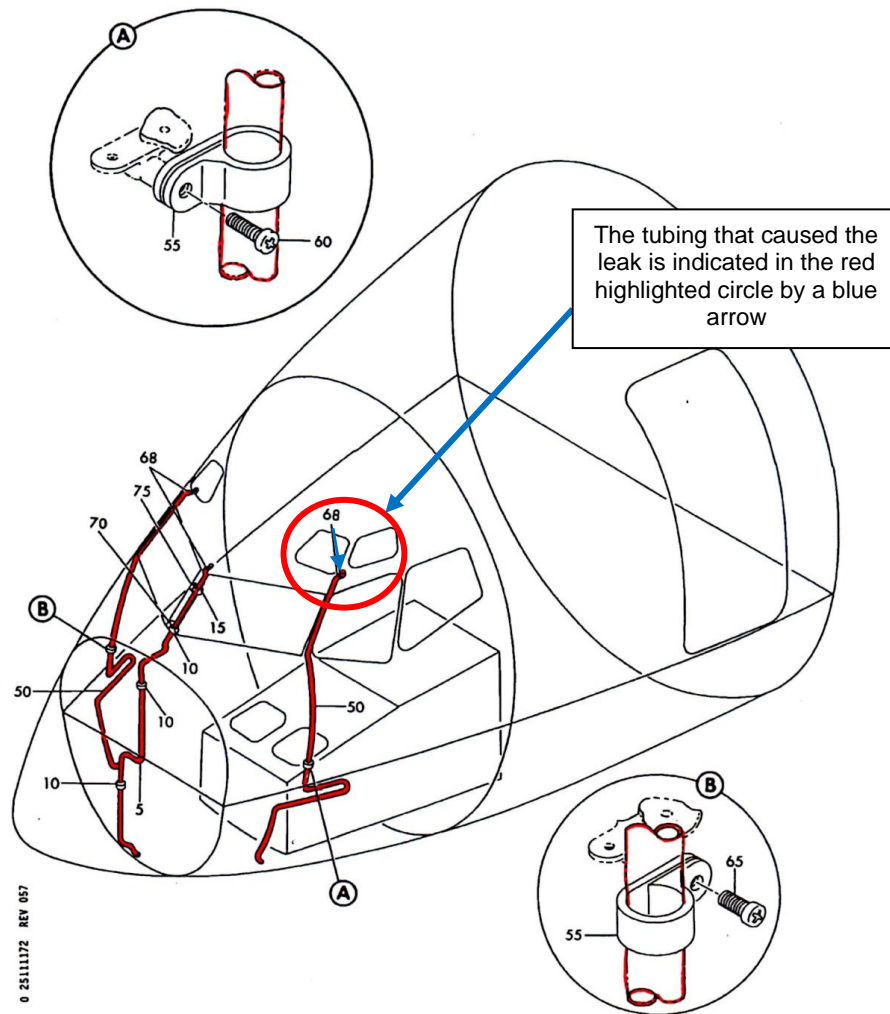
TUBING INSTL-CONT CAB. OVERHEAD DRAIN
FIGURE 72

Figure 2: Schematic of the tubing installation of the overhead cockpit drip pan (water drainage).

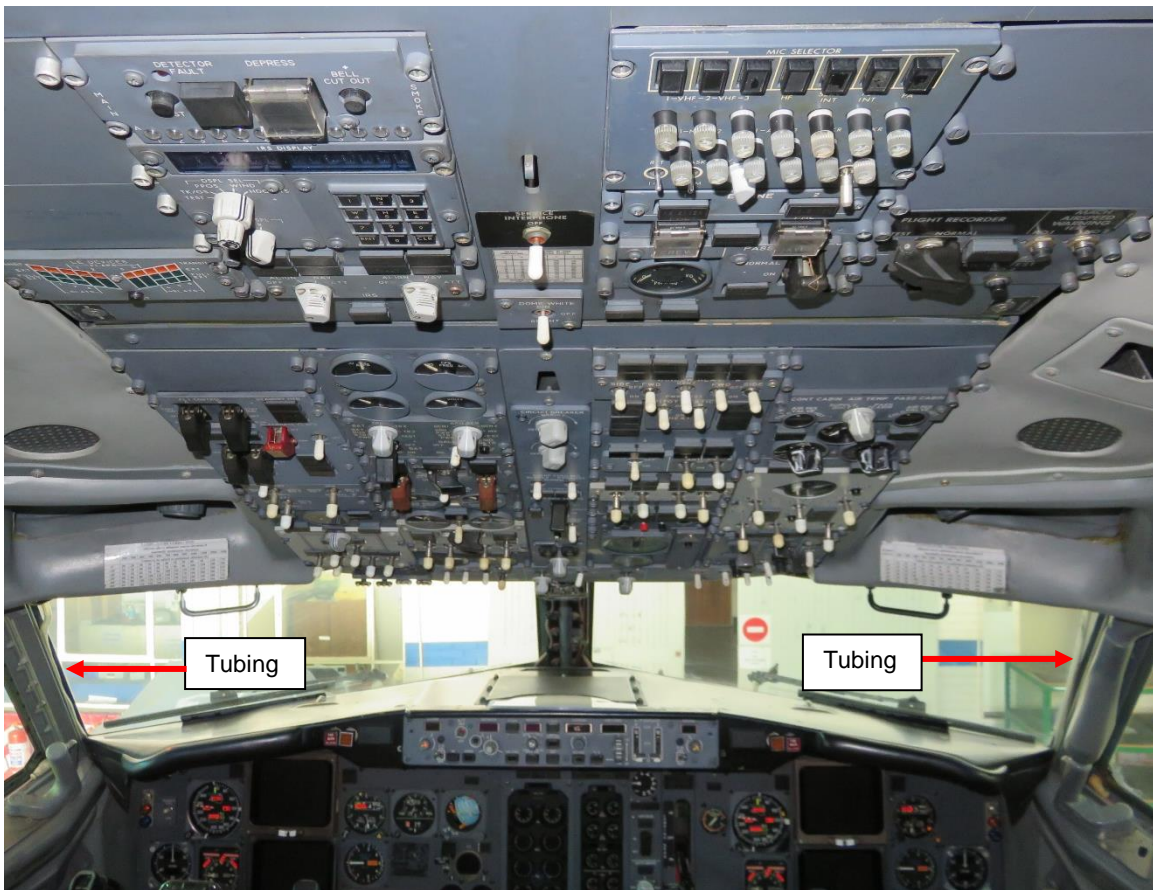
Figure 4: Cockpit of a Boeing 737-400 with the tubing (drain pipes) visible on both sides (see red arrows).

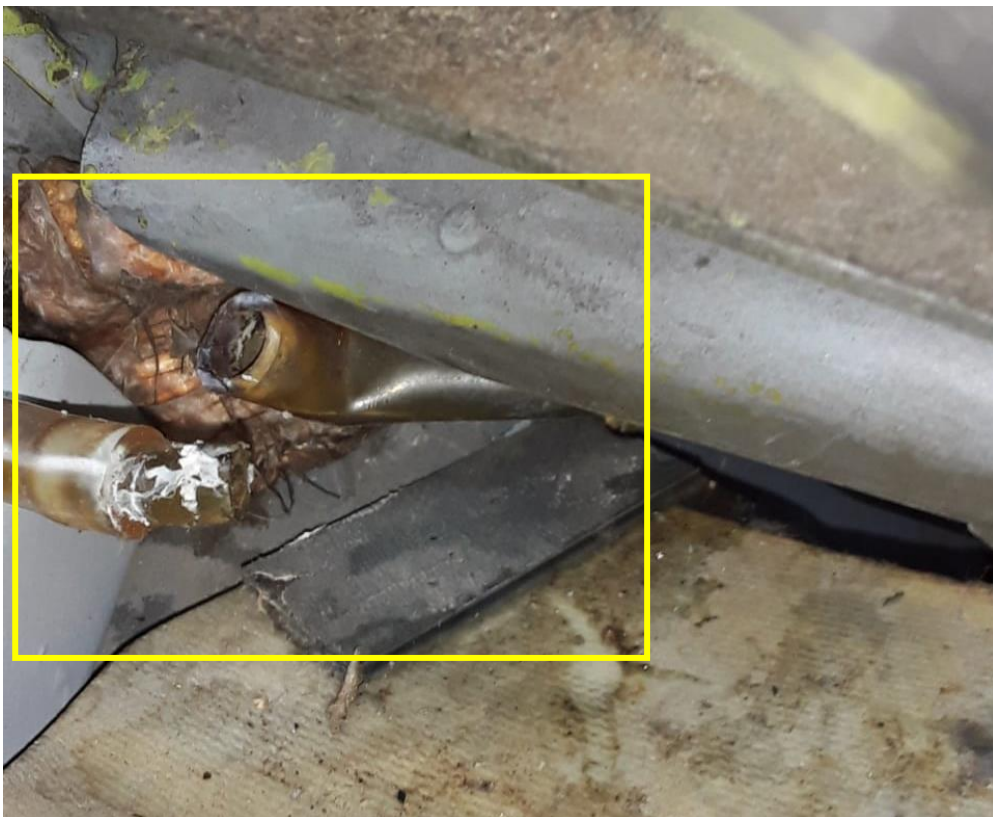
Figure 5: A dislodge water drain tube as found during an inspection by the AMO.
(Source: Safair Aviation Safety Division)

The tubing that was used in this application most probably became increasingly brittle as it was exposed to ultraviolet light for prolonged periods, as well as cold temperatures, which would have degraded the tubing by changing its properties, and which would have included its tensile strength and colour. Ageing of the tubing would also have had an effect as all polymers or plastics undergo some amount of degradation over time, which would cause the tubing to become less flexible and eventually split or crack.

- 3.2.1 The tubing was found to have been exposed to prolonged environmental conditions as well as ageing, which caused it to become hard and brittle, and subsequently became dislodged from a connection fitting which allowed water from the overhead drip pan to leak onto the back of some of the instrumentation situated on the left side (pilot-in-command) of the cockpit. This caused arcing (flash was seen) followed by smoke in the cockpit.

- 4.1 The aircraft operator advised that as a result of this serious incident, they had issued an immediate special inspection on all Boeing 737 series aircraft in their fleet.

The inspection calls for the proper security of the overhead drip pan, which is bolted to the structure above the overhead instrument panel with special emphasis on the security of the tubing (PIC and FO sides) that drains water from the drip pan into the aircraft drain system. This inspection was signed off in the Aircraft Technical Log Report for each of the respective aircraft by the aircraft maintenance engineer (AME) responsible for the task, which was conducted in accordance with AMM 25-11-21, Task 25-11-21-002-031, (see Annexure D).

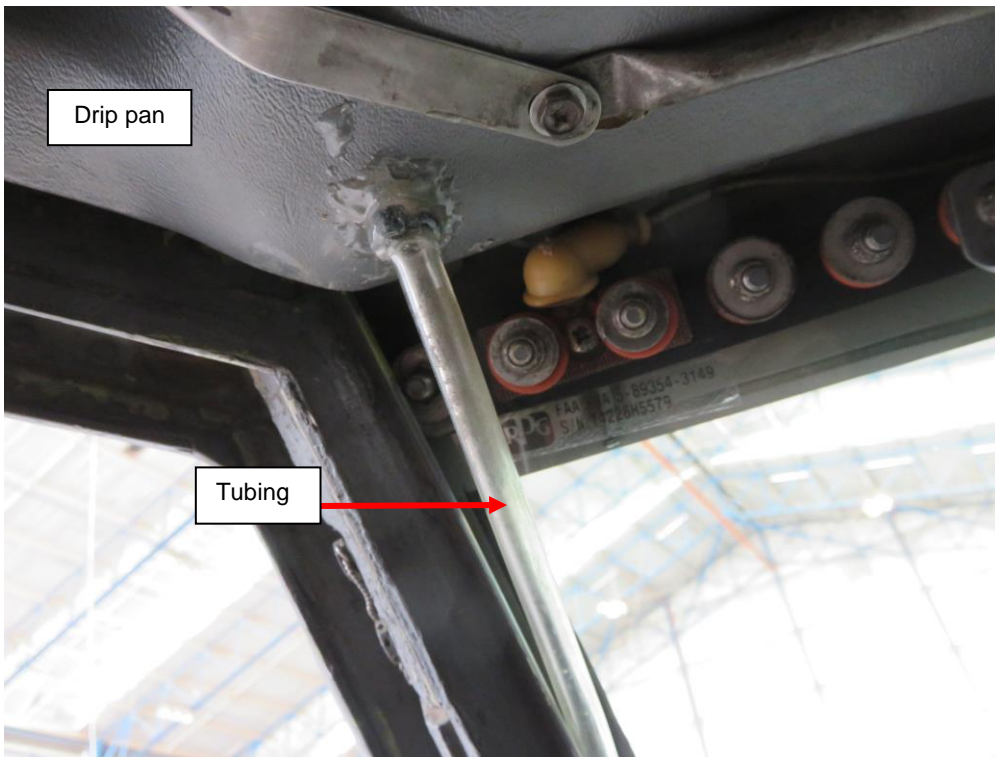
Figure 6: Tubing (drain pipe) viewed from inside the cockpit of another similar aircraft (left side).

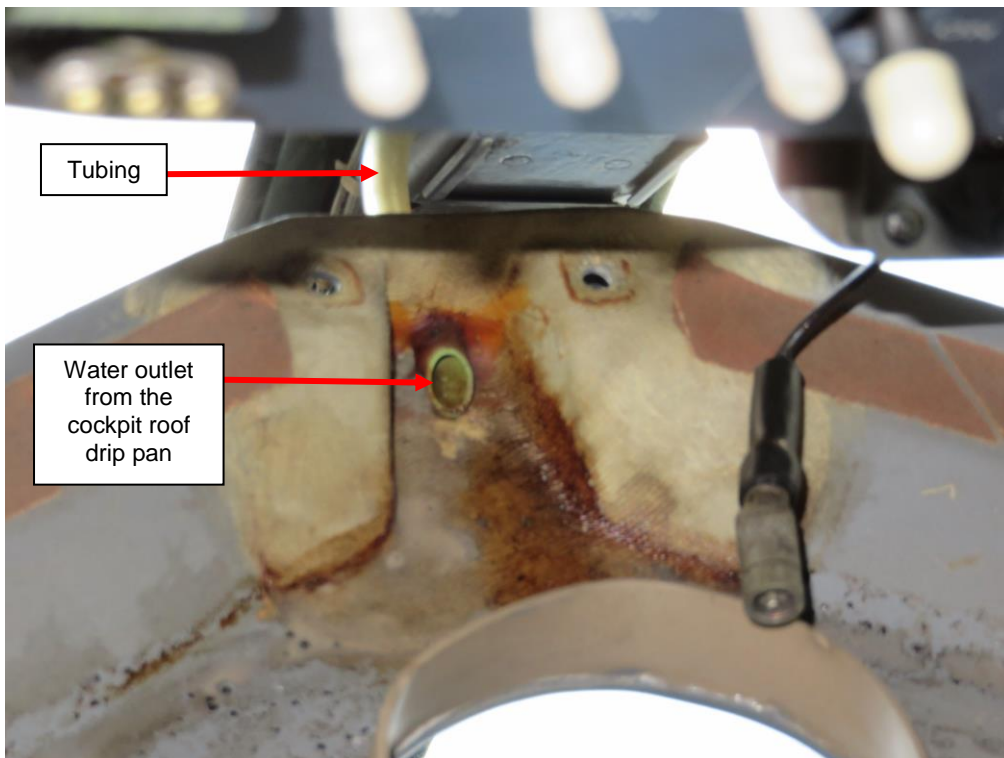
Figure 7: Overhead cockpit drip pan with visible water drain and tubing (centre console).

This was the first flight of the day with this aircraft. While the aircraft was parked outside (at the aerodrome), and most probably during taxi and take-off roll, a small amount of water might have accumulated in the upper cockpit drip pan. Only once the aircraft levelled off at FL280 did the water start to drain via the tubing, which at that stage had most probably become dislodged from the fitting since it had been degrading over an undetermined period due to exposure to different environmental conditions.
