**AIRCRAFT INCIDENT SHORT REPORT**

**CA18/3/2/1301:** Left main landing gear fault indication after retraction of the landing gear.

**Date and time** : 2 January 2020 at 1600Z  
**Location** : Cape Town International Airport (FACT), Western Cape Province  
**Aircraft registration** : TC-JNI  
**Aircraft manufacturer and model** : Airbus A330-343  
**Last point of departure** : FACT  
**Next point of intended landing** : Istanbul International Airport (LTFM) Turkey  
**Location of incident site with reference to easily defined geographical points (GPS readings if possible)** : South 33°58'08.58" East 018°36.06'00" at an elevation of 203 feet.  
**Meteorological information** : Surface wind 190° at 22kt, temp 22° and dew point 16°, CAVOK  
**Type of operation** : Part 121  
**Persons on-board** : 2+11+292  
**Injuries** : None  
**Damage to aircraft** : None

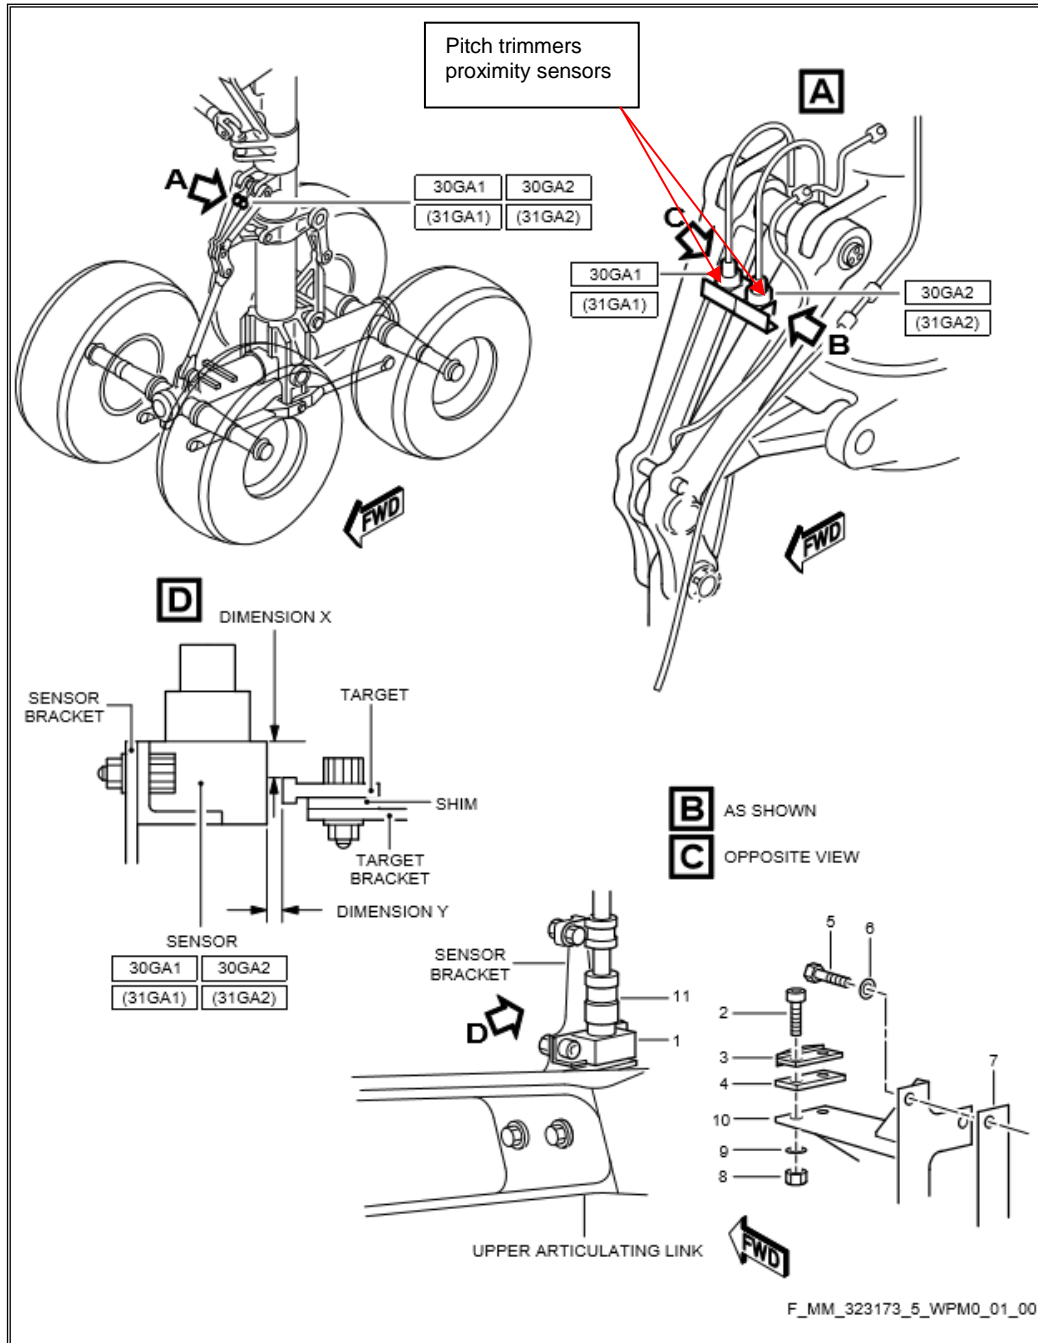
**Figure 3:** The schematic diagram of the location of the main landing gear pitch trimmer proximity sensors 31GA1 and 31GA2. (Source: Airbus AMM 32-31-73-820-804-A)

3.4 The landing gear retraction and extension test was carried out by the engineers and they had identified the same left gear fault indication that the crew had reported, which kept on appearing on the ECAM. A decision to measure both sensors on the left leg was made and the in-board (right hand) proximity sensor measured in accordance with (IAW) the maintenance manual (MM) Part -32-31-73-820-804-A was found to be out of limit. The proximity sensor was measured and found to be 8.40mm out of limit which was 0.10mm above the maximum limit of 8.30mm (the limit should be between 7.70mm and 8.30mm).

3.10 The investigation revealed that after take-off, the landing gear had failed to retract, and this was followed by the ECAM warning message (landing gear retraction fault) in the cockpit. The ECAM warning message appeared as a result of the right-side (in-board) pitch trimmer proximity sensor of the left gear which was out of limit, probably due to damage on the pitch trimmer proximity switch sensor/target as a result of wear and tear.

- 4.1 The cause of the pitch trimmer being out of limit was probably due to the damaged pitch trimmer proximity switch sensor/target as a result of wear and tear.

- The engineers put the aircraft on jacks
- The extension and retraction tests were performed
- Following the tests, it was discovered that the pitch trimmers 31GA1 and 32GA2 were out of limit on the left landing gear leg
- The engineers then adjusted the right-side (in-board) pitch trimmer proximity sensor on the left landing gear
- Landing gear extension and retraction tests were performed and found to be satisfactory
- The landing gear operated within an acceptable limit and was signed out
