| <b>AIRCRAFT INCIDENT SHORT REPORT</b> |

**CA18/3/2/1312:** The landing gears collapsed during the landing roll.

| <b>Aircraft registration</b> | : ZU-TAM |
| <b>Aircraft manufacturer and model</b> | : Jihlavan Airplanes S.R.O. Skyleader 600 |

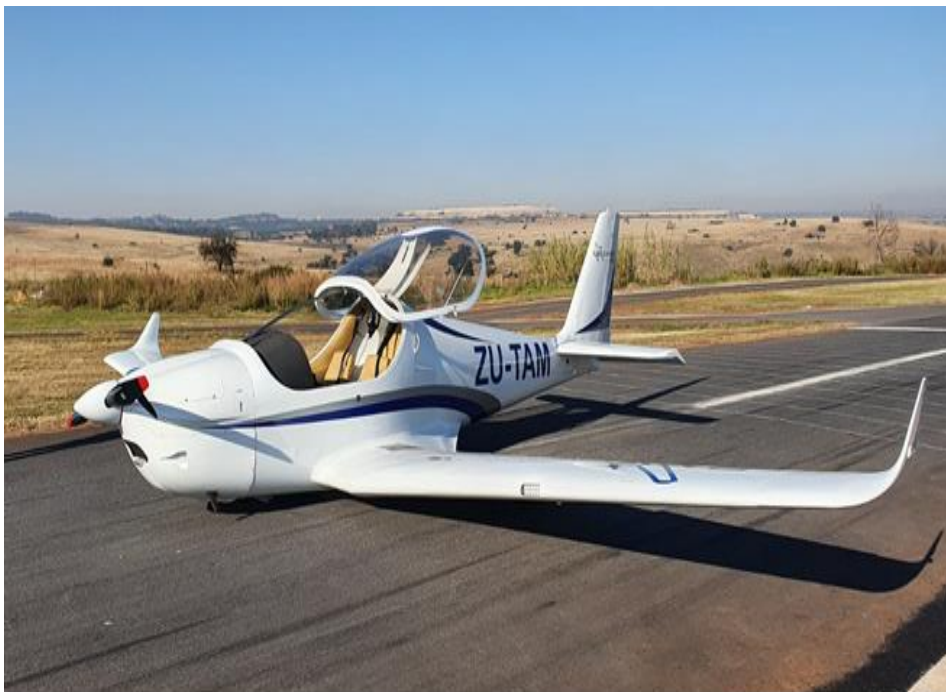
- 2.5 The aircraft sustained substantial damage to the lower fuselage, tyre rims, rib and the guide. The pilot and the passenger were not injured during the incident sequence.

**Figure 2:** The aircraft as it came to rest post-incident. (Source: Pilot)

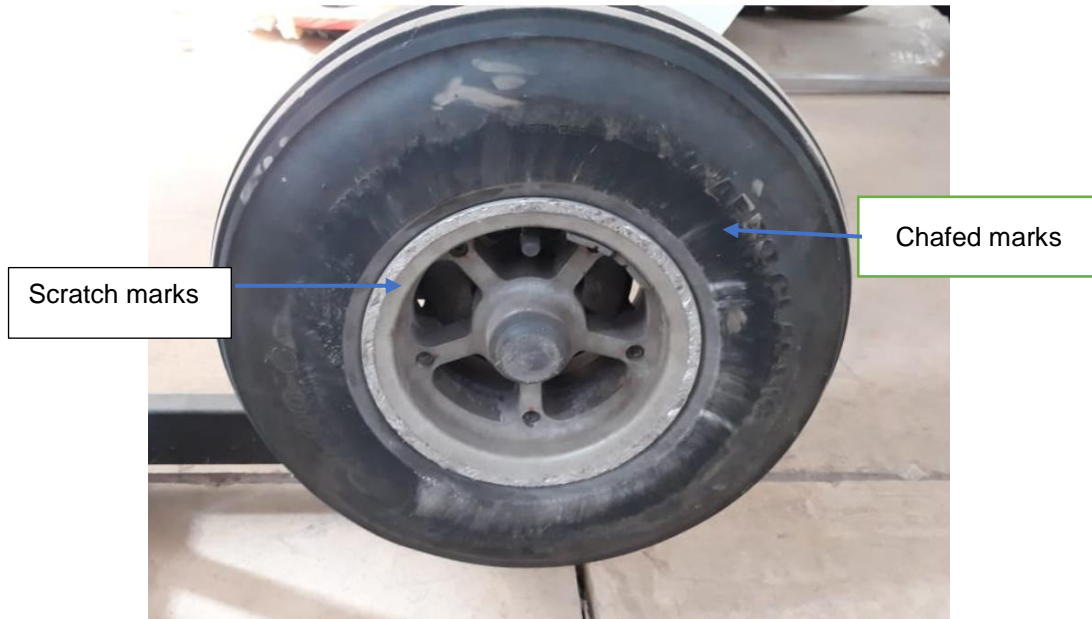
2.9 Upon inspection of the main wheels and tyres, the investigators found scratch marks on the rims, as well as chafed marks on the outboard higher edge of the tyres (See Figure 3). This indicated that upon touch down on the runway, the tyres and the gears were not fully extended, meaning that the gears were at an angle as the aircraft impacted the ground.

**Figure 3:** The aircraft tyres post-incident.
