<b>AIRCRAFT SERIOUS INCIDENT SHORT REPORT</b>
---

**CA18/3/2/1317:** Nose gear collapsed during landing on Runway 29 at FAWB.

**Aircraft registration** : ZS-MZU

**Aircraft manufacturer and model** : Piper Aircraft Corporation, PA-28-180

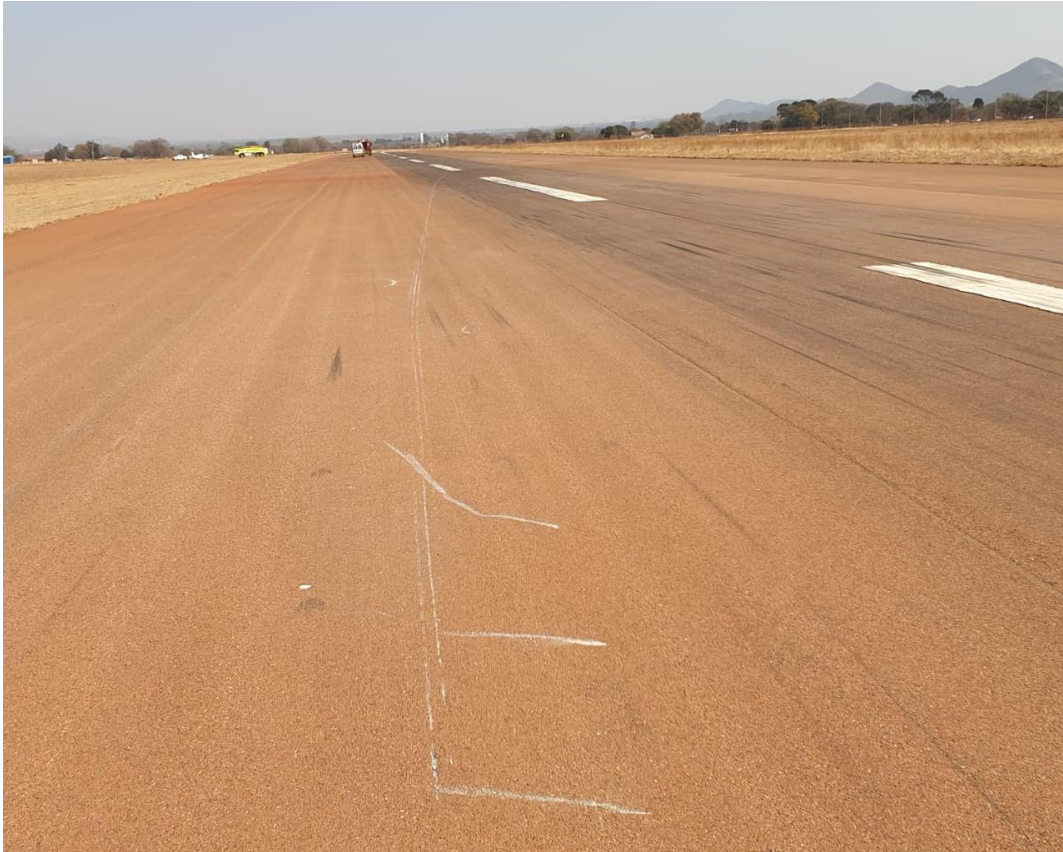
**Figure 1:** Propeller strike markings on Runway 29 at FAWB.

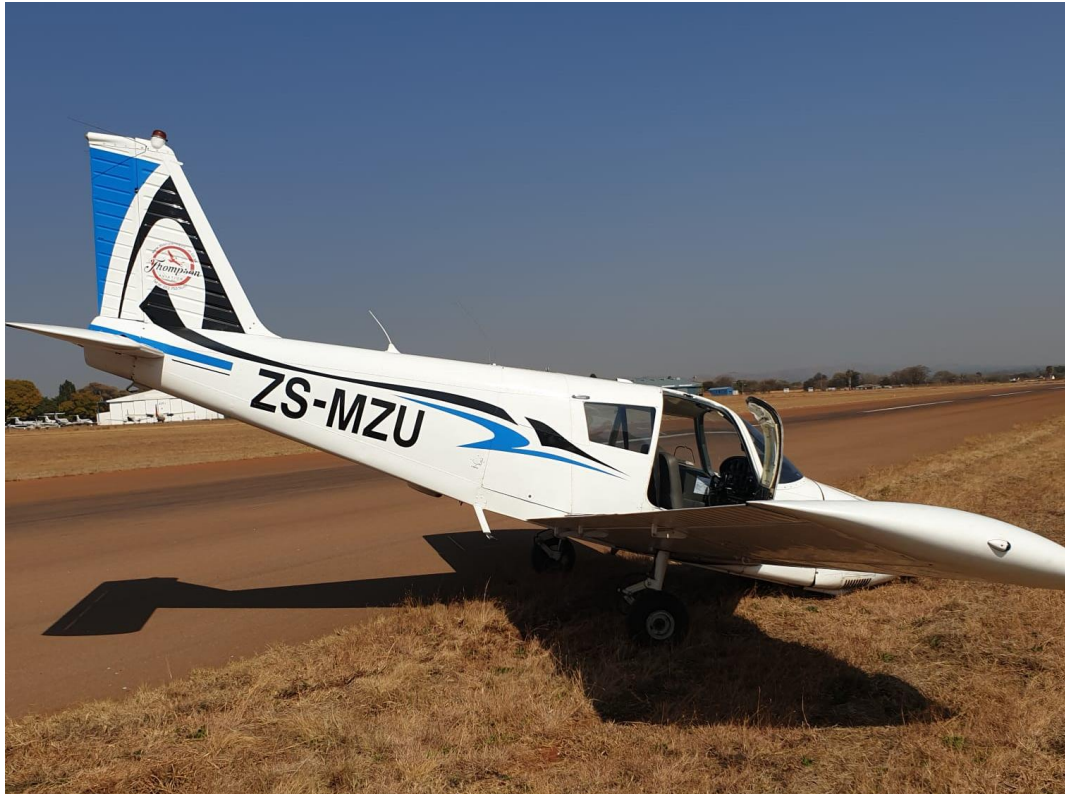
**Figure 2:** The aircraft as it came to rest on the right of Runway 29 at FAWB.

- 4.1 The student pilot became fixated on the aircraft that was on the runway and which had been cleared for take-off while she was on final approach for landing. This resulted in an unstable approach with a steep nose-down approach path, as well as speed acceleration which caused a balloon effect on the round-out. The aircraft bounced several times, which resulted in the collapse of the nose landing gear.

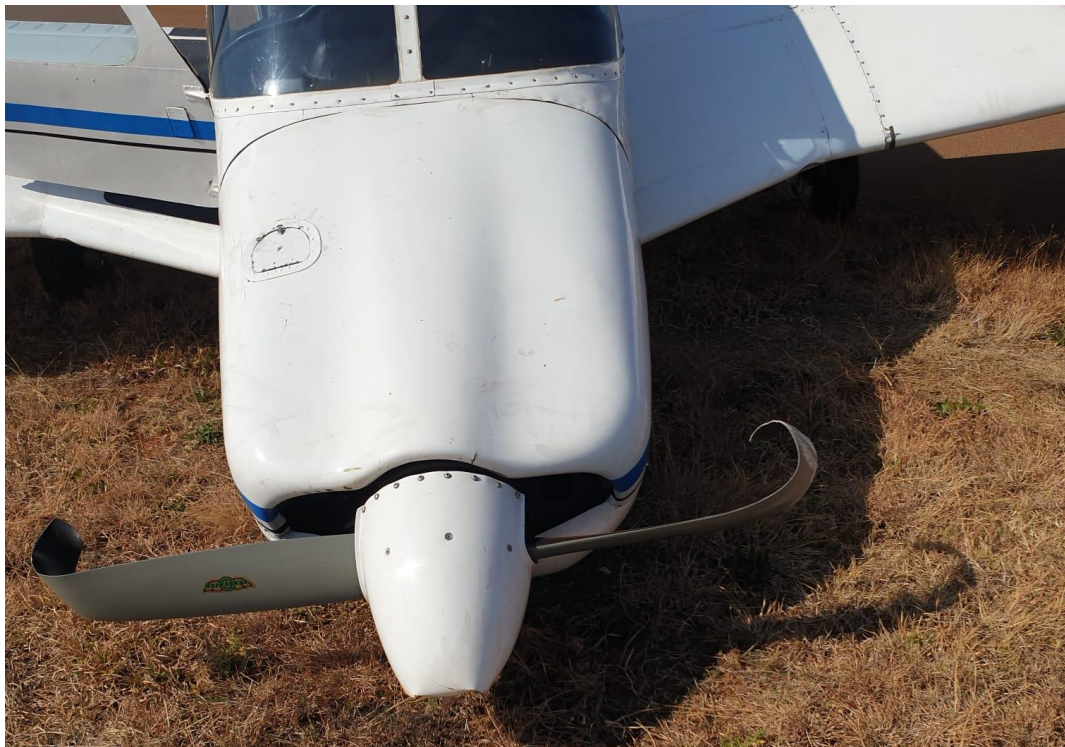
**Figure 3:** Both propeller blade tips were bent backwards following contact with the runway's surface.
