AIRCRAFT SERIOUS INCIDENT REPORT AND EXECUTIVE SUMMARY

Reference:		CA18/3/2/1325	
Aircraft Registration	ZS-OAF	Date of Accident	22 November 2020		Time of Accident	0820Z	
Type of Aircraft	Boeing 737-400			Type of Operation	Air Transport Operations, Passengers (Part 121)		
Pilot-in-command Licence Type	Airline Transport Pilot		Age	37	Licence Valid	Yes	
Pilot-in-command Flying Experience	Total Flying Hours		7 924.0		Hours on Type	3 383.0	
Last Point of Departure	Cape Town International Aerodrome (FACT), Western Cape						
Next Point of Intended Landing	East London Aerodrome (FAEL), Eastern Cape						
Damage to Aircraft	Minor						
Location of the incident site with reference to easily defined geographical points (GPS readings if possible)							
Runway 29 at George Aerodrome (GPS position: 34°00'24.13" South 022°22'27.41" East), elevation 648ft							
Meteorological Information	Surface wind: 210°/10kt; temperature: 19°C; dew point: 14°C; clouds: Scattered at 3300ft

Reference Number : CA18/3/2/1325
Name of Owner : Safair Operations (Pty) Ltd
Name of the Operator : FlySafair
Manufacturer : Boeing Aircraft Company
Model : 737-400
Nationality : South African
Registration markings : ZS-O

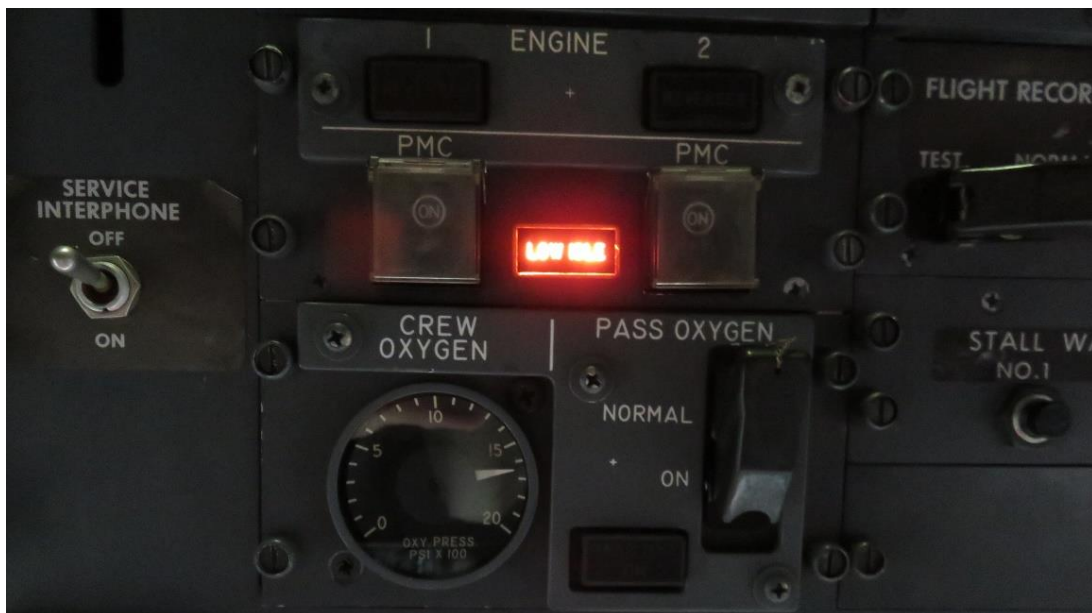
Figure 1: LOW IDLE warning for both engines, located on the overhead panel.
(Aircraft in ground mode)

- (vi) When the crew retarded the thrust levers as they commenced with the emergency descent, the LOW IDLE amber warning light along with the MASTER CAUTION ENG indication activated, which alerted the crew (see Figure 1) that the engines will be entering the sub-idle range which is associated with an N1 rpm of 32% or less when in-flight. A low idle condition is brought about by the system sensing that flight idle is not achieved and the system is still in ground idle, which is several % N1 lower than flight idle. The crew followed the correct procedure by disconnecting auto throttle and

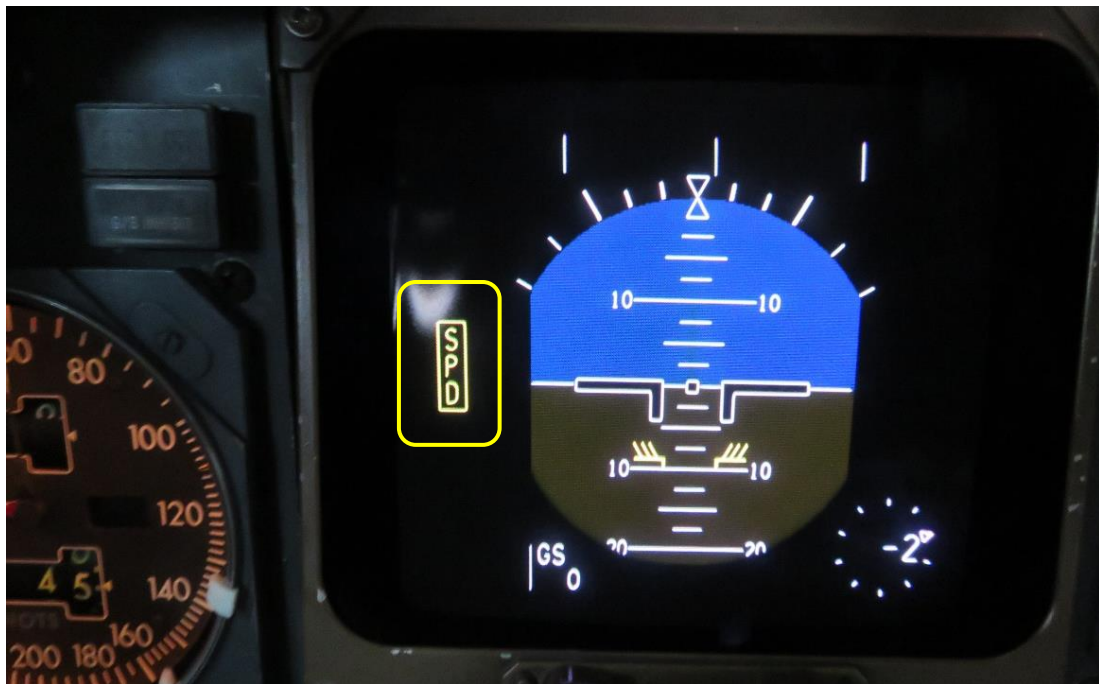
Figure 2: Amber SPD warning (in yellow window) displayed on the EADI (aircraft in ground mode).

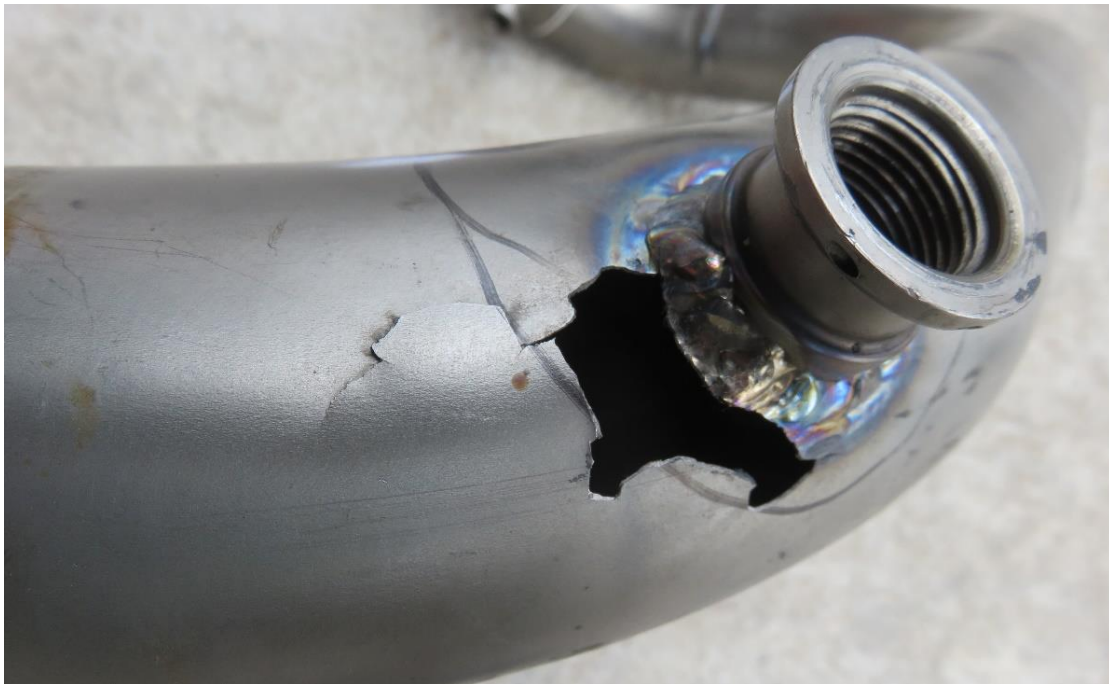
1.3.1 There was no damage to the airframe of the aircraft. Damage was limited to the aircon bay compressor outlet duct with Part No. 65-51552-8 located on the left air-conditioning pack, and the aft cargo compartment door seal had to be replaced.

Figure 7: Damage to the aircon bay compressor outlet duct (left air-conditioning pack).

The left Aircon Bay Pack/Machine Compressor Outlet Duct Assembly with Part No. 65-51552-8 was found to have ruptured in the same area where it was previously repaired. This component was removed and was metallurgically examined. *The cause of the failure of the ducting was due to an incorrect welding procedure, resulting in material embrittlement as the result of oxygen contamination. The mechanism of failure was initial brittle fracture that continued with a fatigue mechanism.*

It could not be determined when this outlet duct had fractured; however, the aircraft had no previous defects that could have been associated with such a failure and it could, therefore, not be ruled out to have occurred during this flight. The left and right packs are completely independent of each other and normally operate in parallel. The cockpit requires only a fraction of the air supply provided by the left pack, with the majority of the left pack supply being routed to the mix manifold. The output of the two packs is combined in the mix manifold. According to technical information, the cabin altitude can be maintained with only one pack operating; this was, however, not the case in this serious incident. The investigator noted that the cockpit crew fitted their oxygen masks, which was most probably related to the reduced air supply from the left pack following the failure of this outlet duct. The subsequent replacement of this component improved the efficiency of the left air-conditioning pack considerably as well as the entire system.

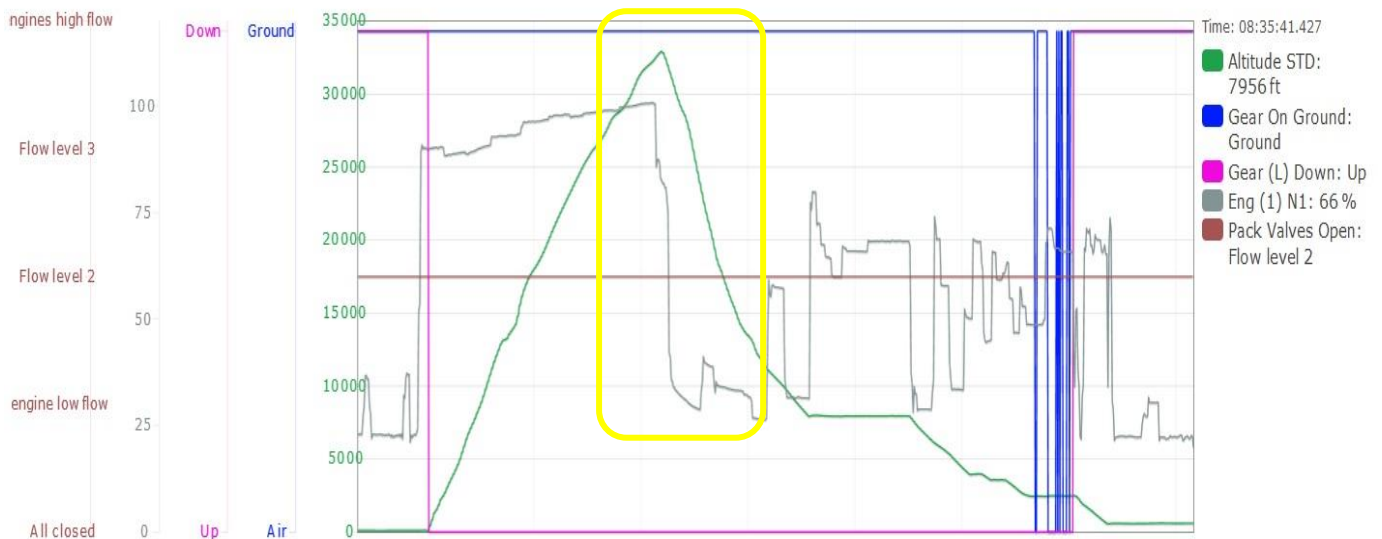
1.11.2 The aircraft was equipped with a digital flight data recorder (DFDR). From the graph below, the yellow window indicates when the crew commenced with the descent (green line) after the Cabin Altitude Warning activated and both engines' N1 decayed to approximately 30% (grey line).

Figure 8: The graph of the serious incident flight with essential data captured. (Source: Safair)

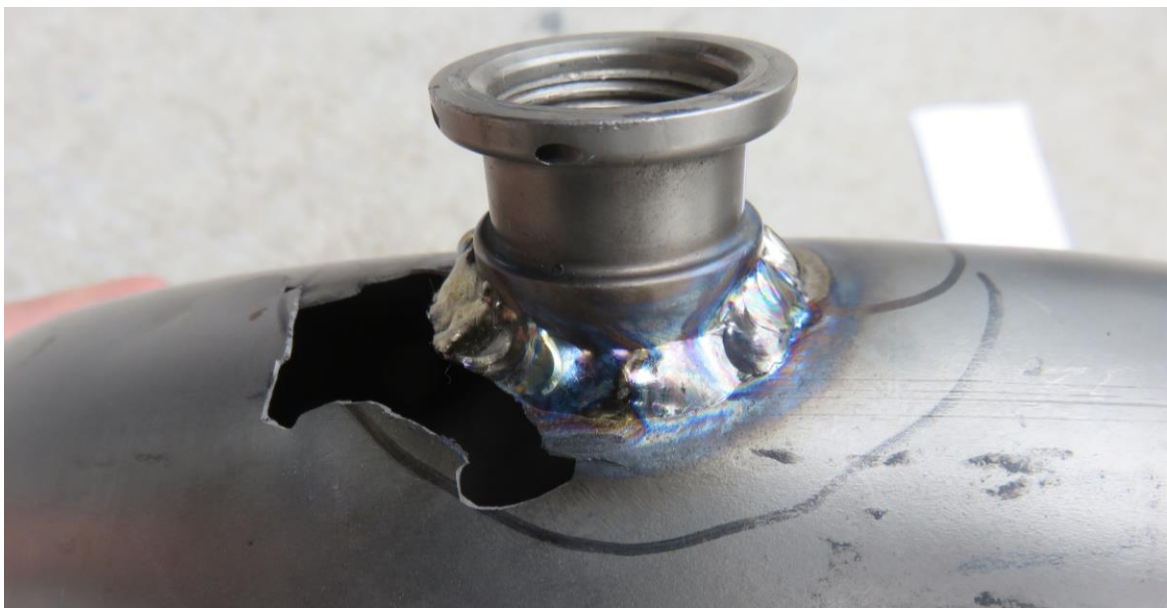
The duct was manufactured from thin-wall tubing. The nipple-to-duct joint contained a discoloured weldment around the circumference. The weld-cap (or bead crown) is very irregular with a qualified convex profile (see Figure 9).

Figure 9: Closer view of the discoloured welding around the circumference of the nipple.

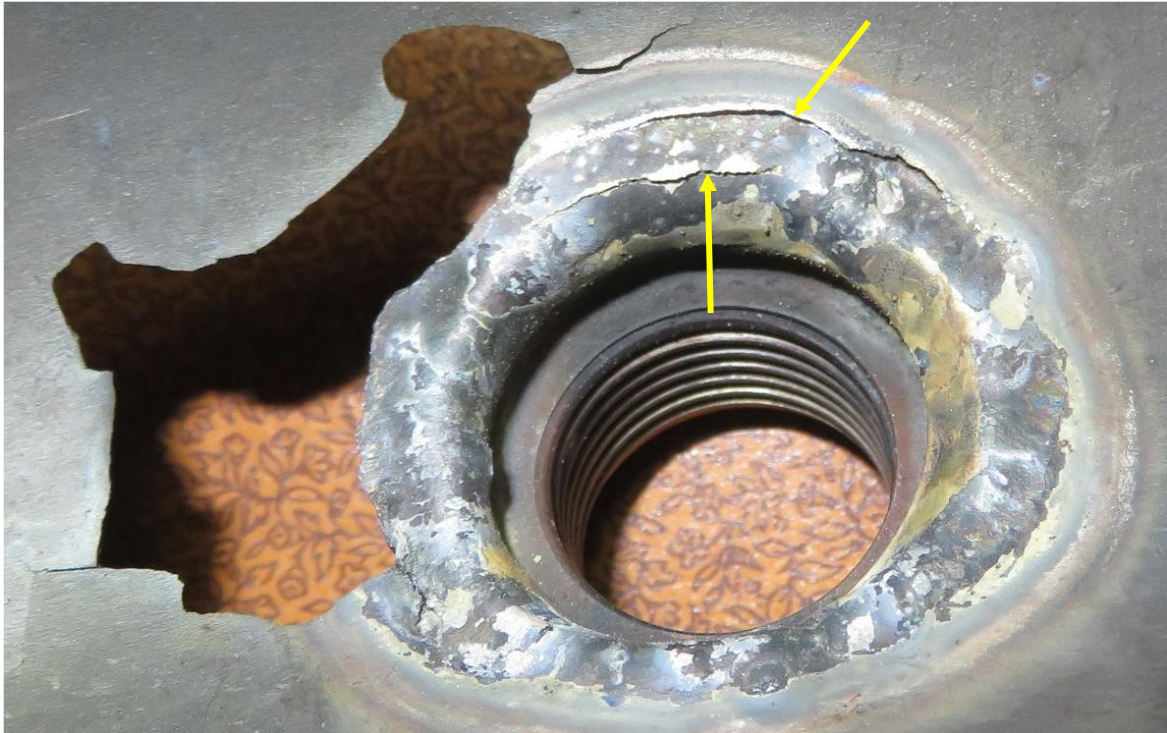
through the material thickness (see Figure 10). The presence of another two cracks underneath the weld material and NOT related to the external toe cracks was also confirmed (see Figure 10). The location of these two cracks was in the middle of the external weld. Evidence of melting at one of the cracks and the presence of porosity inside the cracks are indicative that the welding was affected on top of the two cracks. The orientation and location of the cracks are significant with respect to the duct geometry. The cracks are on opposite sides of the nipple circumference on the transition curve between the nipple and duct and the cracks are almost parallel to the longitudinal axis of the duct – considering that the duct is curved at this location.

Figure 10: Closer view of the inside of the duct showing the multi-coloured flaky surface layer on the duct surface below the external weld. Note the open and through thickness crack associated with the toe of the weld as indicated by the top arrow. In addition, one of the original cracks that was weld-repaired is indicated by the bottom arrow. The second crack on the opposite side of the throat is not visible due to the angle of the image.

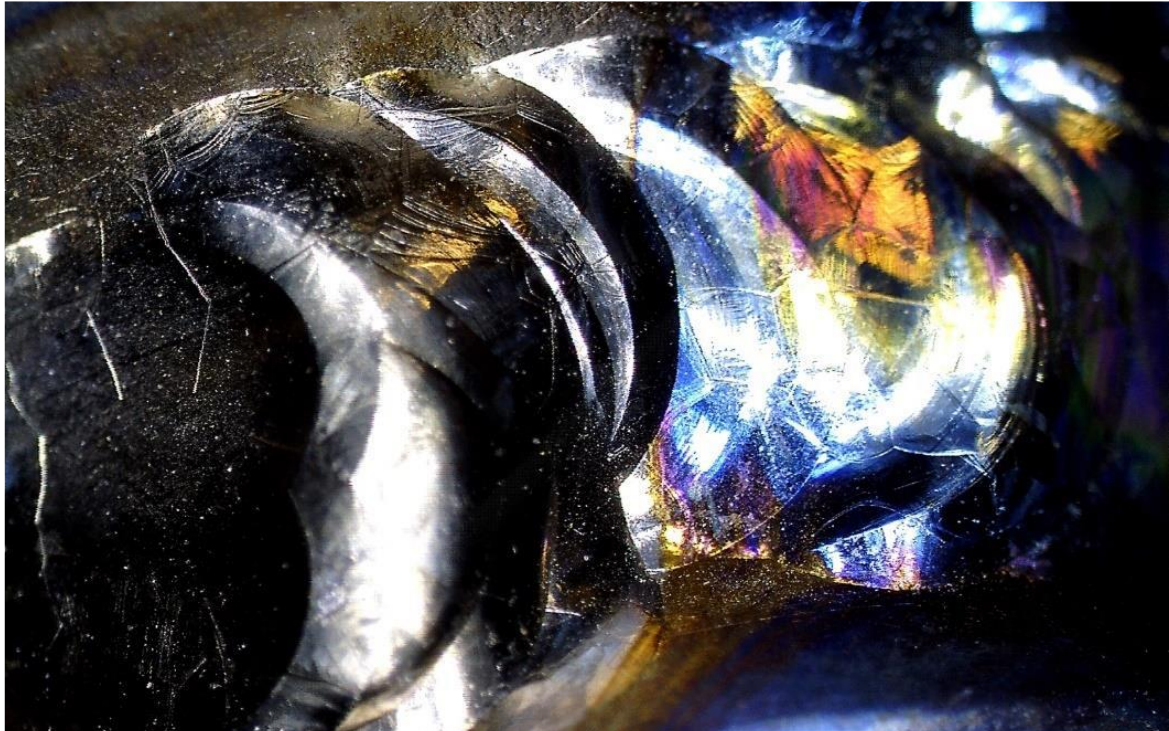
1. The weld discolouration due to in-adequate shield-gas protection as well as very irregular weld cap profile was confirmed (see Figure 11).
2. The detail of the external toe crack was confirmed (see Figure 12).
3. There are three distinct types of internal cracks at the nipple throat and adjacent duct material. The first type is the network of secondary cracks in the duct material that contributed to the rupture of the duct material. The second type is the crack associated with the stress concentration caused by the toe of the weld to the duct material and that had propagated through the thickness of the duct material. The

4. The internal toe crack showed evidence of a brittle nature with extensive branching and parallel micro-cracks (see Figures 11 & 12).

Figure 11: Magnified view of the weld surface showing the discolouration due to in-adequate shield-gas protection as well as a very irregular weld cap profile.

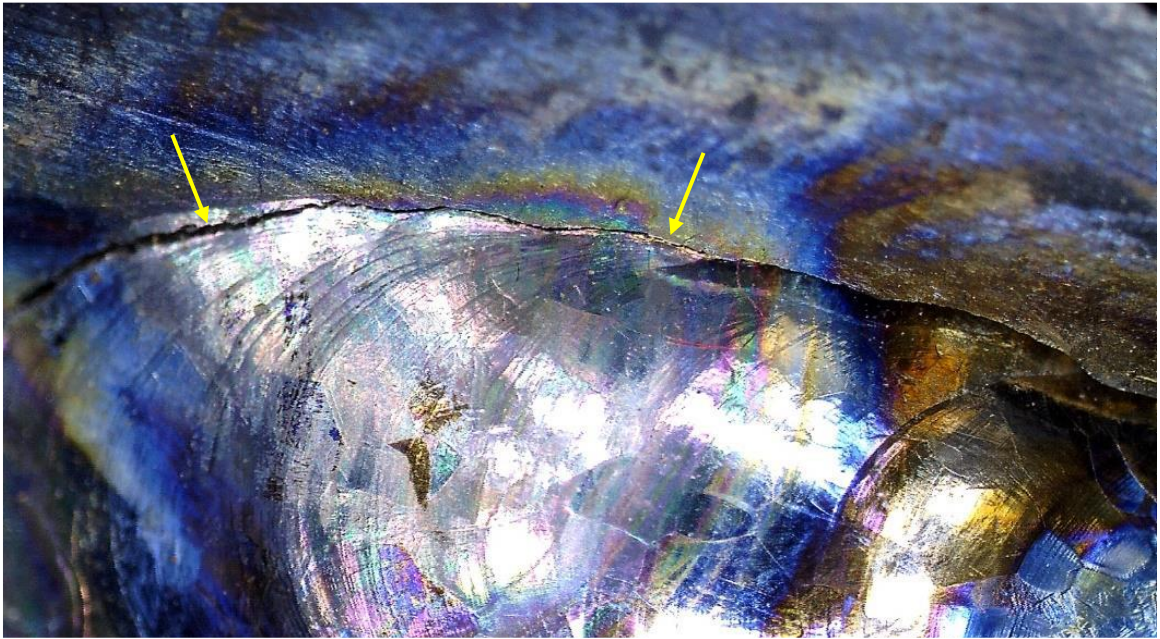
third type is the original crack that was the reason for the weld repair on the external surface (see Figure 12).

Figure 12: Magnified view of the toe area of the weld showing the toe crack following the weld profile. Note the extensive discolouration that extends well onto the duct material.

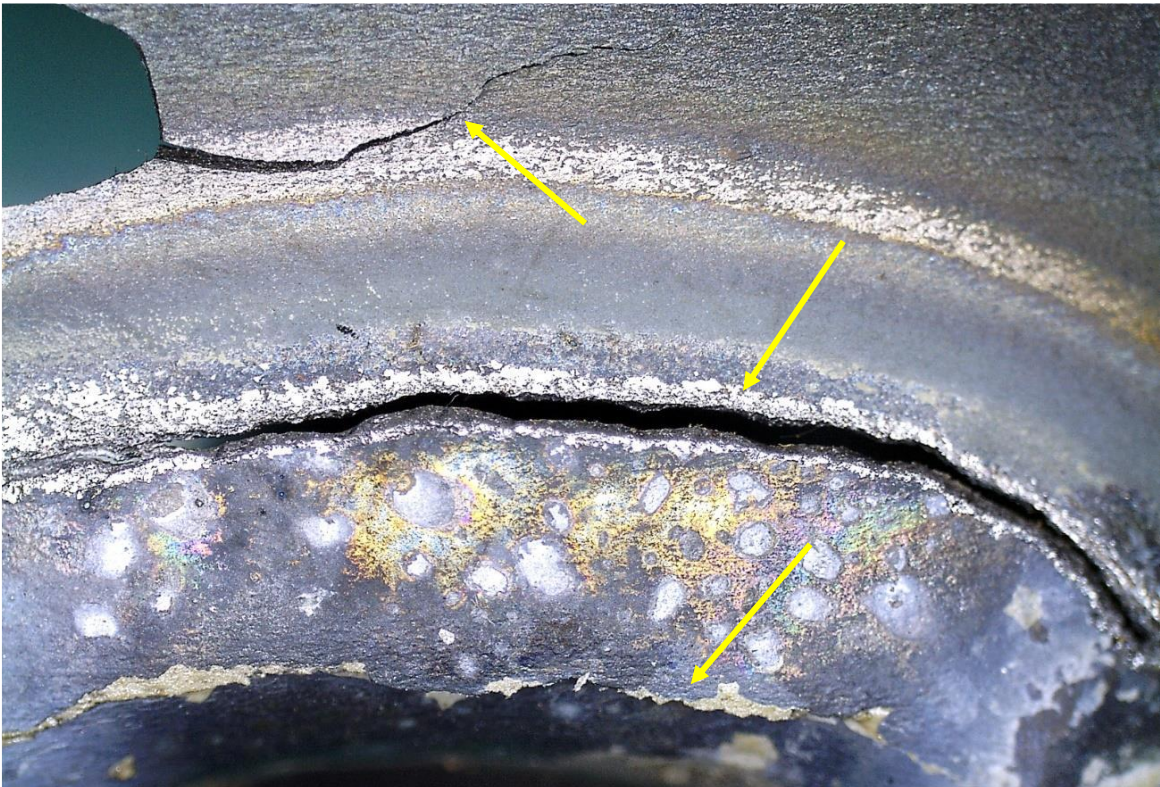
Figure 13: General magnified view of the three variations of cracks that were observed on the inside of the nipple. At top is a secondary crack that formed part of the rupture of the duct material and the association with the edge of the HAZ is quite obvious. The crack in the middle is directly related to the toe of the weld on the outside of the duct. The crack at the bottom is one of the original cracks that was the reason for the external weld repair.

- (ix) ***The cause of the failure of the ducting was due to an incorrect welding procedure, resulting in material embrittlement as the result of oxygen***

contamination. The mechanism of failure was initial brittle fracture that continued with a fatigue mechanism.

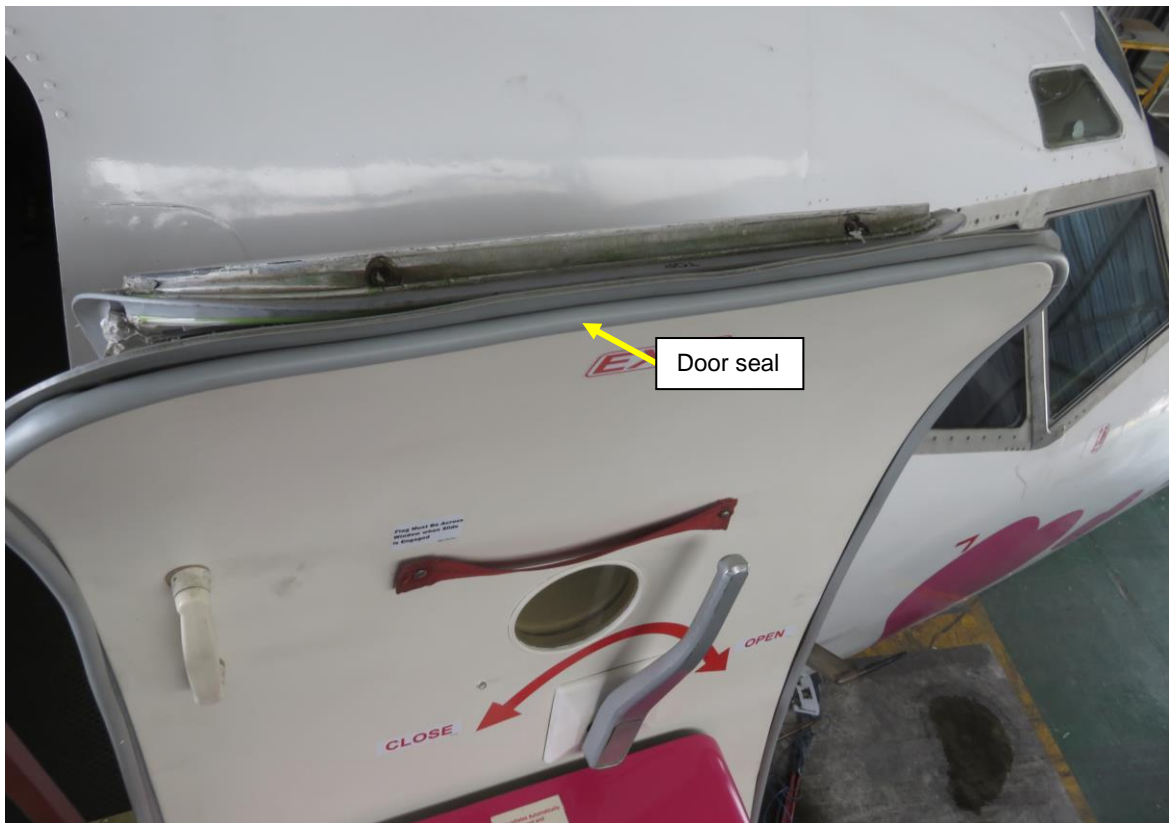
Figure 14: Door 1R in the open position, with no damage visible on the 'grey' door seal.

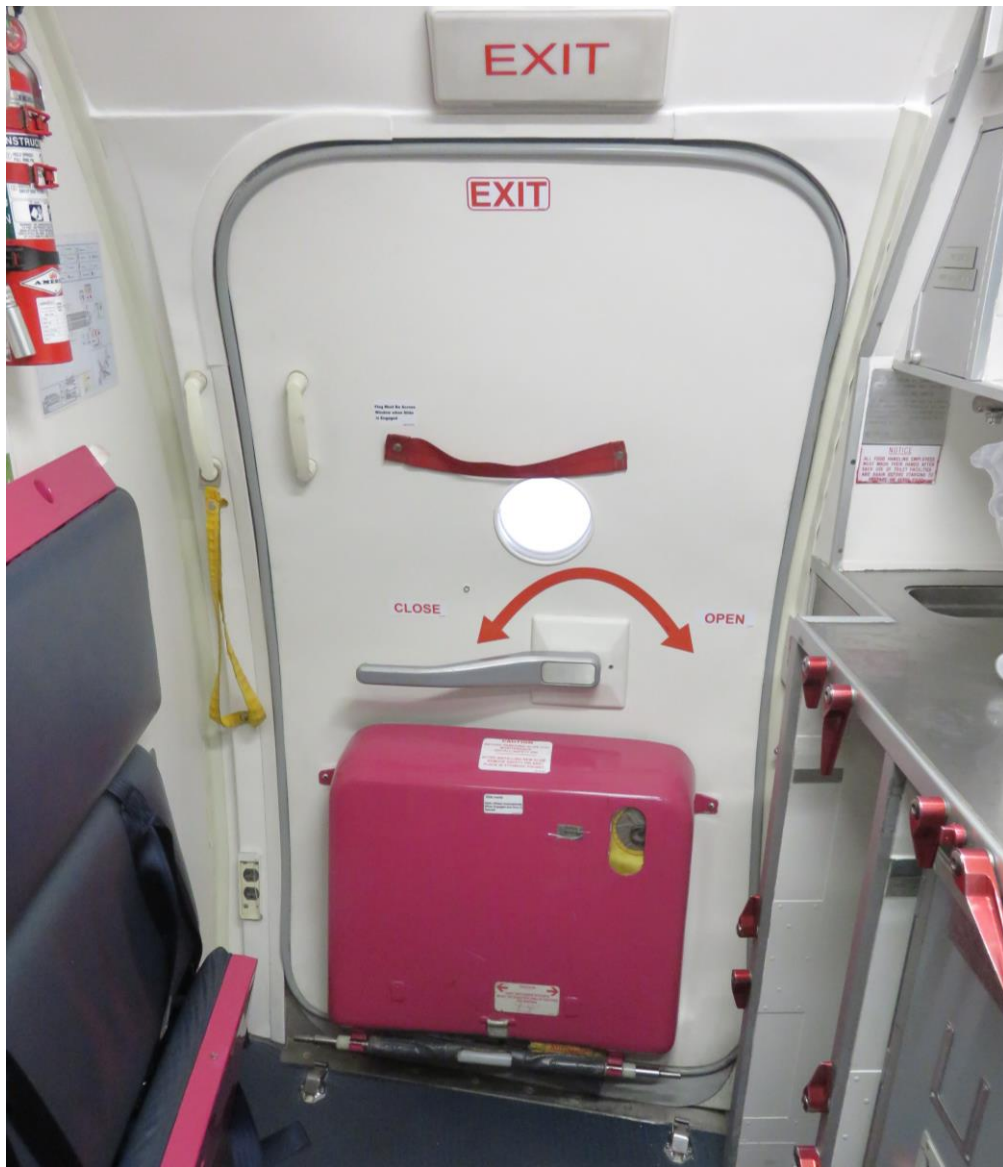
Figure 15: The right aft door (2R) in closed position.

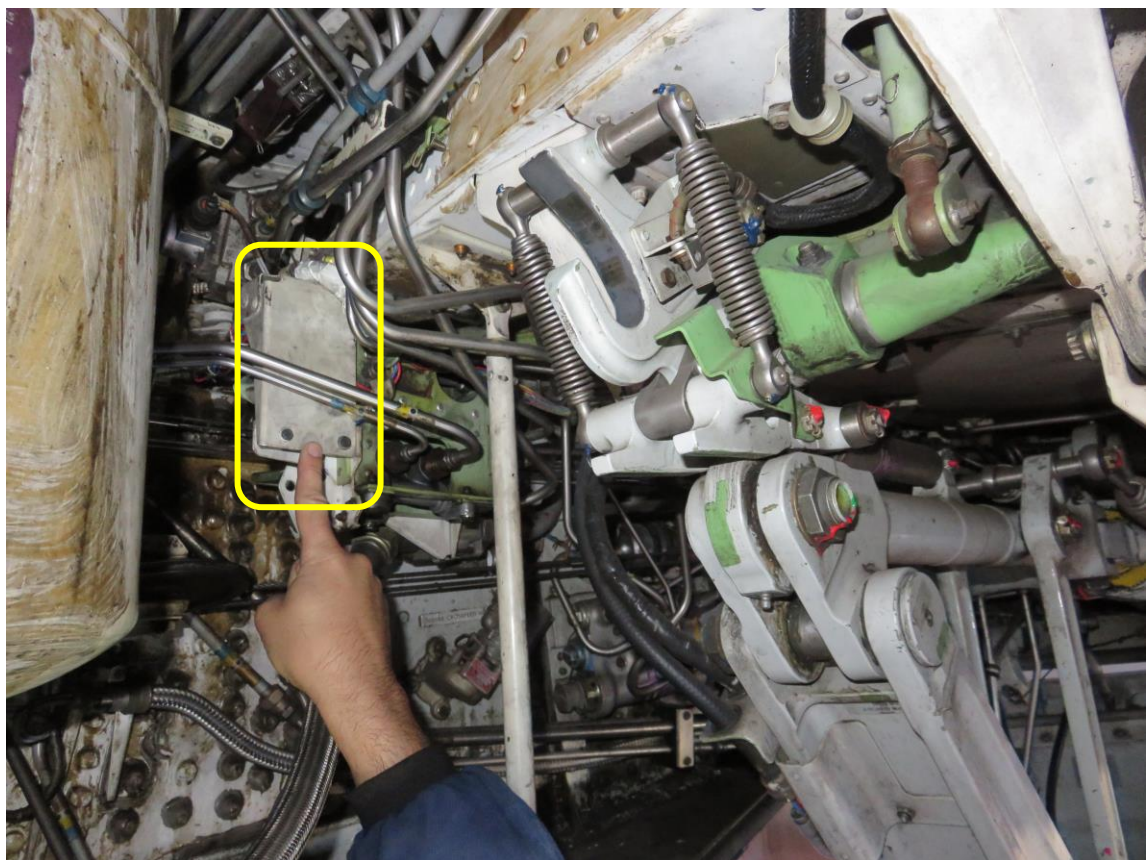
Further inspections were carried out in accordance with the manufacturer's Fault Isolation Manual (FIM). The Air/Ground proximity sensor located in the right main landing gear wheel well was found to be defective and was replaced. The aircraft was then jacked up and several retractions were performed to confirm correct operation of the switches. A post-maintenance acceptance (confidence) flight was performed, and all operations were found to be normal. No adjustments were made to the Teleflex cable on the right main gear. This sensor was found to have caused numerous warnings the crew encountered in the cockpit during the flight. Attached to this report as Appendix B is a list of the Air/Ground Logic System Table.

Figure 18: The Air/Ground proximity sensor is pointed out in the right main wheel well.

In consultation with the aircraft manufacturer fault isolation maintenance procedure, it was determined that these multiple cockpit indications were as a result of a defective Air/Ground proximity switch, which was located in the right main wheel well. The proximity switch was replaced, and the problem did not present itself again during the confidence/post-maintenance acceptance flight.

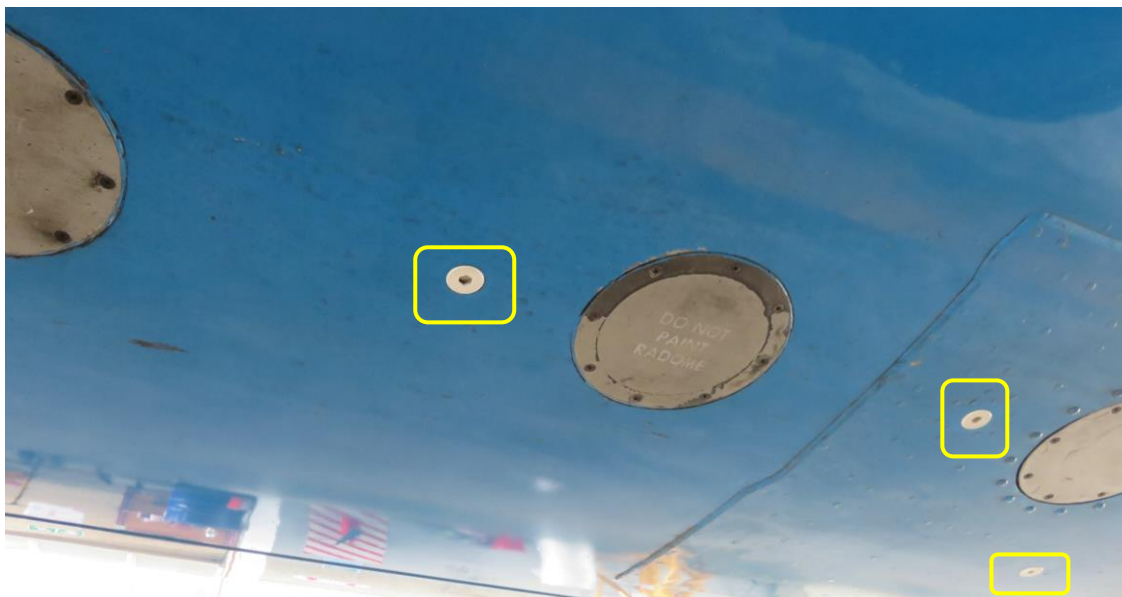
A bleed down check was performed on the aircraft and it was found that most of the bilge drains were not closing at 2.5 pounds per square inch (psi), which were subsequently replaced. *“A "bilge" valve, adapted to be mounted on the lowermost wall of an aircraft fuselage, is disclosed in which the valve has a normally open condition to drain accumulated condensate through a registering opening in the fuselage wall when the interior cabin is depressurised, and assumes a closed condition in response to a differentially higher cabin pressure relative to outside air pressure to seal off the interior of the fuselage.”*

Figure 20: The bilge valves mounted at various places on the lower fuselage.
