## AIRCRAFT SERIOUS INCIDENT REPORT AND EXECUTIVE SUMMARY

<b>Reference:</b>		CA18/3/2/1336	
<b>Aircraft Registration</b>	ZS-SJF	<b>Date of Serious Incident</b>	25 January 2021		<b>Time of Serious Incident</b>	1232Z	
<b>Type of Aircraft</b>	Boeing 737-800		<b>Type of Operation</b>		Commercial (Part 121)		
<b>Pilot-in-command Licence Type</b>	Airline Transport Pilot Licence		<b>Age</b>	50	<b>Licence Valid</b>	Yes	
<b>Pilot-in-command Flying Experience</b>	<b>Total Flying Hours</b>		11 261.4		<b>Hours on Type</b>	1 841.2	
<b>Last Point of Departure</b>	O.R. Tambo International Airport (FAOR), Gauteng Province						
<b>Next Point of Intended Landing</b>	King Shaka International Airport (FALE), KwaZulu-Natal Province						
<b>Damage to Aircraft</b>	None						
<b>Location of the serious incident site with reference to easily defined geographical points (GPS readings if possible)</b>							
En route from FAOR to FALE abeam Dundee (GPS position: South 28°07'.6" East 030°22'.2")

**Reference Number** : CA18/3/2/1336  
**Name of Owner/Operator** : Mango Airlines SOC (Ltd)  
**Manufacturer** : Boeing Aircraft Company  
**Model** : Boeing 737-800  
**Nationality** : South African  
**Registra

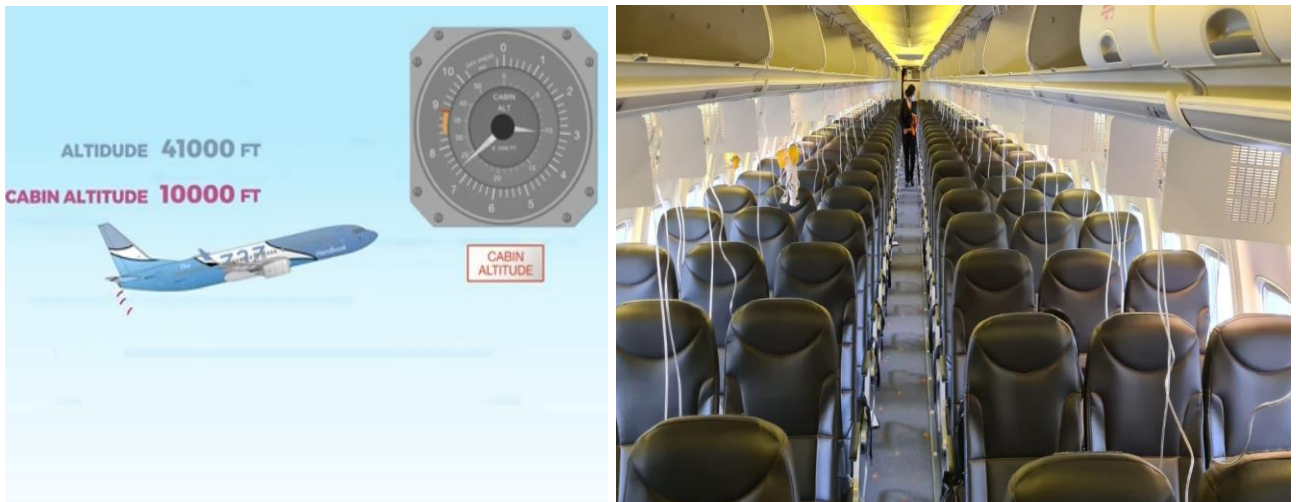
**Figures 1 & 2:** On the left is an illustration of a B737 aircraft animation snap shot showing the “cabin altitude” warning illuminated and the Cabin Altitude which was above 10000 ft; and on the right is a picture of the ZS-SJF aircraft showing the deployed oxygen masks.

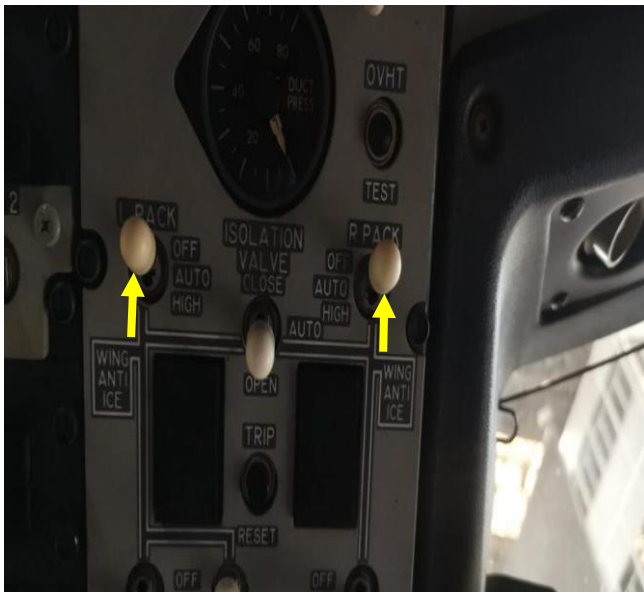
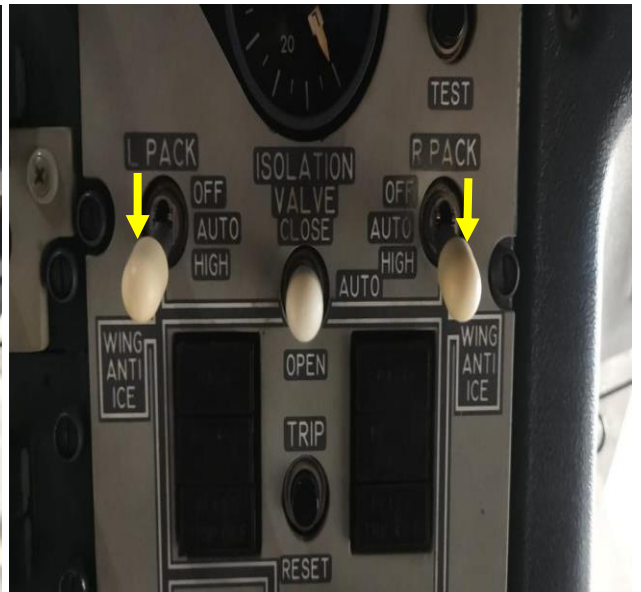
**Figures 6 & 7:** The aircraft pneumatic panel on the P5 cockpit overhead panel area showing the air-conditioning packs toggle switches (Bleed 1 & 2) on OFF (left) and HIGH (right).

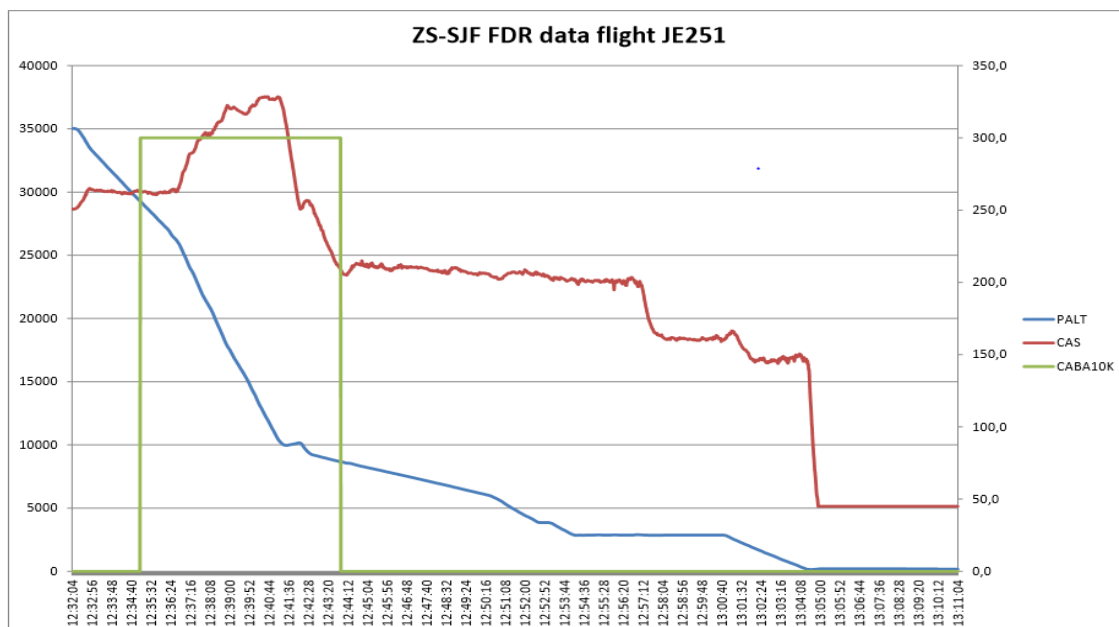
1.11.2 From the FDR graph below (Figure 15), it is evident from the Aircraft Information Management System (AIMS) that the aircraft packs were operating engine 1 Low and engine 2 High, which is in correlation to the aircraft's configuration as it departed FAOR. At 1232Z, the crew commenced their descent, and while passing FL270, the crew got a "Cabin Altitude Warning" and, according to the captain's written report, declared an emergency. The crew continued with the descent at a maximum of 330kts to FL110 where a deceleration to 250kts was made.

**Figure 15:** The graph of the serious incident flight with the captured essential data. (Source: (SAAT))

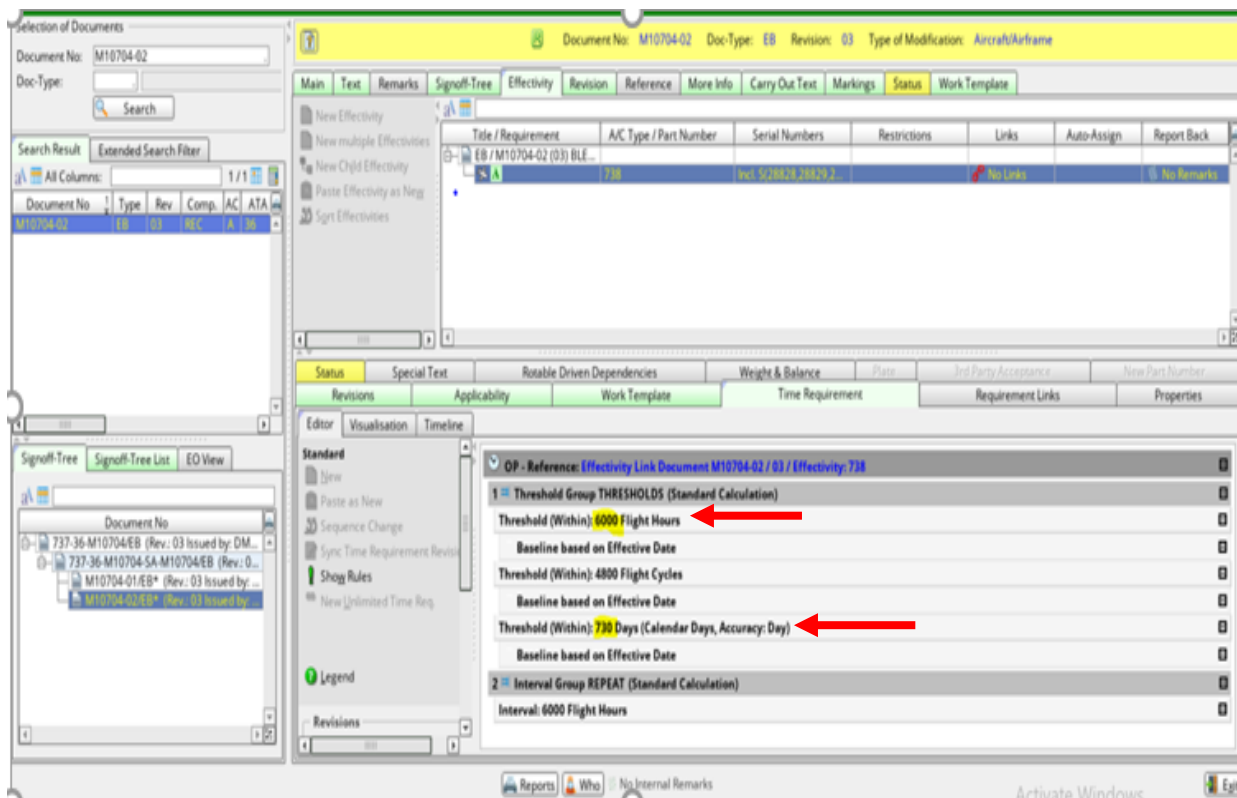
0001. The A-check scheduled maintenance inspection conducted does not require an inspection of the bleed air system and associated components. The No. 1 and 2 bleed health system checks were last conducted on 11 July 2019 at 47 490.30 airframe hours, work order number 1880360R1, IAW AMM task:36-11-03/401 Rev: 069. The repeat inspection is required to be conducted every 730 days or within 6000 flight/airframe hours (FH) IAW the original equipment manufacturer (OEM – Boeing) and the operator’s aircraft maintenance program (OAMP). According to the operator’s maintenance planning records, the next bleed health system checks are planned to happen between 11 May 2021 and 14 June 2021, work order 1880361R1. The aircraft had flown a total of 2440,11 and 565 days since the last bleed health checks were performed.

Figure 16: Print out of the OEM and OMPD program.

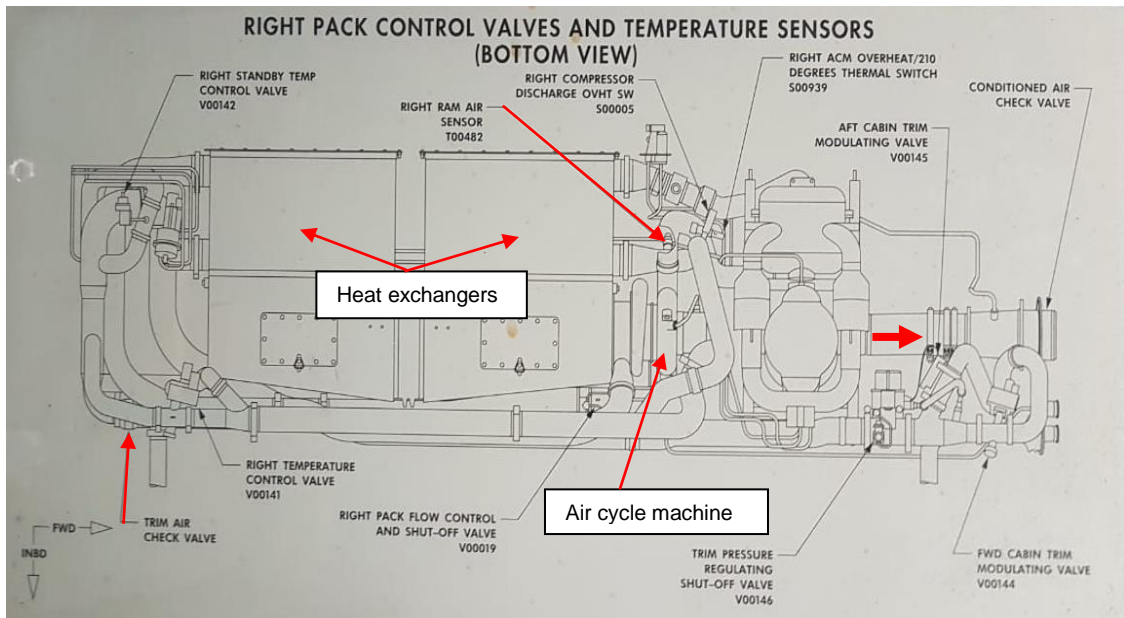
- 1.16.4 The right ACM, Part No: 2206400-2 was replaced IAW the AMM 21-51-04 rev 73 because of its intermittent reluctance to operate. The No.2 air-conditioning pack trim air check valve was found unserviceable. A defective trim air check valve, Part No: 3202444-1 was replaced with a serviceable one IAW the AMM 21-61-03. The trim air check valve test was later carried out and it operated normally. This was followed by an extensive ground run and pressurisation/cabin altitude test using the APU and the engines as the pneumatic source. The bleed air and air-conditioning system were configured in various combinations and temperature selections. The systems operated normally and nothing unusual was observed. On 7 February 2021, a pre-flight inspection was carried out in preparation for a test flight. The cabin altitude tested normal with nil defects reported. Before the aircraft was released to service on 8 February 2021, two serviceable recorders (FDR and CVR) were fitted IAW the AMM 31-3171PO401.

1.16.6 Below is the schematic of an aircraft air-conditioning pack showing (in red) replaced components during post-serious incident maintenance.

**Figure 16:** The air-conditioning pack.

- 3.3.1 Defective right-side air-conditioning pack components that included the primary heat exchanger, air cycle machine, sense line and the trim air check valve.

- 1.16.3 Examination of the aircraft TL indicated no air-conditioning/pressurisation snags. There were also no bleed defects reported for the past six months on either engine. On 27 January 2021, the No.1 engine 9<sup>th</sup> stage bleed air valve was put on open position. That was followed by a short engine ground run by SAAT engineers IAW the AMM task 71-00-00-800-810-F00 Ref. 73. During the engine run, the No.1 engine duct pressure recorded 15 psi and the No. 2 engine duct recorded 5 psi (low). This was an indication that there was an anomaly on the right-side pack. Another engine ground run was performed, followed by leak checks/pneumatic health confidence check IAW the AMM 36-11-00-700-803. A leak was detected on the No. 2 air-conditioning pack air cycling machine (ACM) sense line. A leaking sense line, Part No - AS141G0120N045L was replaced with a serviceable one IAW the AMM 21-51-04. In addition, multiple cracks were detected on the No.2 air-conditioning pack primary heat exchanger. The primary heat exchanger, Part No:182820-2 and the secondary heat exchanger Part No: 182820-3 were replaced with serviceable ones IAW the AMM 21-51-03.
