**LIMITED INCIDENT INVESTIGATION**

<b>Reference Number</b>		CA18/3/2/1343					
<b>Classification</b>	Incident	<b>Date</b>	10 May 2021		<b>Time</b>	1408Z	
<b>Type of Operation</b>		Flight Training (Part 141)					
<b>Location</b>							
<b>Place of Departure</b>		Wonderboom National Aerodrome		<b>Place of Intended Landing</b>		Wonderboom National Aerodrome	
<b>Place of Accident</b>		FAD 127 Wonderboom General flying Area					
<b>GPS Co-ordinates</b>	<b>Latitude</b>	25°29'24.95" S	<b>Longitude</b>	028°14'25.80" E	<b>Elevation</b>	7000 feet	
<b>Aircraft Information</b>							
<b>Registration</b>		ZS-GDA					
<b>Registration</b>		ZS-PMX					
<b>Model/Make</b>		Cessna 172 P (Both)					
<b>Damage to Aircraft ZS-GDA</b>		None		<b>Total Aircraft Hours</b>		18 141.1	
<b>Damage to Aircraft ZS-PMX</b>		None		<b>Total Aircraft Hours</b>		6 362.5	
<b>Pilot-in-command</b>							
<b>Licence Type ZS-GDA</b>		Commercial Pilot Licence		<b>Gender</b>		Male

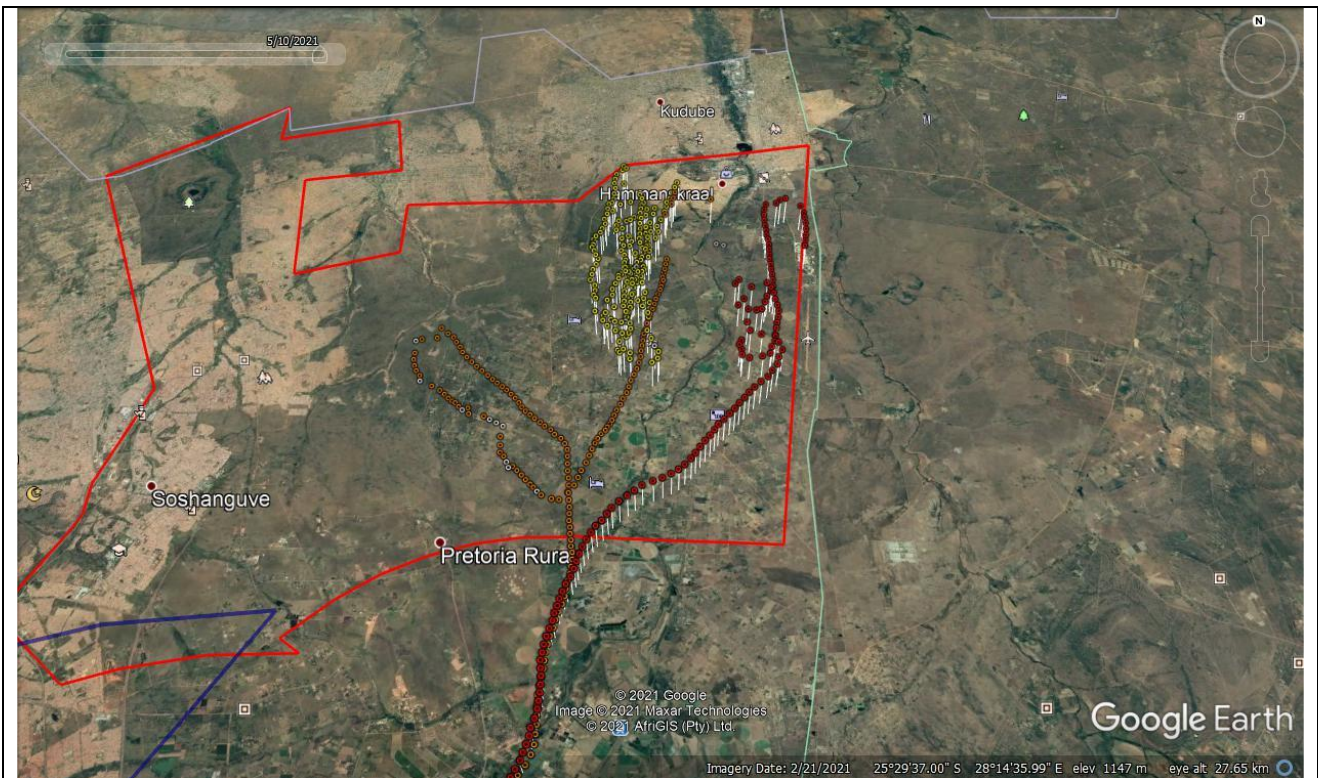
The path of the ZS-GDA aircraft that took off 20 minutes prior to ZS-PMX from FAWB to carry out aerial work in the north-eastern section of FAD 127 is depicted in Figure 1, (indicated by the yellow dotted lines). According to the radar data, at 14:08:18Z, the two aircraft came too close to each other. The ZS-GDA aircraft was flying at 6 900ft in a southerly direction at the time. The transponder mode C on ZS-PMX aircraft was switched off or was not functional at the time as it was not possible for radar to detect the height the aircraft was flying at while heading in a north north-easterly direction towards the north-eastern corner of FAD 127. The red dotted line shows another training aircraft that was flying within FAD 127 on the eastern boundary; the aircraft took off from FAWB approximately 4 minutes after ZS-PMX. From the statement of the flight instructor on-board ZS-PMX, their aircraft was slightly higher than the ZS-GDA aircraft as he had observed the aircraft flying below theirs. The flight instructor of ZS-GDA aircraft stated that he read the registration of ZS-PMX and made a radio call as they were not aware of their intention at FAD 127.

**Figure 1:** The orange dots show the flight track of ZS-PMX aircraft while the yellow dots show the flight track of ZS-GDA aircraft.

The investigation revealed no evidence of avoidance manoeuvre from the radar records. It is likely that when entering the FAWB GFA, the ZS-PMX aircraft did not correctly change the radio frequency, resulting in them not being heard by other aircraft in the GFA. It is also possible that the two aircraft may have flown very close to each other. It is always important for aircraft to make position reports and intentions using the correct frequency.

- 1 It is recommended that all aircraft flying in South Africa file a flight plan. This allows for all aircraft to be allocated a squawk code as well as making it possible to be tracked by radar. Should a distress situation arise, the last known position of the aircraft would be known in case any search and rescue action is required. Pilots should view filing a flight plan as their advantage. In this incident, neither aircraft filed a flight plan, therefore, none were allocated a squawk code, which made it difficult to identify these aircraft on radar.

- 2 It is recommended that pilots always remain vigilant during flights as the general flying areas can get congested quickly, especially in areas in and around Gauteng where there is a substantial number of aircraft training organisations (ATOs). A proper lookout and frequent radio transmission on the correct frequency in those areas is recommended.

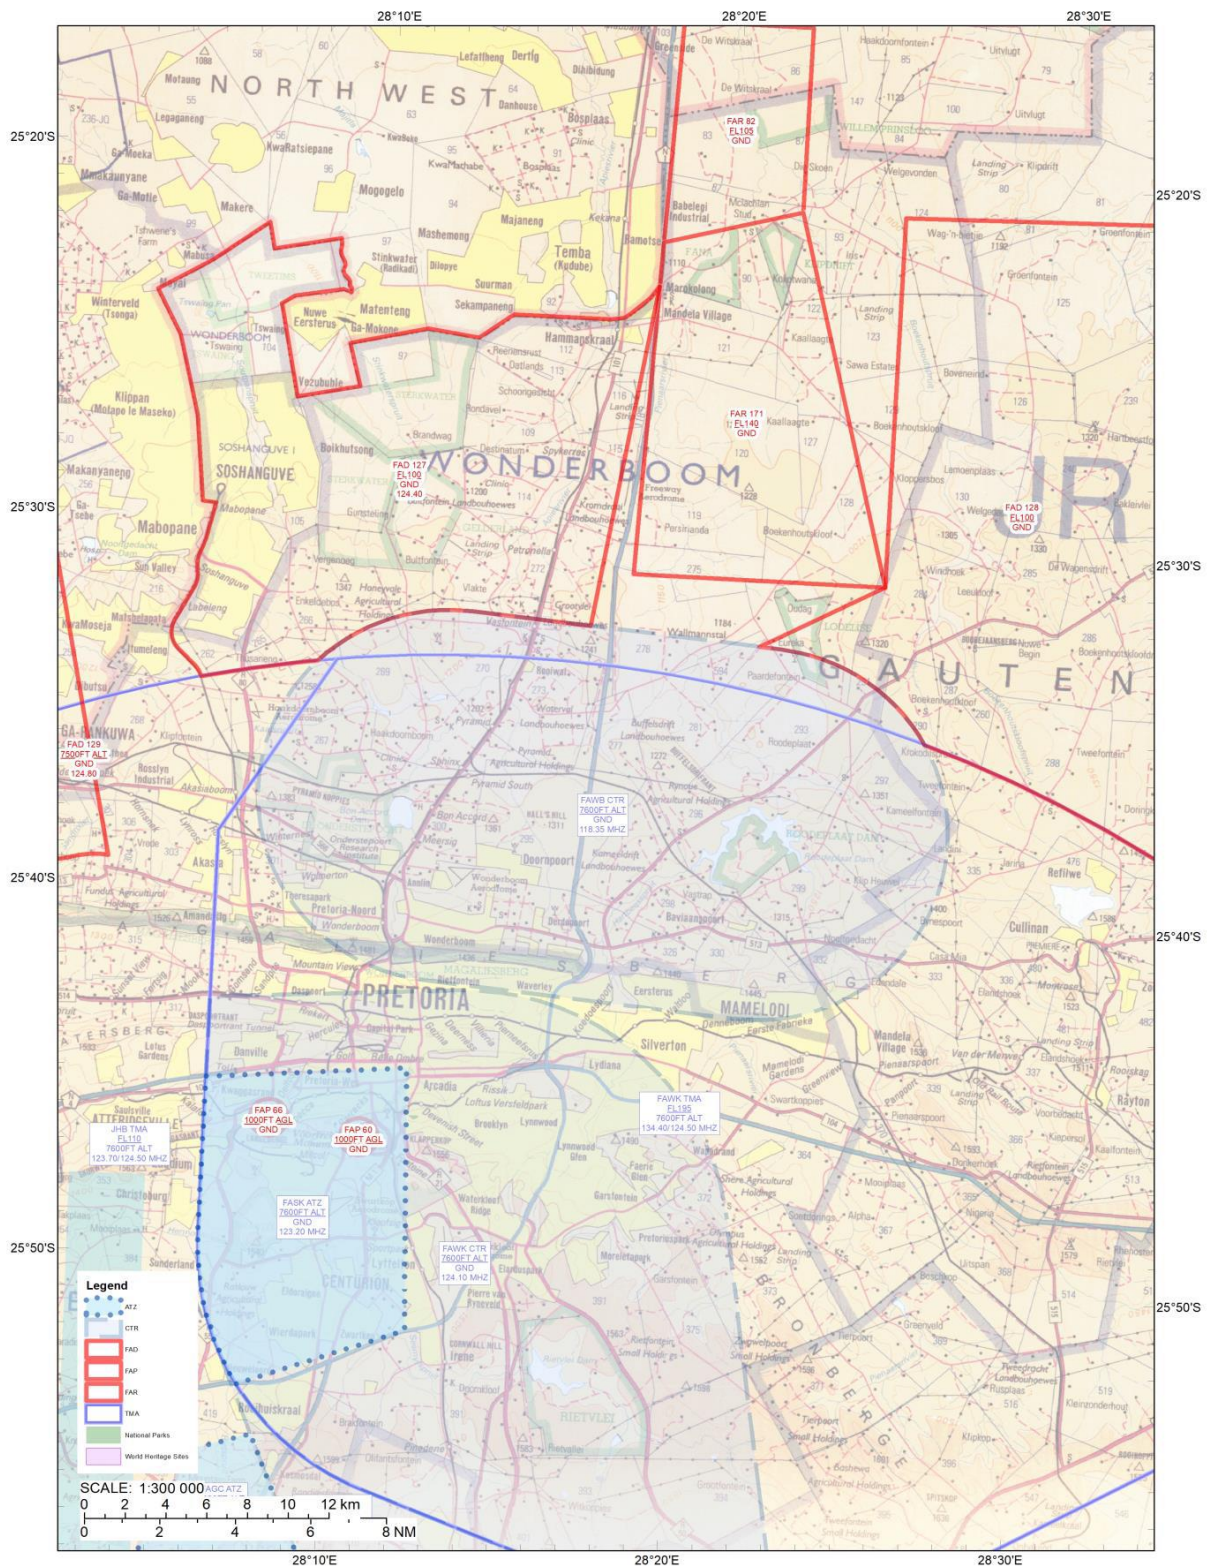
The serious incident occurred during the day at Global Positioning System (GPS) determined to be 25°29'24.95" South 028°14'25.80" East.

**Figure 2:** Airspace map indicating the incident site within FAD 127 Flying Training Area.
