<b>AIRCRAFT SERIOUS INCIDENT REPORT AND EXECUTIVE SUMMARY</b>
---

<b>Reference:</b>		CA18/3/2/1344	
<b>Aircraft Registration</b>	ZS-FIY	<b>Date of Incident</b>	22 May 2021		<b>Time of Incident</b>	1145Z	
<b>Type of Aircraft</b>	Cessna 182L		<b>Type of Operation</b>		Private (Part 91)		
<b>Pilot-in-command Licence Type</b>	Private Pilot Licence		<b>Age</b>	52	<b>Licence Valid</b>	Yes	
<b>Pilot-in-command Flying Experience</b>	<b>Total Flying Hours</b>		415.5		<b>Hours on Type</b>	318.9	
<b>Last Point of Departure</b>	Ermelo Aerodrome (FAEO), Mpumalanga Province						
<b>Next Point of Intended Landing</b>	Ermelo Aerodrome (FAEO), Mpumalanga Province						
<b>Damage to Aircraft</b>	Minor						
<b>Location of the incident site with reference to easily defined geographical points (GPS readings if possible)</b>							
Private farm, next to Arnot Power Station Airfield (GPS co-ordinates: 25°55'56.5" South 29°49'17.7" East) at an elevation of 5 625ft							
<b>Meteorological Information</b>	Surface wind: 360°/5kts, temperature: 17°C; dew point: 6°C; cloud cover: CAVOK, visibility: 9999m, QNH: 1030hPa

<b>Probable Cause and Contributory Factors</b>							
<p>During flight, the engine's num

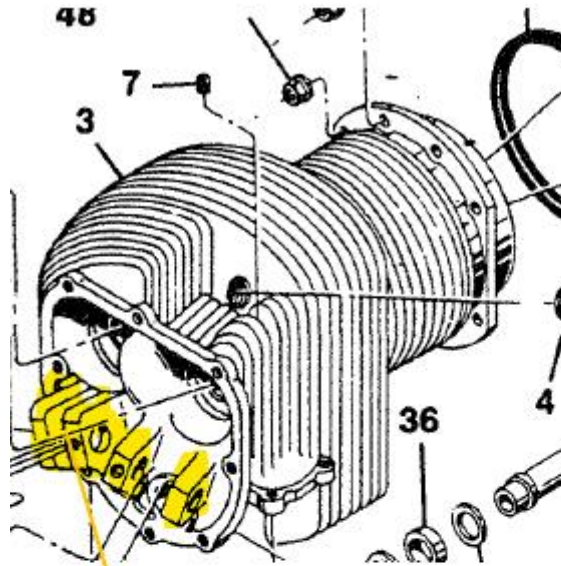
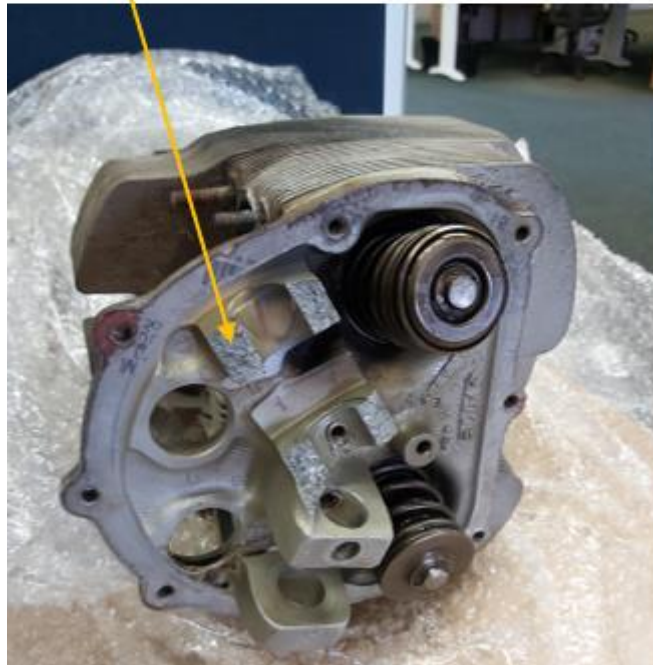
1.3.1. The aircraft sustained minor damage to the engine on cylinder number 5 and wheel fairing.

Figure 2: Damage caused to the number 5 cylinder rocker shaft boss.

- 2.2.8 Post-incident investigation established that it is likely that during the flight, the rocker shaft boss lugs failed due to fatigue, causing the engine to run rough as a result of vibration and, subsequently, lost power. The pilot followed the emergency procedures as stipulated in the POH after the engine lost power. The aircraft started losing height and the pilot executed a successful forced landing on an open grass field (farm land).

3.3.1 It is likely that during flight, the rocker shaft boss failed due to fatigue, causing the engine to run rough as a result of vibration and, subsequently, lost power.

1.6.5 Post-incident, the remaining 5 cylinders were removed and sent to the Aircraft Powerplant Company (Pty) Ltd in Pretoria for NDT (Florescent Dye Inspection and Magnetic Particle inspection) and repairs. The number 5 replacement cylinder was already inspected and repaired. All parts passed the inspections and tests that were performed on them as per the TCM SB 96-12 Part 2 and TCM Standard Practice Maintenance Manual.

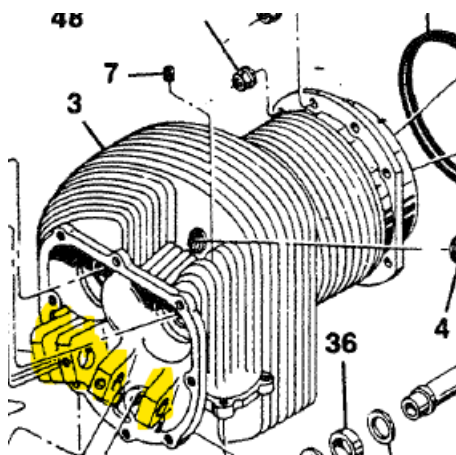
1.6.6 The boss that is highlighted in Diagram 1 is part of the cylinder. Precaution is taken when cleaning these assemblies (parts). These machined surfaces must be protected during blasting operation.

**Diagram 1:** Cylinder showing cylinder boss (highlight). (Source: Cessna 182 Service Manual)

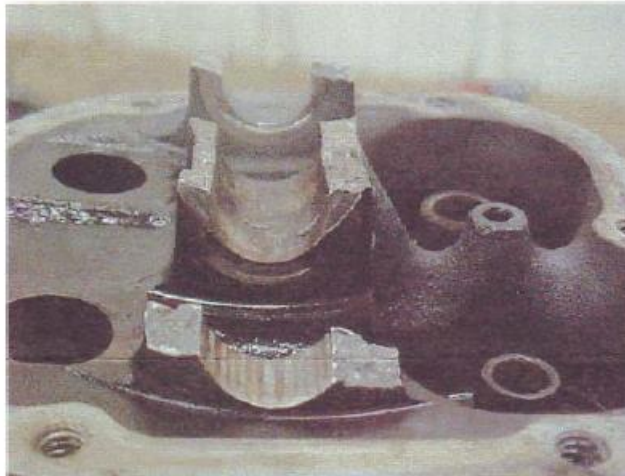
Service Difficulty Reports continue to be received describing in flight failures of cylinder rocker shaft bosses. The outer boss or lug typically breaks off at the base first, overstressing the centre boss leading to the rocker shaft breaking through the top of the centre lug or boss as the engine continued to operate. This type of failure results in a rough running engine which will not develop full RPM and power and, in some cases, may result in total engine failure.

Many failures may be attributed to not following the engine manufacturer's overhaul and maintenance instructions and / or not following good overhauling component handling practices. The bosses are cast into the head and are susceptible to any shock loading.

Alert operators and maintainers to the hazard of loss of power and in-flight engine failures resulting from rocker shaft boss failures.
