**LIMITED INCIDENT INVESTIGATION**

<b>Reference Number</b>	CA18/3/2/1346						
<b>Classification</b>	Incident	<b>Date</b>	6 June 2021	<b>Time</b>	1320Z		
<b>Type of Operation</b>	Private (Part 91)						
<b>Location</b>							
<b>Place of Departure</b>	New Tempe Airfield (FATP)	<b>Place of Intended Landing</b>	George Airport (FAGG)				
<b>Place of Incident</b>	Private farm, 6km from Sedgefield, Western Cape Province						
<b>GPS Co-ordinates</b>	<b>Latitude</b>	S 33°57'55."	<b>Longitude</b>	E 22°48'50"	<b>Elevation</b>	666ft	
<b>Aircraft Information</b>							
<b>Registration</b>	ZS-VYM						
<b>Model/Make</b>	Fairchild 24R 46A						
<b>Damage to Aircraft</b>	Minor	<b>Total Aircraft Hours</b>	988				
<b>Pilot-in-command</b>							
<b>Licence Valid</b>	Yes	<b>Gender</b>	Male	<b>Age</b>	44		
<b>Licence Type</b>	Private Pilot Licence (Aeroplane)						
<b>Total Hours on Type</b>	35		<b>Total Flying Hours</b>	211			
<b>People On-board</b>	1+0	<b>Injuries</b>	0	<b>Fatalities</b>	0	<b>Other (On Ground)</b>	0

On 6 June 2021, a Fairchild 24R 46A aircraft with registration ZS-VYM was en route to George Airfield (FAGG) from New Tempe Airfield (FATP). The pilot was the sole occupant on-board

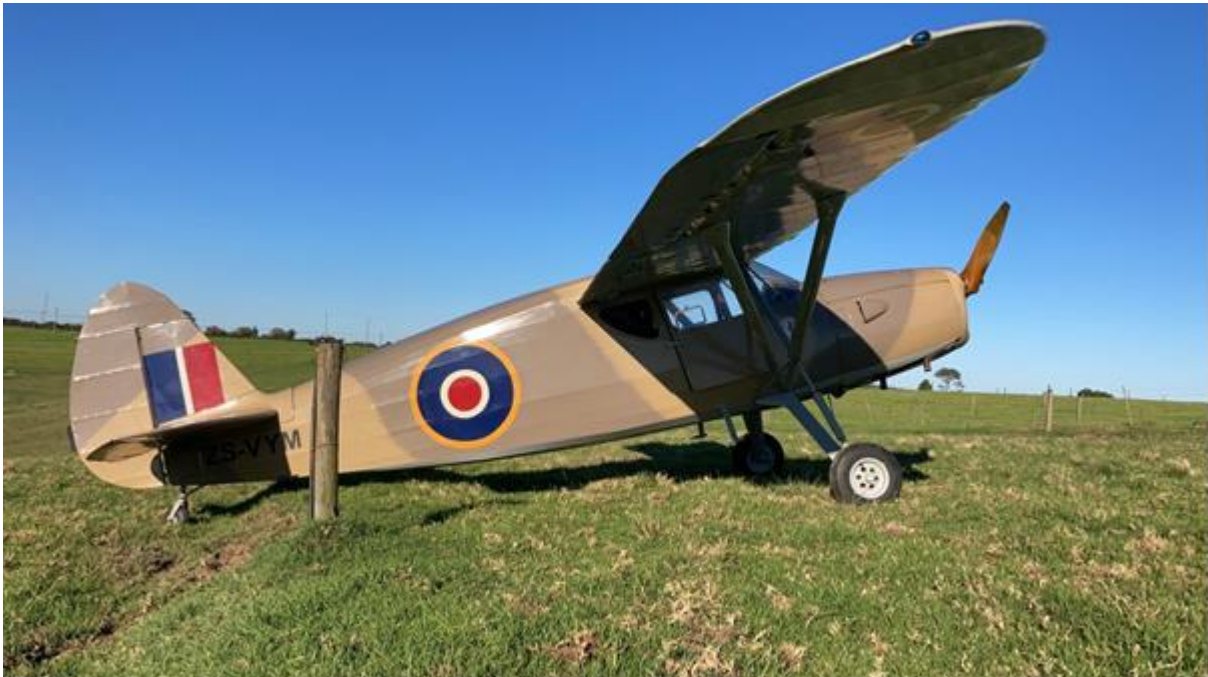
About 21 nautical miles (nm) from FAGG, the pilot heard the engine run rough and, subsequently, experienced a slight loss of power. He decided to execute a precautionary landing on an open field, a private farm in Sedgefield located about 6nm from Leppan Airfield. The aircraft landed safely with no damages, and the pilot was not injured during the landing phase. Upon landing, the pilot had just under half-a-tank of fuel remaining, according to his fuel gauge.

**Figure 1:** The aircraft as it came to rest post-incident.

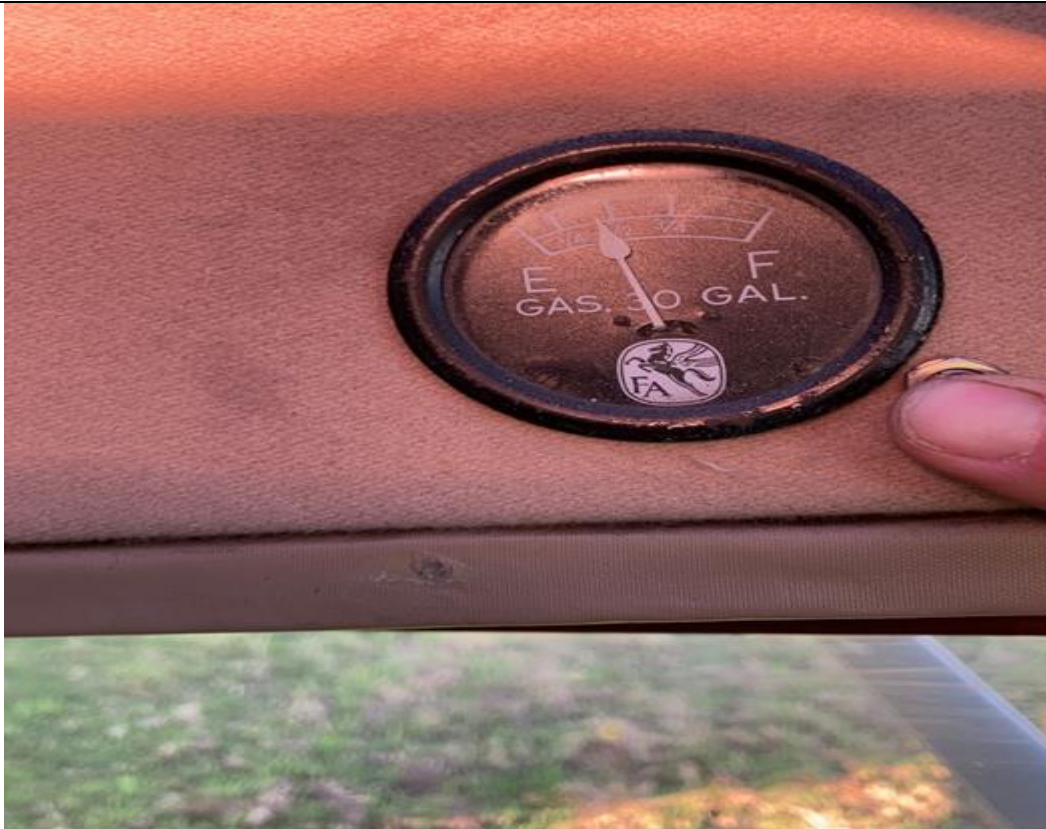
**Figure 2:** Gauge showing fuel remaining after the incident.

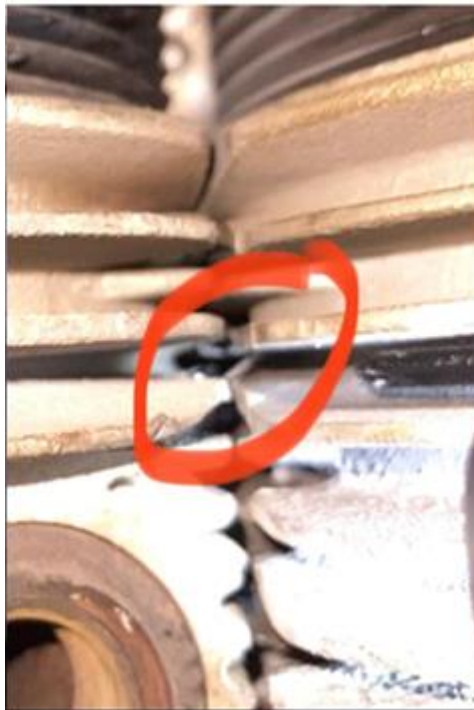
information and overhaul history was held back. Available manuals for this aircraft did not show any specific hours for overhaul as well as time between overhauls. The overhaul of 6 July 2018 was the only overhaul that the (current) owner carried out on the aircraft engine after acquiring it. The aircraft had an annual inspection carried out on 22 July 2020 at 958.1 hours by an approved person and was flown 29.9 hours before the incident date. Post-incident inspections were carried out in George (Western Cape) by an approved person and they revealed that the engine had a hole on the number five-cylinder wall, which was attributed to the rough running engine and loss of power.

The engine ran rough and lost power due to a hole on the number five-cylinder.

**Figure 3:** Hole on engine cylinder.
