**LIMITED INCIDENT INVESTIGATION**

<b>Reference Number</b>		CA18/3/2/1347					
<b>Classification</b>	Serious Incident	<b>Date</b>	10 June 2021		<b>Time</b>	1039Z	
<b>Type of Operation</b>	Part 91 (General Aviation) (Acceptance Flight)						
<b>Location</b>							
<b>Place of Departure</b>	Wonderboom National Airport (FAWB)		<b>Place of Intended Landing</b>	Wonderboom National Airport (FAWB)			
<b>Place of Incident</b>	Runway 11, Wonderboom National Airport (FAWB), Gauteng Province						
<b>GPS Co-ordinates</b>	Latitude	25°39'13.88" S	Longitude	28°13'53.63" E	Elevation	4038 ft	
<b>Aircraft Information</b>							
Registration	ZS-NDN						
Model/Make	Piper PA-31-350 Chieftain						
Damage to Aircraft	None		Total Aircraft Hours	15472.6			
<b>Pilot-in-command</b>							
Licence Type	Air Transport Pilot Licence (ATPL)		Gender	Male	Age	30	
Licence Valid	Yes						
Total Hours on Type	661.7		Total Flying Hours	2534.6			
<b>People On-board</b>	1+0	Injuries	0	Fatalities	0	Other	0

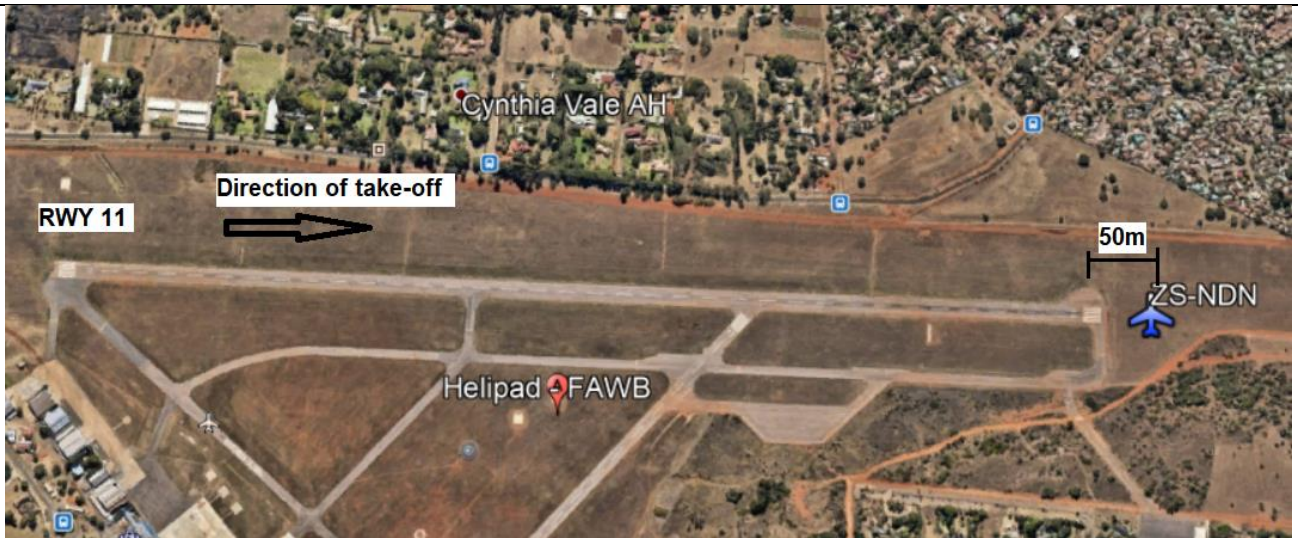
**Figure 1:** An aerial view of the incident site. (Source: Google Earth)

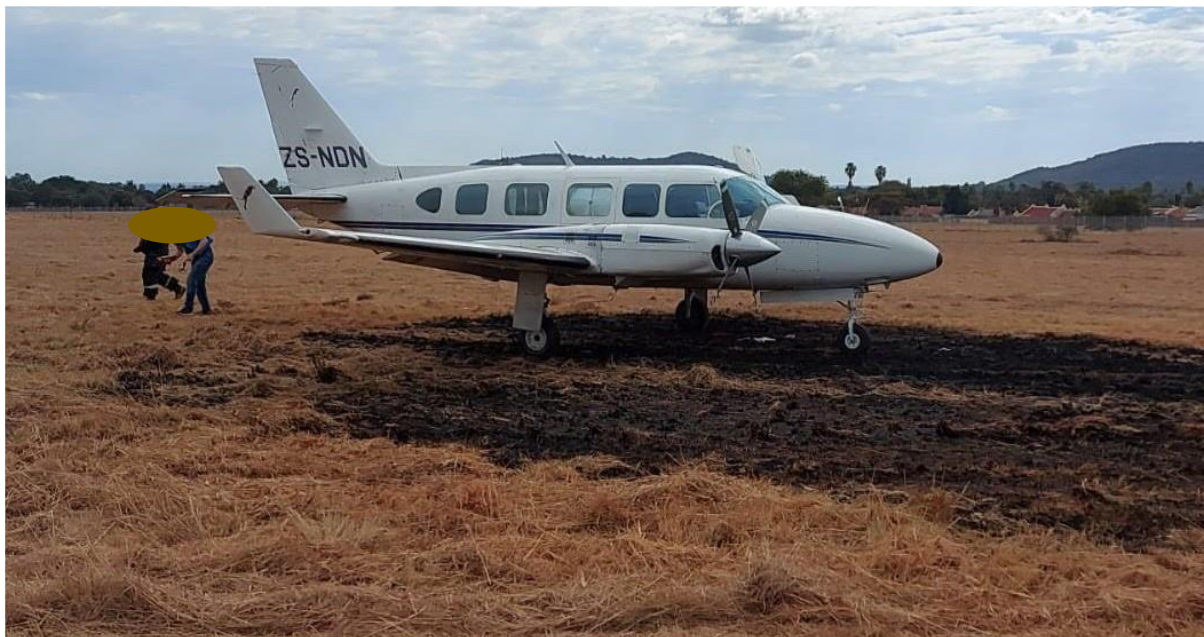
The aircraft exited the runway and came to a stop on the grass area, about 50 metres from the threshold of Runway 29. The dry grass where the aircraft had stopped was ignited by hot main landing gear brake assemblies. The pilot instantly notified the air traffic control (ATC) about the incident and requested assistance. On arrival, the FAWB fire and rescue services managed to extinguish the fire before damage was caused to the aircraft. There were no injuries reported and there was no damage to the aircraft.

**Figure 2:** The aircraft as it came to rest. (Source: Pilot)

Following the reporting of the occurrence, the pilot stated that the aircraft's elevator trim tap (located on the elevator right-side) was not correctly trimmed for take-off on the trim wheel in the cockpit, which led to the control column being heavy to pull back at rotation. The elevator trim was found in a reverse sense (position) for take-off, meaning that it was trimmed in a nose-down attitude.

<p>Probable cause:</p> <p>The aircraft failed to rotate due to the elevator trim being set to a nose-down attitude; the cause was attributed to the pilot's failure to conduct a proper pre-flight inspection prior to initiating his flight.</p>
<p><b>Safety Action/s</b></p>
<p>As a result of this occurrence, the pilot informed the AIID that to ensure that a similar occurrence does not happen to him again, he would diligently carry out the before take-off checks going forward.</p>
<p><b>Safety Message and/or Safety Recommendation/s</b></p>
<p>Safety message: Pilots are advised to always carry out a proper pre-flight inspection and follow the pre-flight checklist at all times when conducting a pre-flight inspection.</p>
<p><b>Purpose of the Investigation</b></p>
<p><i>In terms of Regulation 12.03.1 of the Civil Aviation Regulations (CAR) 2011, this report was compiled in the interest of the promotion of aviation safety and the reduction of the risk of aviation accidents or incidents and <b>not to apportion blame or liability.</b></i></p>
